DATE: January 28, 2026

TO: Emily Brickman, P.G., *Senior Project Manager – Geologist, EnSafe*

FROM: Caleb Gourley, *Senior Staff Scientist, Harbor*

RE: Bi-weekly Site Inspection
NABORS Landfill
Mountain Home, AR
Harbor Project No: L8247885

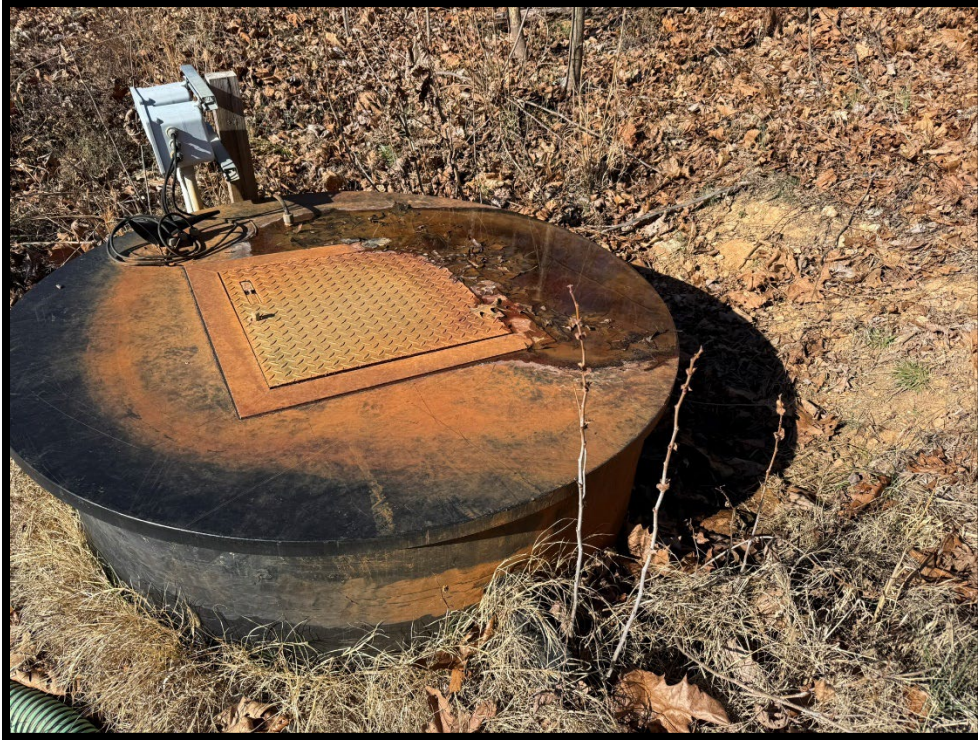
- Vertical leachate collection sump (VLCS)-1 was not functioning correctly, and the sump was observed at capacity and overflowing (see photographs 1-2).
-

Photograph 1: View of VLCS-1 overflowing.

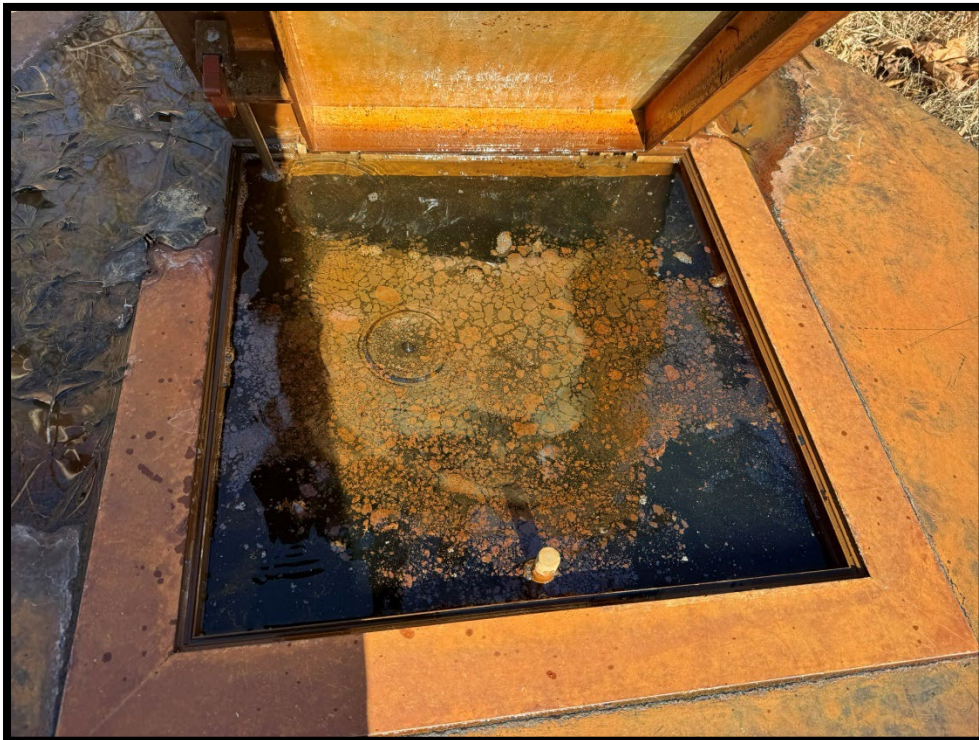
Photograph 2: View of VLCS-1 at capacity.

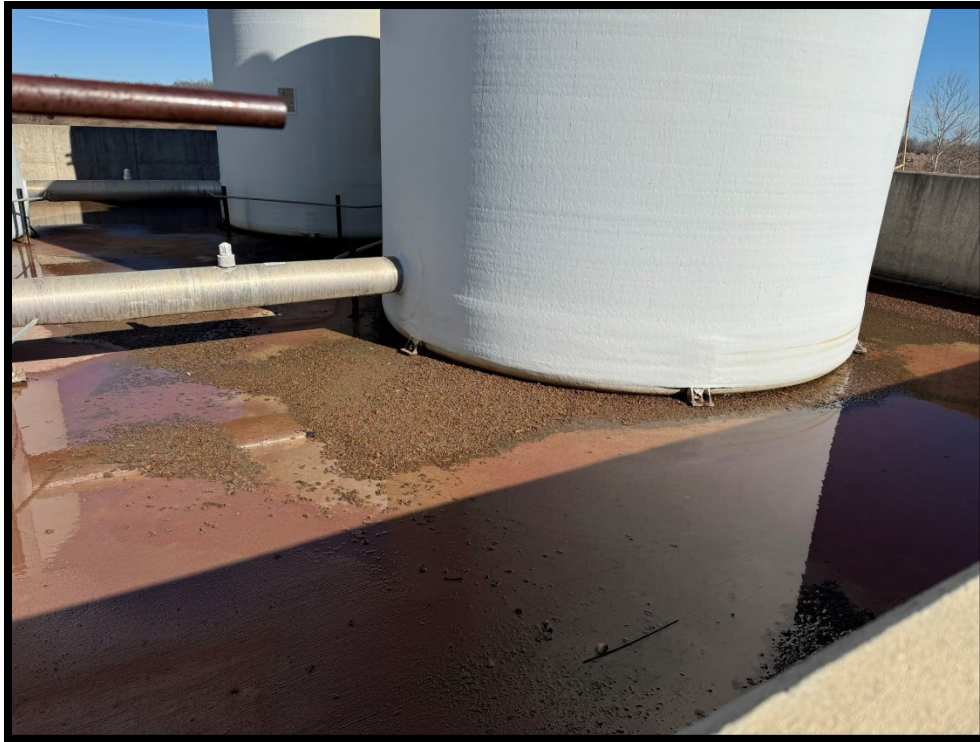
- VLCS-2 appeared to be functioning correctly and was observed at 1/2 capacity.
 - The leachate tank battery level was 86.3 inches.
 - Minimal stormwater was observed in the leachate tank containment. As such, no stormwater was released from the containment (see photograph 3).

Photograph 3: View of minimal stormwater in leachate tank containment.

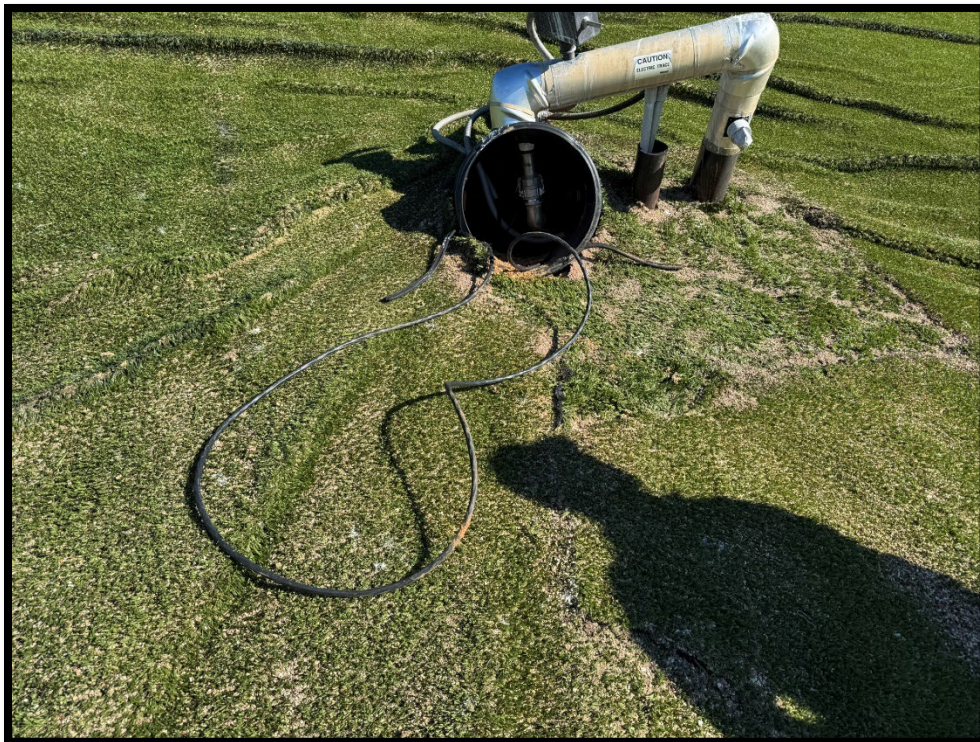
- LCS-4 displayed a leachate level of 20.7 inches. The station appeared to be operating in both "hand" and "auto" modes. The wooden end cap on the sump housing had been removed and wire trace pulled out of the sump housing. The wire trace was tucked back inside the housing and wood cap was replaced (see photograph 4).

Photograph 4: View of wire trace and wooden cover removed from LCS-4 sump housing.

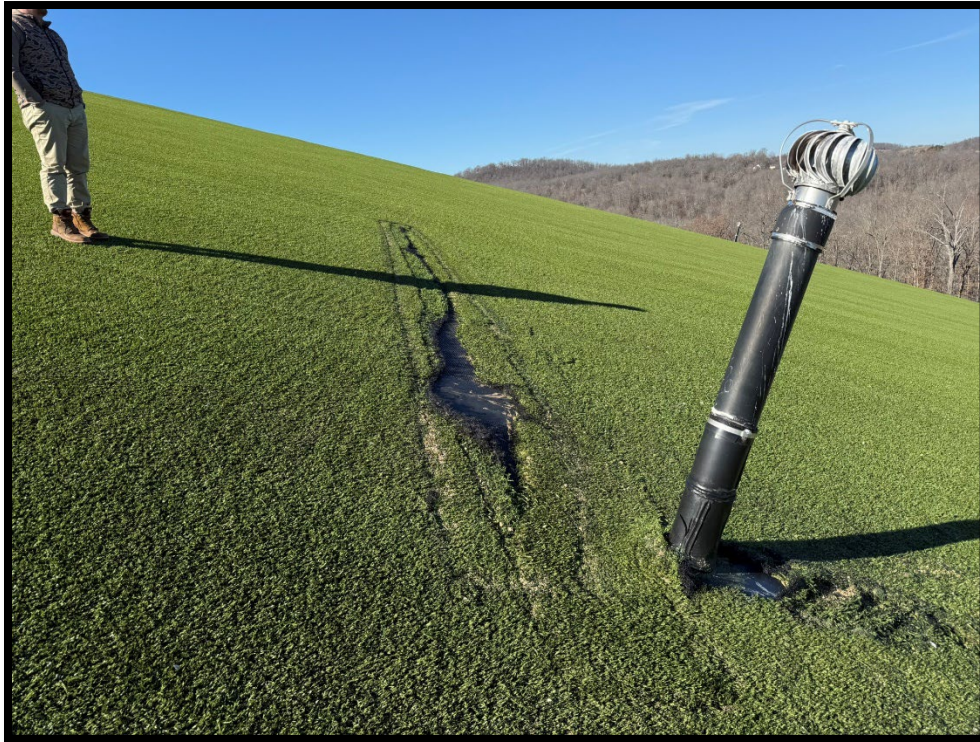
- Damaged closure turf (DCT-1) was observed on the north side of Area 1-2 at coordinates 36.46181, -92.45045. The damage is approximately 30 feet long by 3 feet wide. The damage was first observed on July 2, 2025. An additional crack has developed, spurring off the original, that extends approximately 20 feet (see photographs 5-6).

Photograph 5: View of DCT-1 on north side of Area 1-2, at 36.46181, -92.45045.

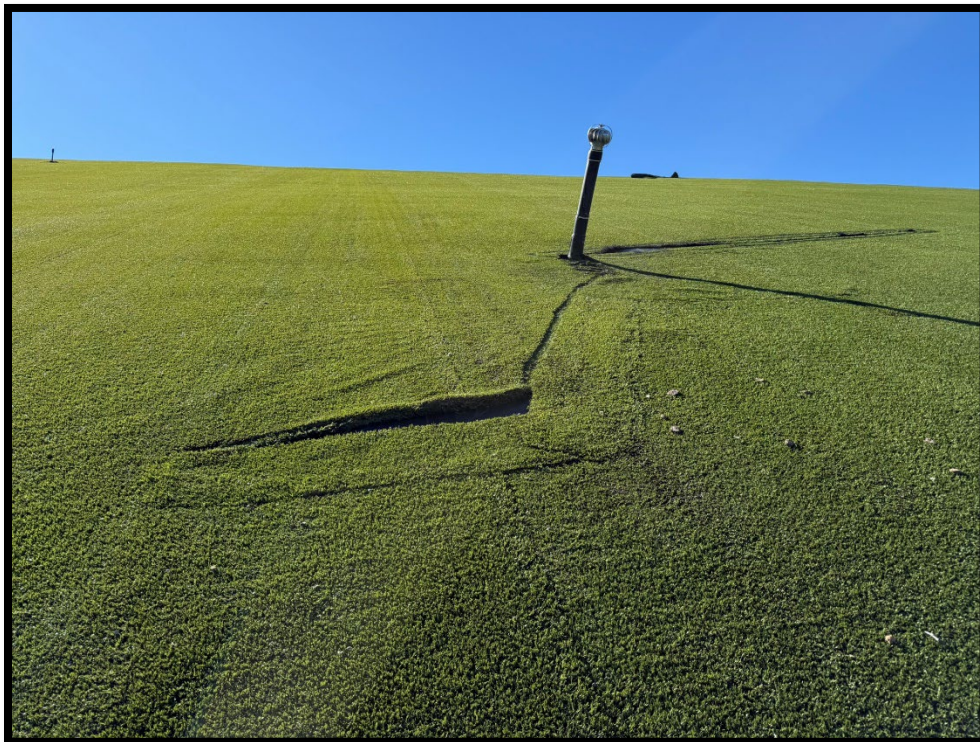
Photograph 6: View of additional damage related to DTC-1 on north side of Area 1-2.

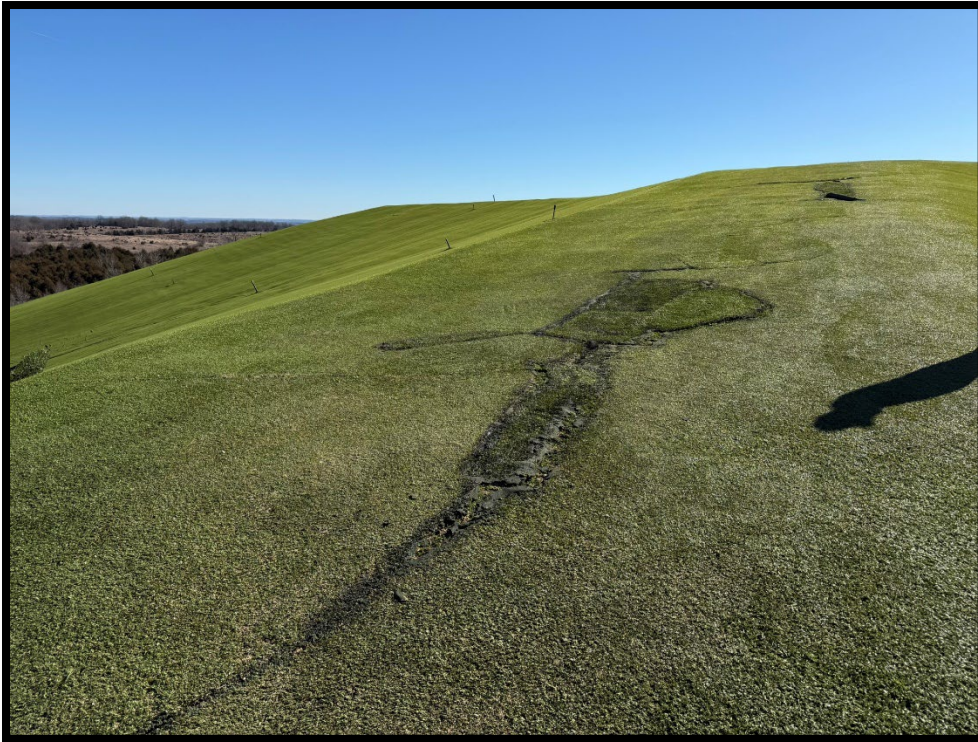
- Additional closure turf damage (DCT-2) was observed on the north side of Area 1-2 near coordinates 36.461453, -92.450493. The damage consists of several areas where closure turf patches have failed or are beginning to fail (see photographs 7-8).

Photograph 7: View of DCT-2 on top of north side of Area 1-2, near 36.461453, -92.450493.

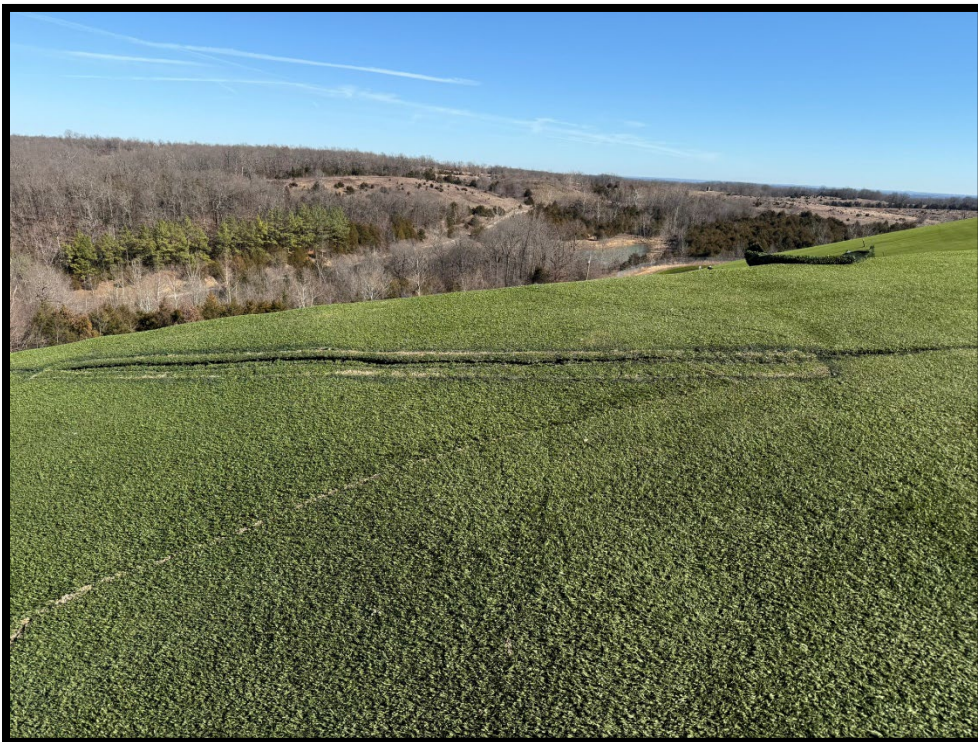
Photograph 8: View of DCT-2 on top of north side of Area 1-2, near 36.461453, -92.450493.

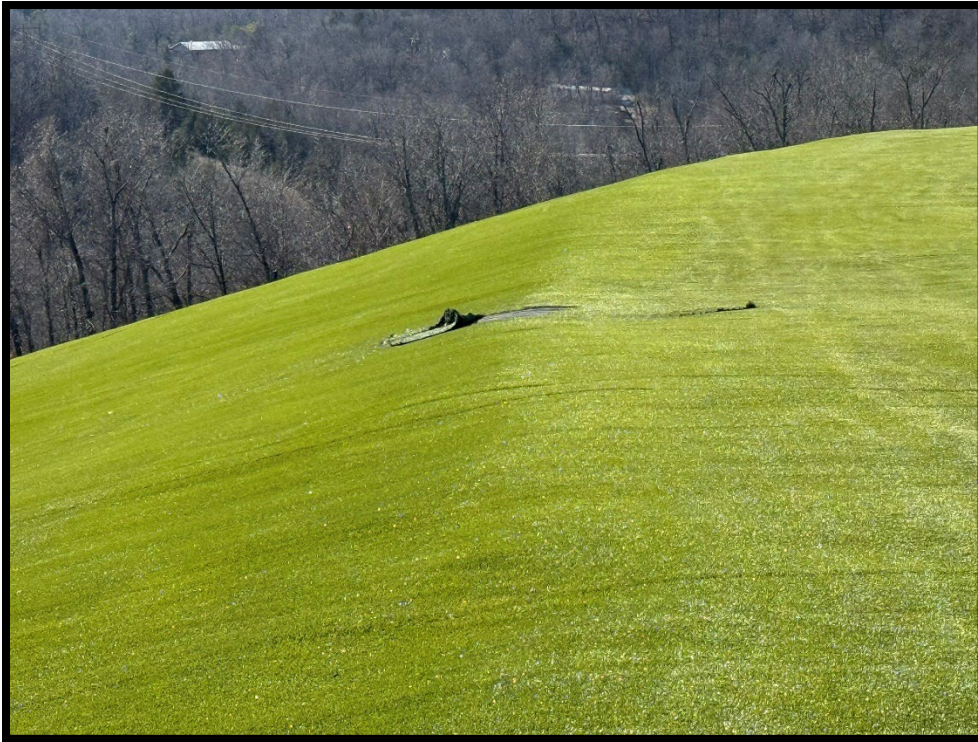
- Additional closure turf damage (DCT-3) was observed on the south side of Area 1-2 near coordinates 36.460177, -92.450569, above LCS-2 (see photographs 9-10).

Photograph 9: View of DCT-3 on south side of Area 1-2, above LCS-2 near 36.460177, -92.450569.

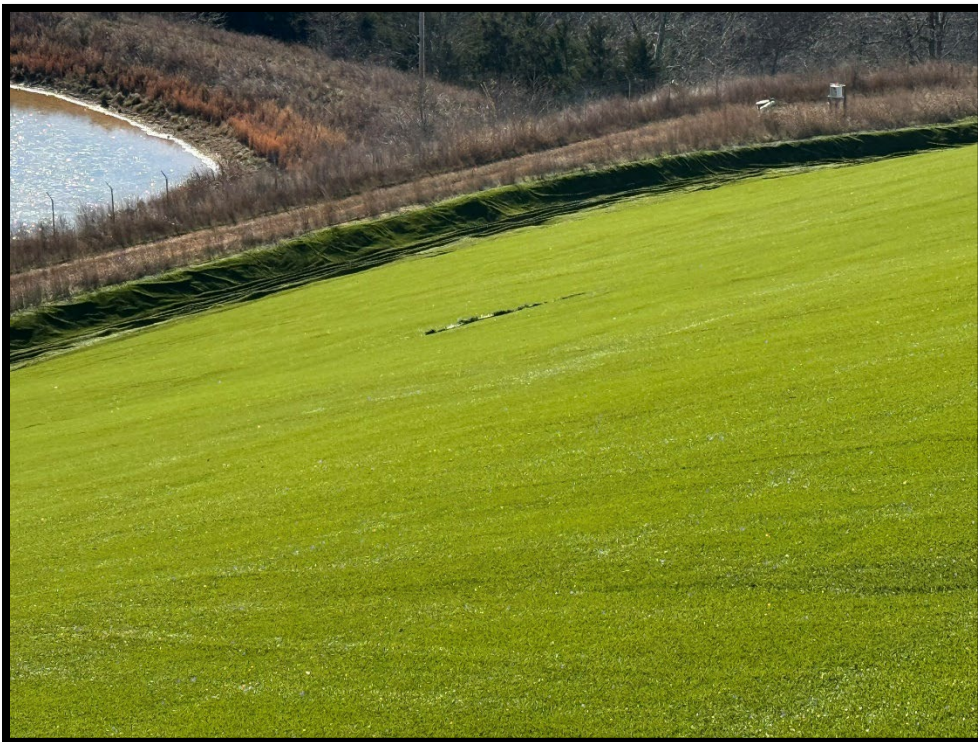
Photograph 10: View of DCT-3 on south side of Area 1-2, above LCS-2 near 36.460177, -92.450569.

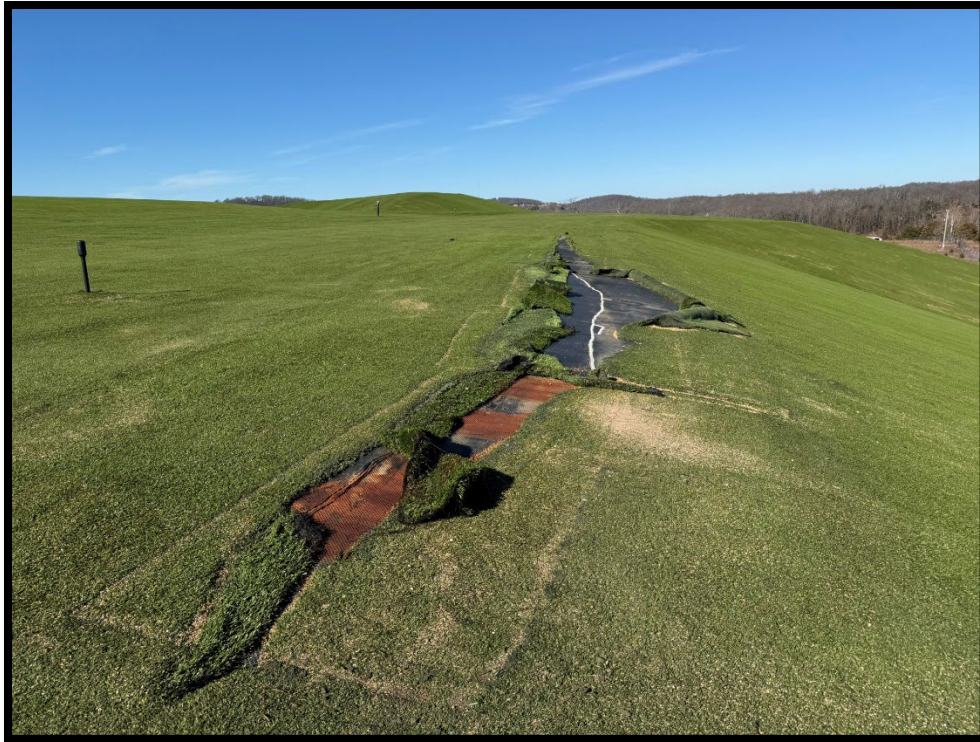
- Damaged closure turf (DCT-4) was observed on the east side of Area 1-3, above LCS-7. The damage is approximately 100 feet long by 9 feet wide near coordinates 36.459656, -92.445638. The closure turf tear was first observed on June 17, 2025 (see photograph 11).
-

Photograph 11: View of DCT-4 on east side of Area 1-3, above LCS-7 near 36.459656, -92.445638.
