**DATE:** January 7, 2026

**TO:** Emily Brickman, P.G., *Senior Project Manager – Geologist, EnSafe*

**FROM:** Caleb Gourley, *Senior Staff Scientist, Harbor*

**RE:** Bi-weekly Site Inspection  
NABORS Landfill  
Mountain Home, AR  
*Harbor Project No: L8247885*

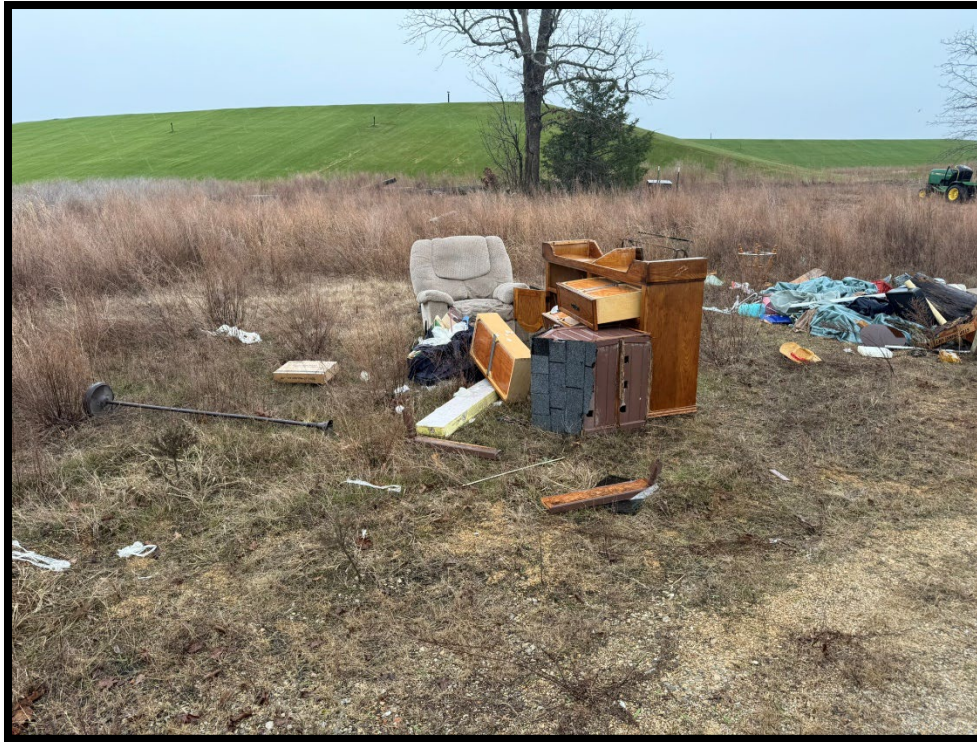
- When Harbor arrived on-site, the main entrance gate was in a fully opened position, and it appeared as though someone had tampered with one of the locks on the gate. Once inside, Harbor personnel discovered that general household refuse had been dumped near the leachate tank containment area (see photographs 1 – 2).
  - Vertical leachate collection sump (VLCS)-1 was not functioning correctly, and the sump was observed at capacity and overflowing (see photographs 3 – 4).
  - VLCS-2 appeared to be functioning correctly and was observed at 1/2 capacity.
-

**Photograph 1:** View of discarded refuse near leachate tank containment.

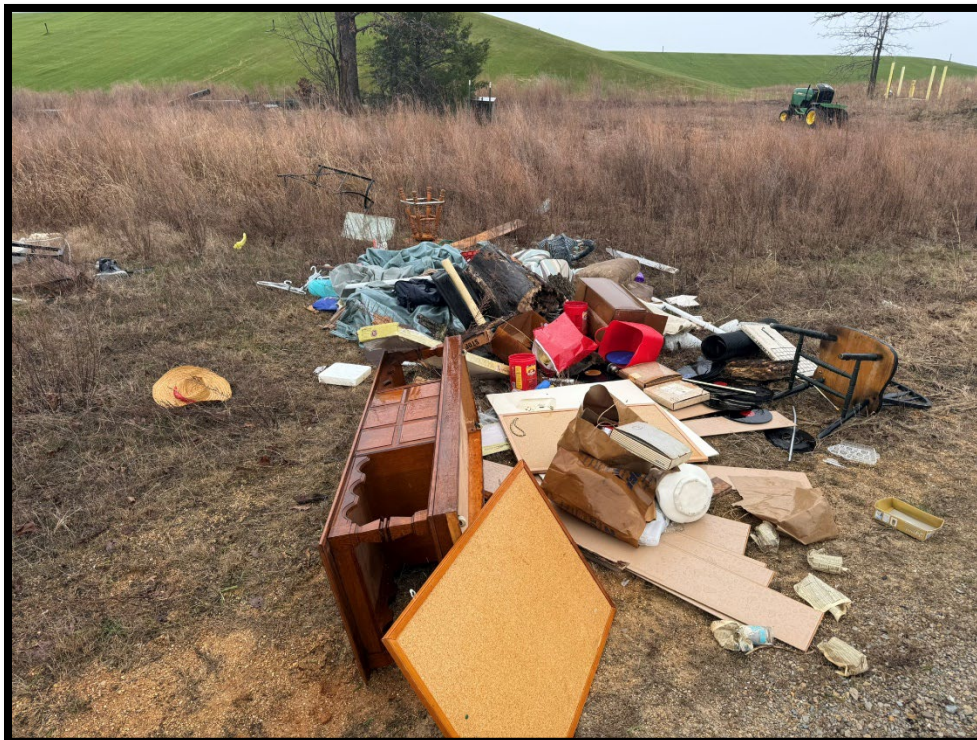
**Photograph 2:** View of discarded refuse near leachate tank containment.

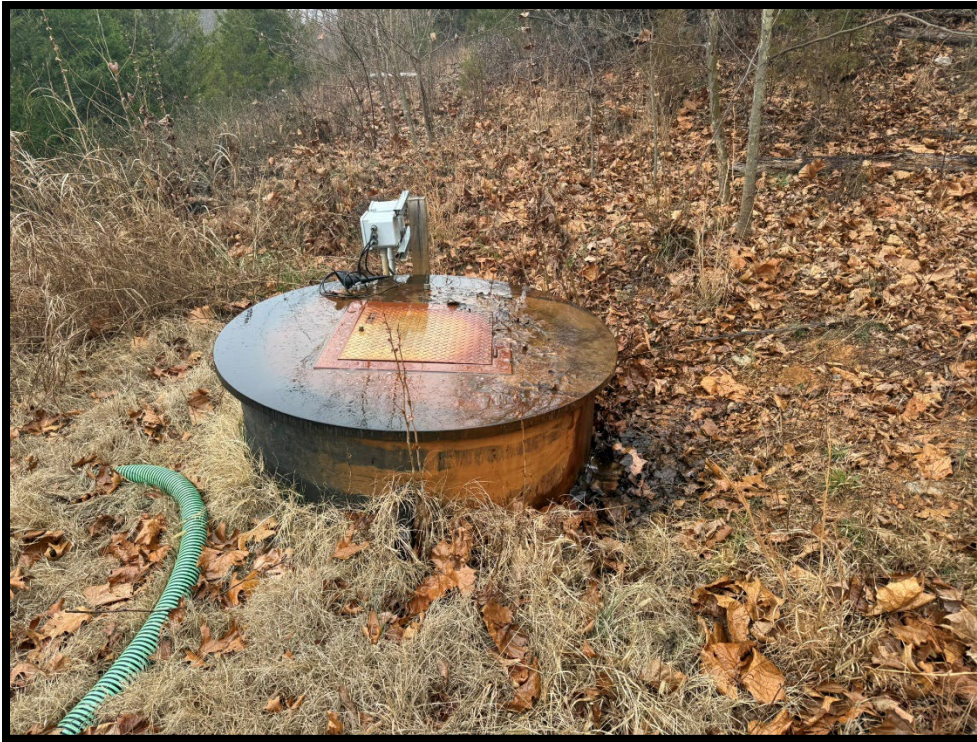
**Photograph 3:** View of VLCS-1 overflowing.

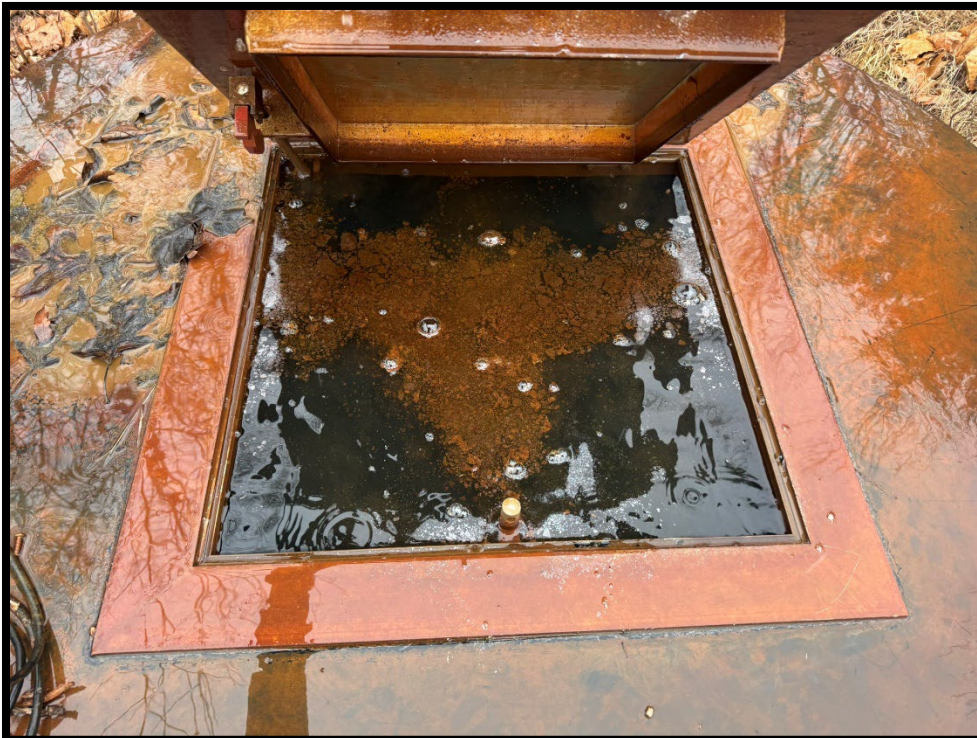
**Photograph 4:** View of VLCS-1 at capacity.
