DATE: February 6, 2026

FROM: Ian Klein, P.E., *Project Engineer, Harbor*

RE: Bi-weekly Site Inspection
NABORS Landfill
Mountain Home, AR
Harbor Project No: L8247885

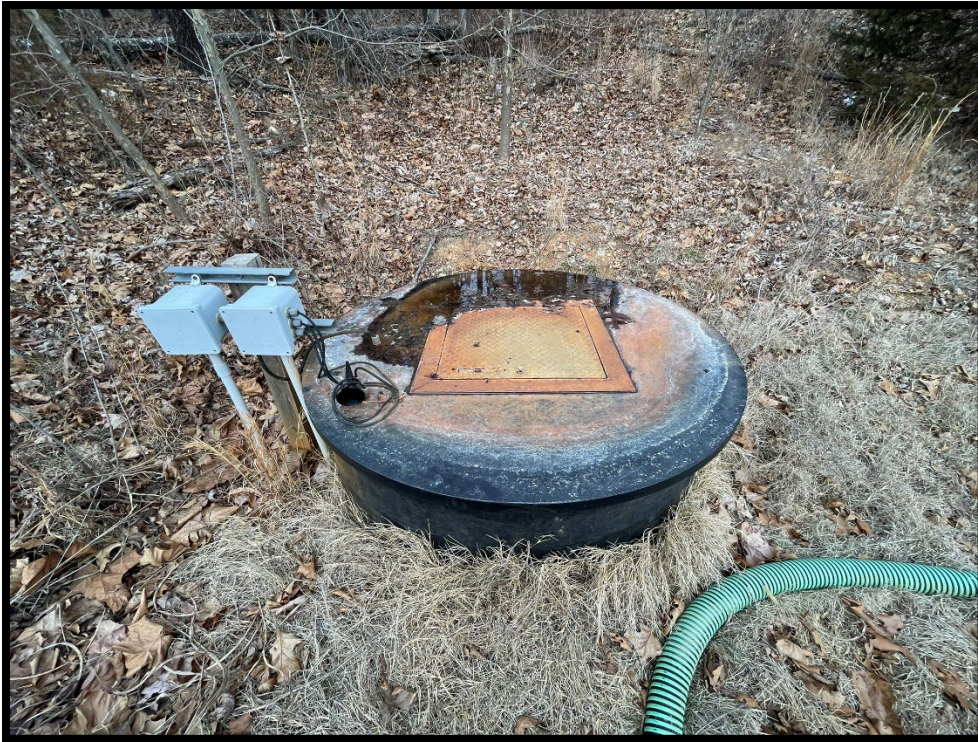
- Vertical leachate collection sump (VLCS)-1 was not functioning correctly, and the sump was observed at capacity and overflowing (see photograph 1).
-

Photograph 1: View of VLCS-1 overflowing.

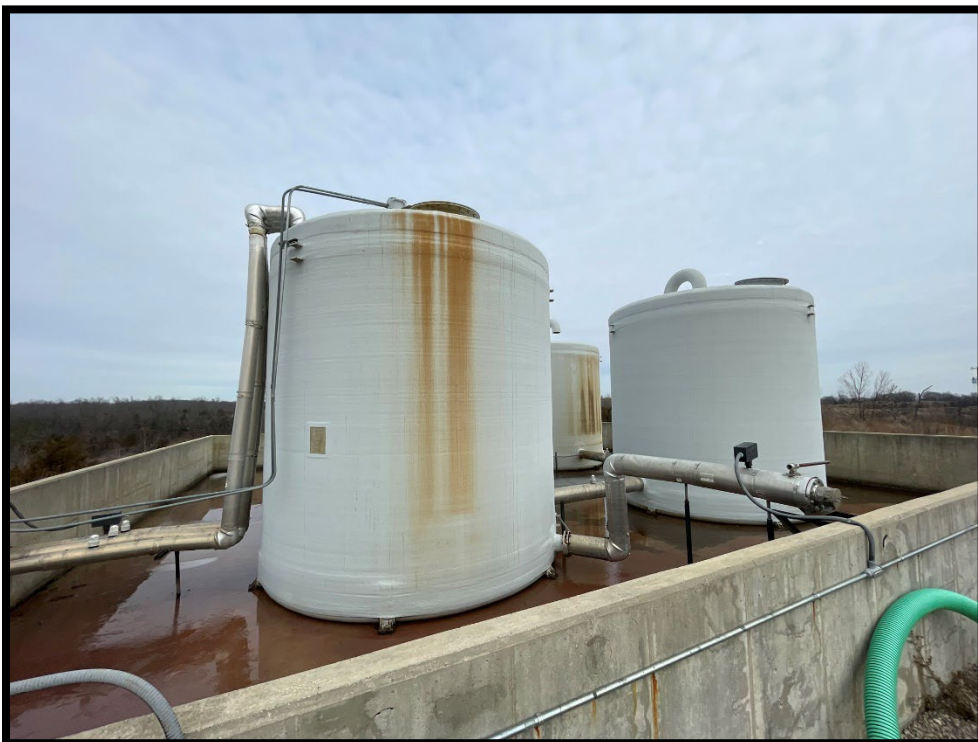
- VLCS-2 appeared to be functioning correctly and was observed at 1/2 capacity.
- The leachate tank battery level was 86.0 inches.
- Minimal stormwater was observed in the leachate tank containment. As such, no stormwater was released from the containment (see photograph 2).

Photograph 2: View of minimal stormwater in leachate tank containment.

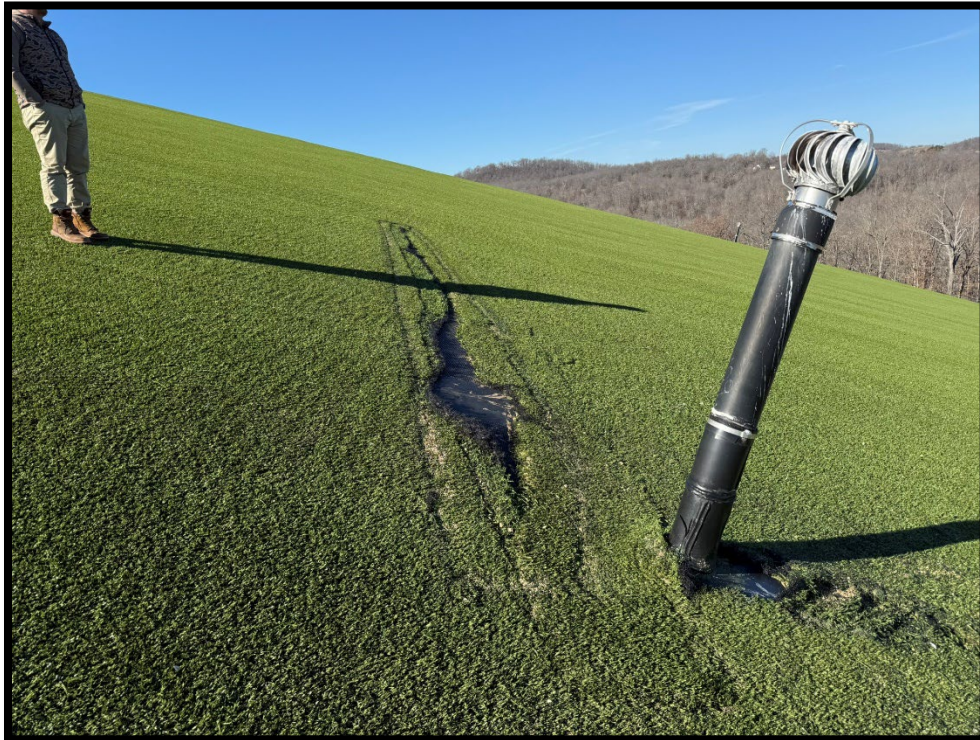
- Damaged closure turf (DCT-1) was observed on the north side of Area 1-2 at coordinates 36.46181, -92.45045. The damage is approximately 30 feet long by 3 feet wide. The damage was first observed on July 2, 2025. An additional crack has developed, spurring off the original, that extends approximately 20 feet (see photographs 3-4).

Photograph 3: View of DCT-1 on north side of Area 1-2, at 36.46181, -92.45045.

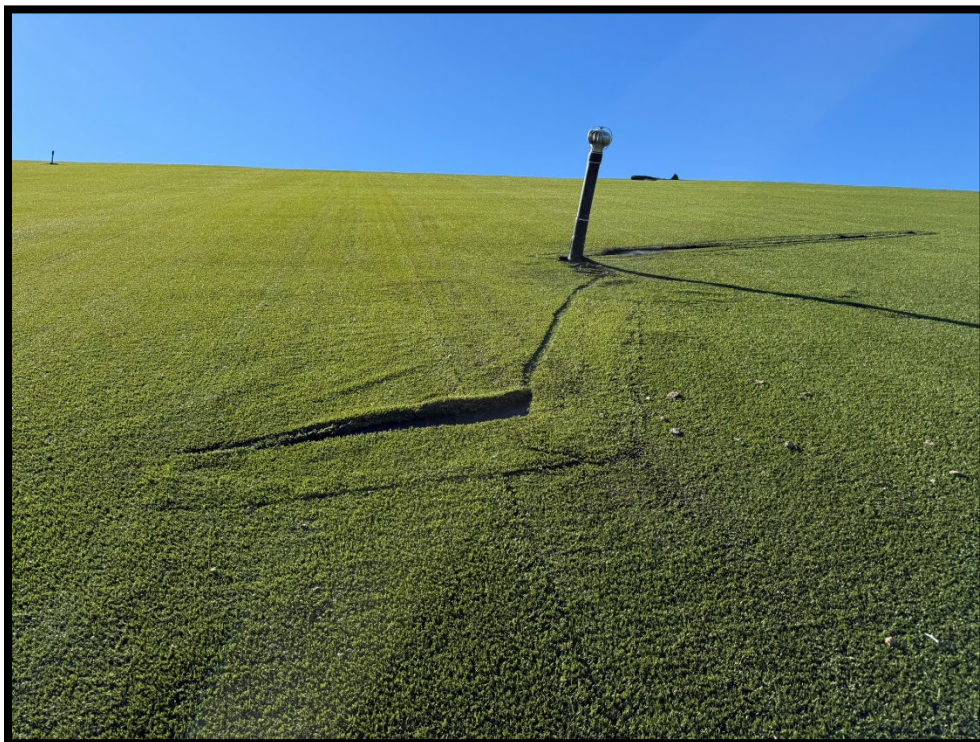
Photograph 4: View of additional damage related to DTC-1 on north side of Area 1-2.

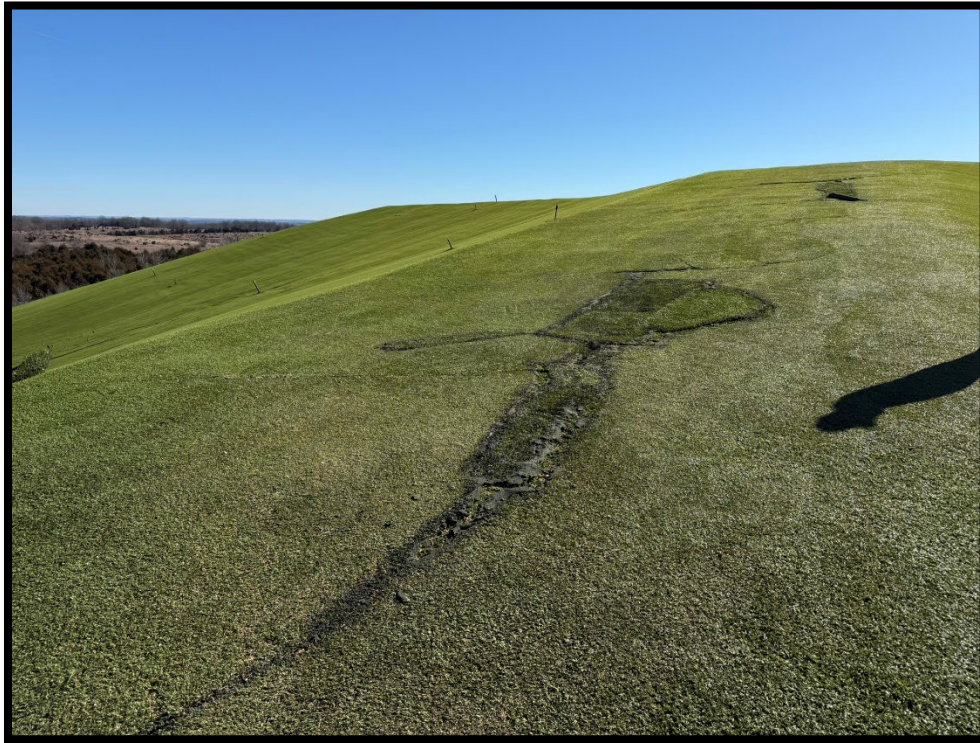
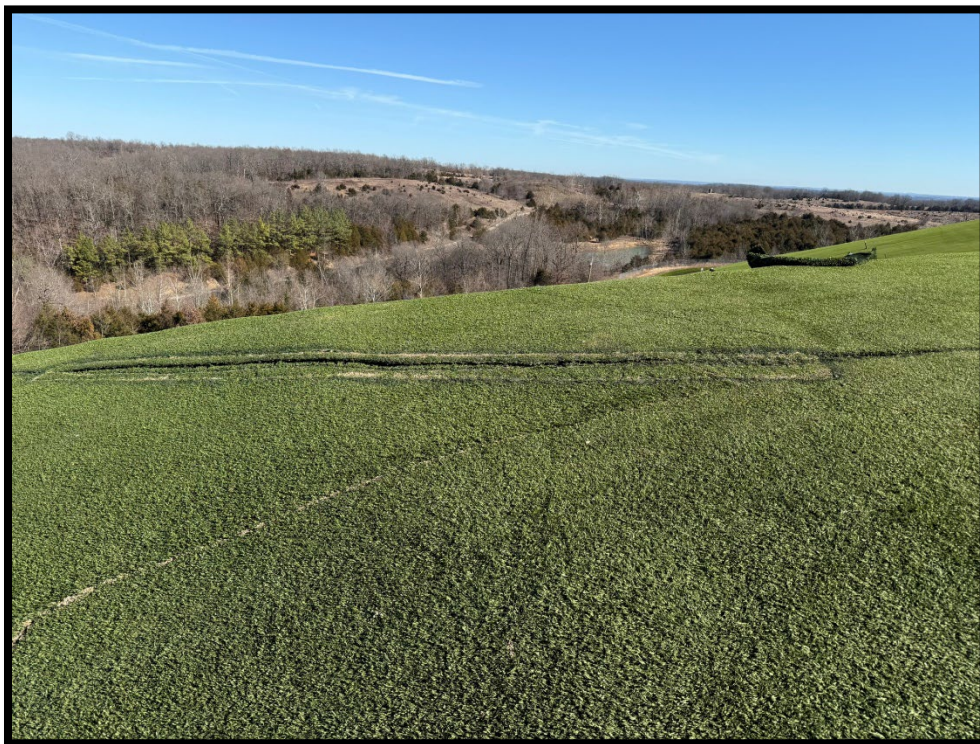
- Additional closure turf damage (DCT-2) was observed on the north side of Area 1-2 near coordinates 36.461453, -92.450493. The damage consists of several areas where closure turf patches have failed or are beginning to fail (see photographs 5-6).

Photograph 5: View of DCT-2 on top of north side of Area 1-2, near 36.461453, -92.450493.

Photograph 6: View of DCT-2 on top of north side of Area 1-2, near 36.461453, -92.450493.

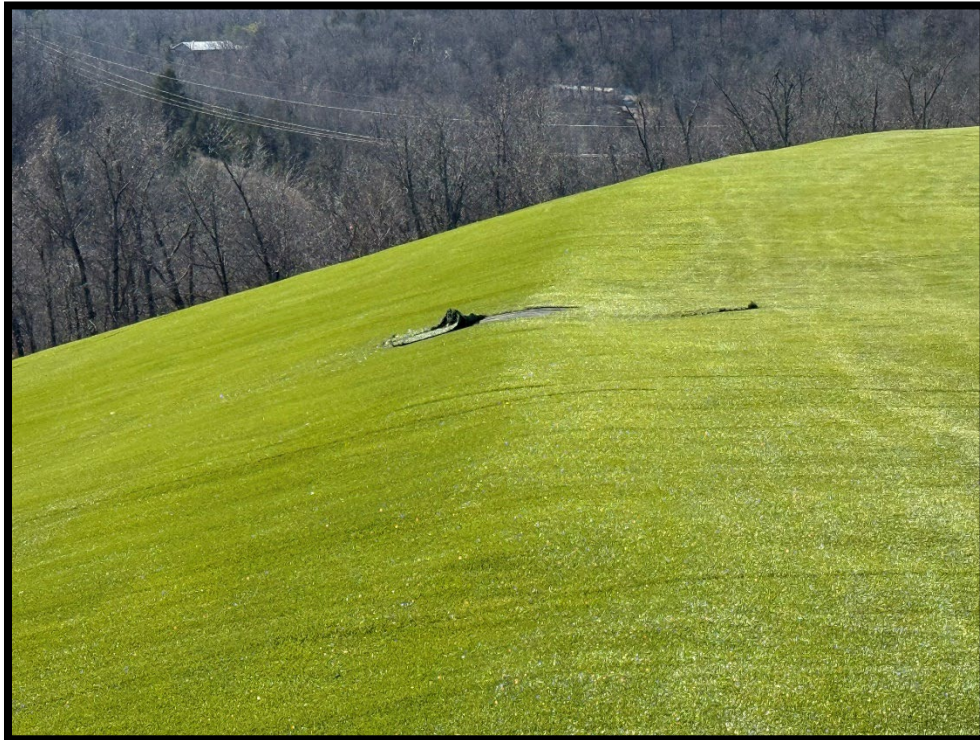
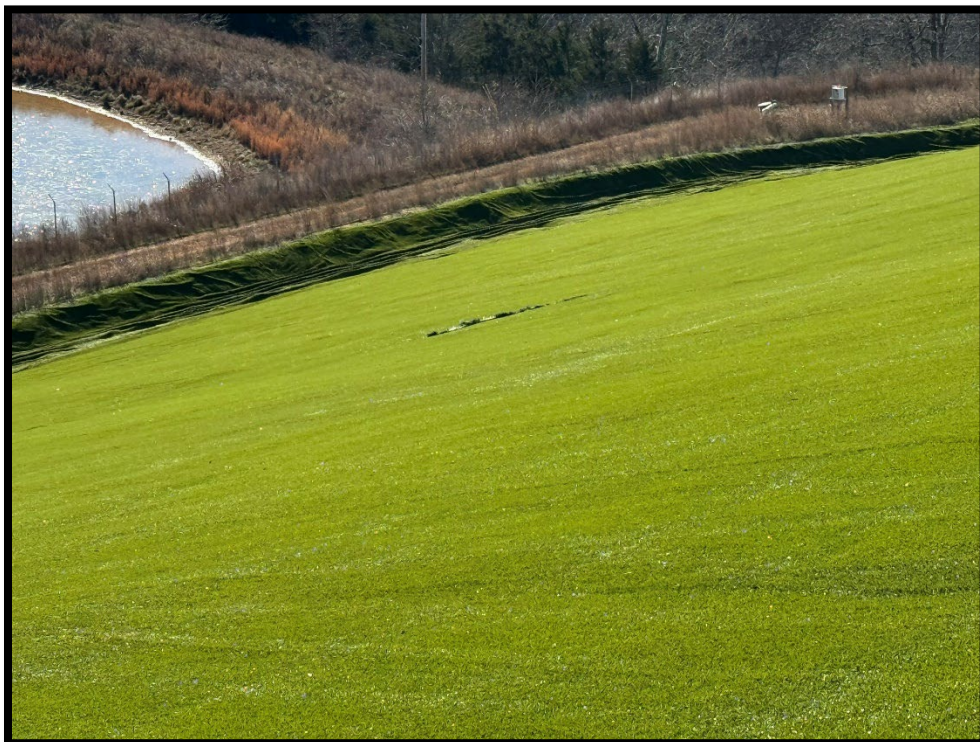
- Additional closure turf damage (DCT-3) was observed on the south side of Area 1-2 near coordinates 36.460177, -92.450569, above LCS-2 (see photographs 7-8).

Photograph 7: View of DCT-3 on south side of Area 1-2, above LCS-2 near 36.460177, -92.450569.

Photograph 8: View of DCT-3 on south side of Area 1-2, above LCS-2 near 36.460177, -92.450569.

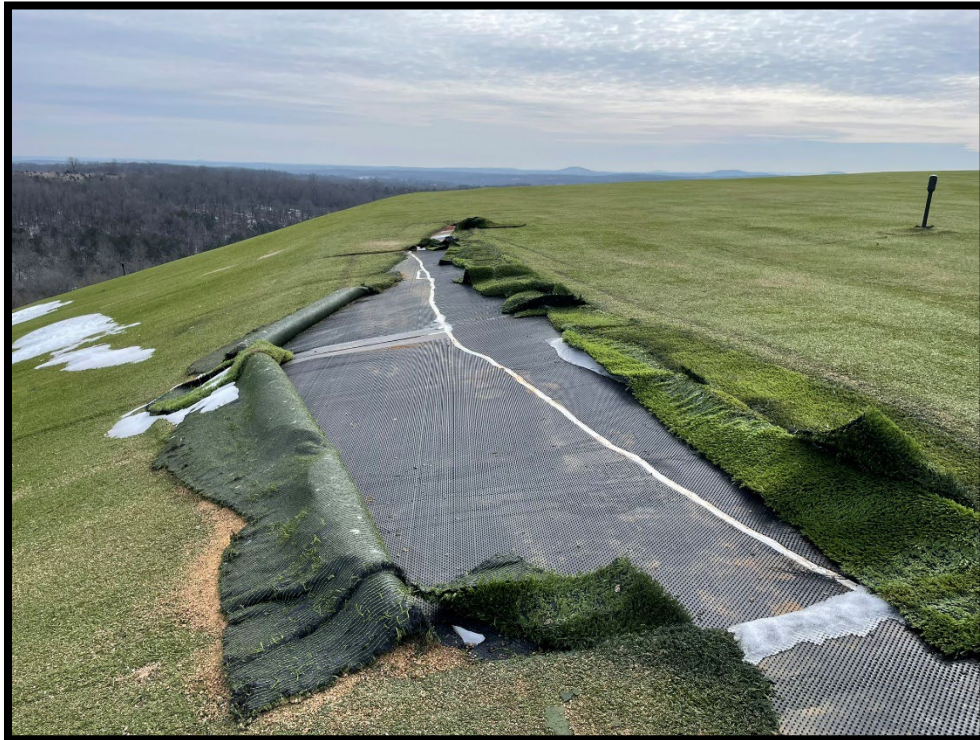
- Damaged closure turf (DCT-4) was observed on the east side of Area 1-3, above LCS-7. The damage is approximately 100 feet long by 9 feet wide near coordinates 36.459656, -92.445638. The closure turf tear was first observed on June 17, 2025 (see photograph 9).

Photograph 9: View of DCT-4 on east side of Area 1-3, above LCS-7 near 36.459656, -92.445638.
