DATE: April 30, 2026

RE: Bi-weekly Site Inspection #1
NABORS Landfill
Mountain Home, AR
Harbor Project No: L8257760

Harbor conducted the bi-weekly site visit at the NABORS landfill in Mountain Home, Arkansas on April 17, 2026, to assess the general condition of the landfill and the leachate collection system (LCS).

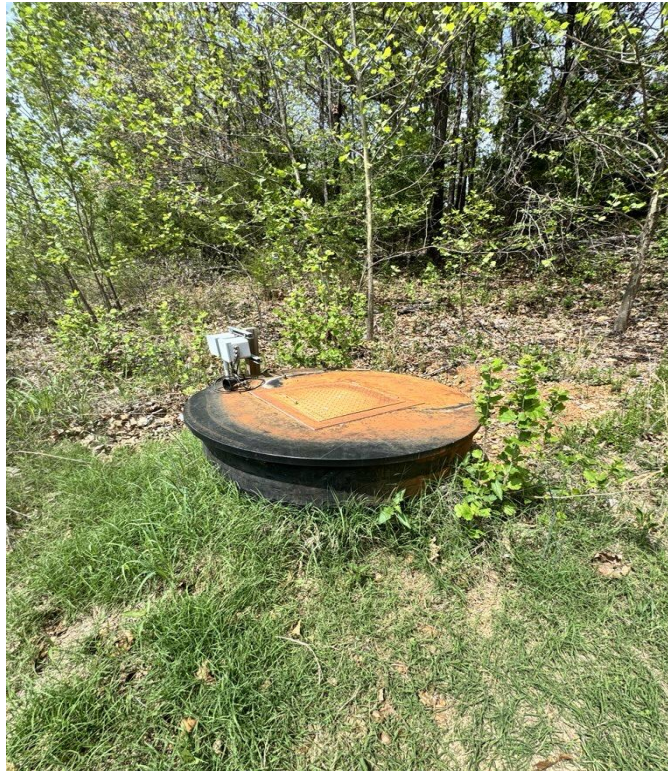
- Vertical leachate collection sump (VLCS)-1 was not functioning correctly, and the sump was observed at 1/2 capacity (see photograph 1).
 - VLCS-2 appeared to be functioning correctly and was observed at 1/2 capacity.
 - The leachate tank battery level was 22.4 inches.
 - Minimal stormwater was observed in the leachate tank containment. As such, no stormwater was released from the containment (see photograph 2).
-

Photograph 1: View of VLCS-1. Staining from past overflows is visible on the lid.

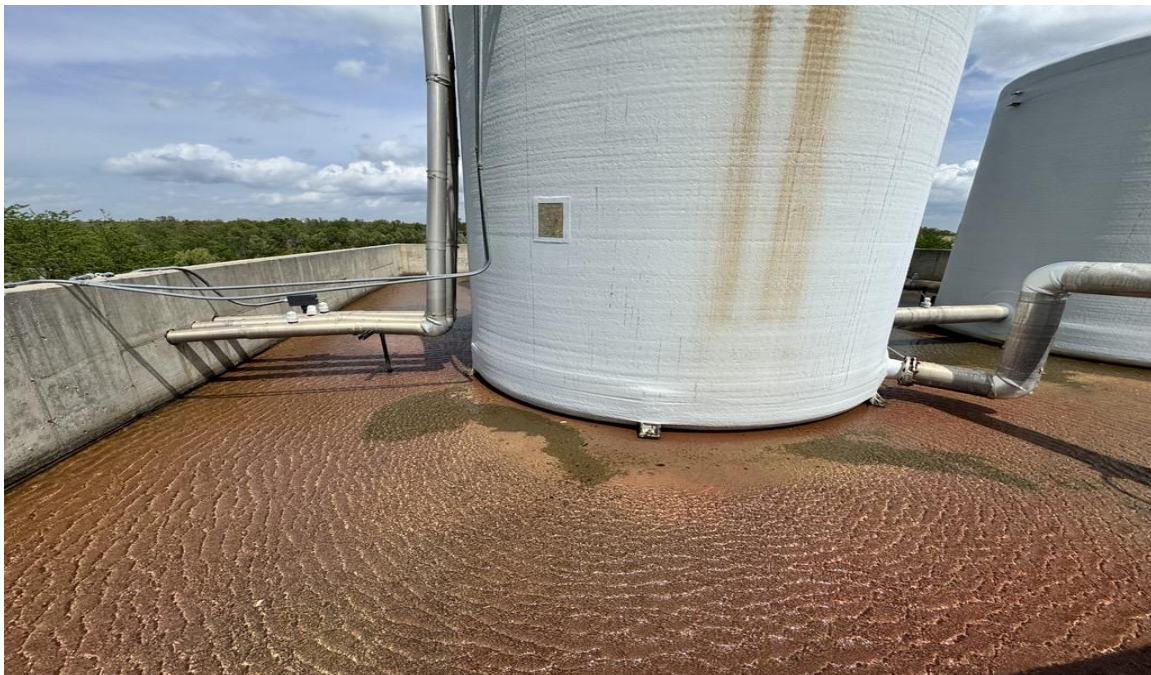
Photograph 2: View of minimal stormwater in leachate tank containment.

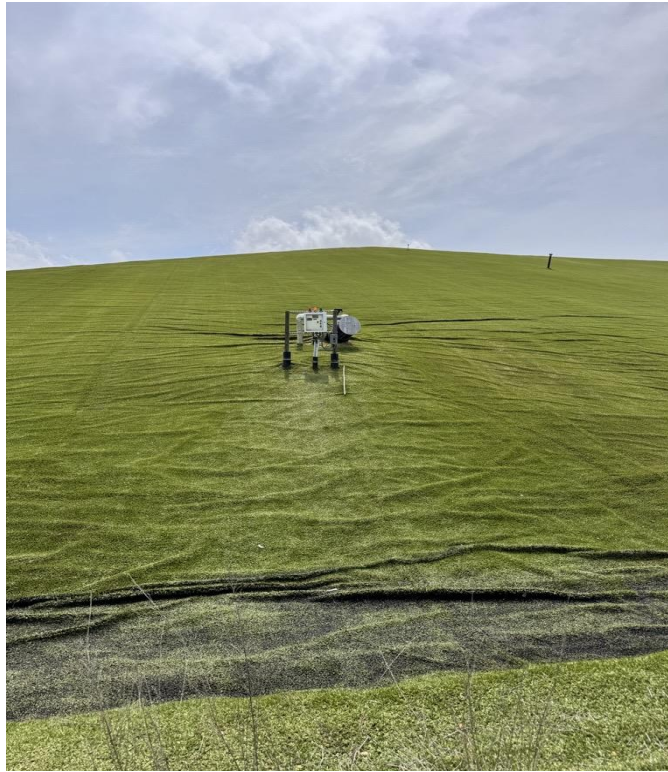
- Additional Damaged noted prior to inspections ceasing includes:
 - An approximately 30-ft by 3-ft rip first observed July 2, 2025 on the north side of Area 1-2. Additional cracking developed from this segment for approximately 20 feet.

Photograph 3: View of DCT-1 on north side of Area 1-2, at 36.46181, -92.45045.

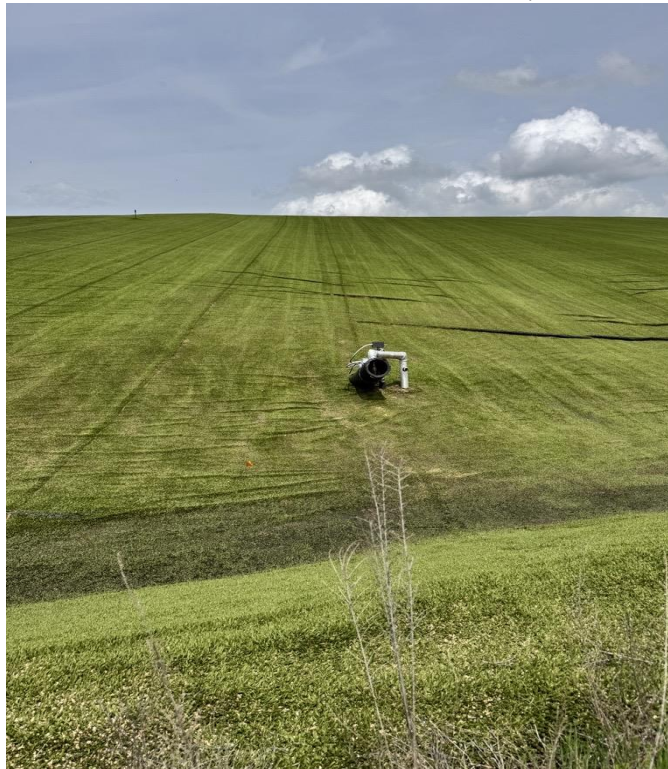
Photograph 4: View of south side of Area 4, above LCS-9 showing sagging closure turf.

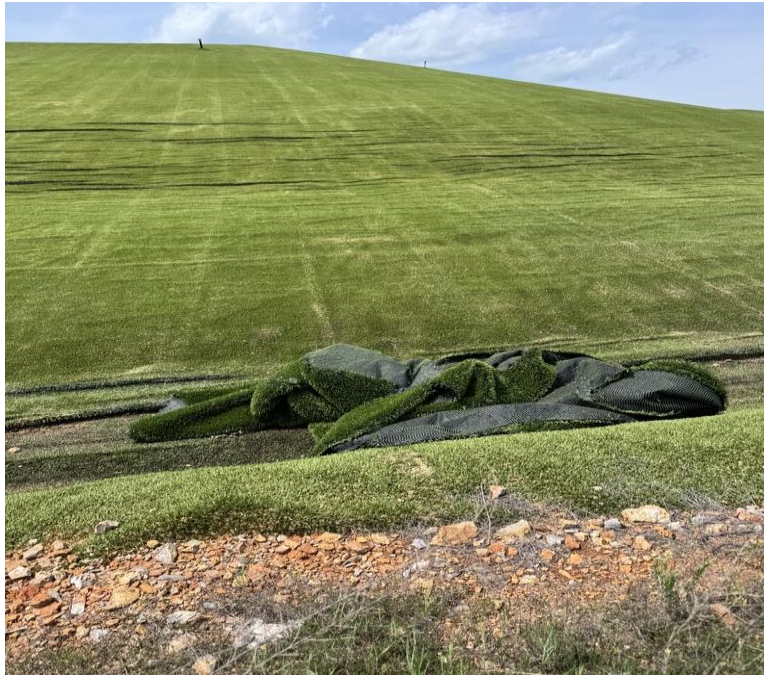
Photograph 5: View of south side of Area 1-3, near LCS-7 showing damaged closure turf that has migrated to the ditch at the bottom of the slope.

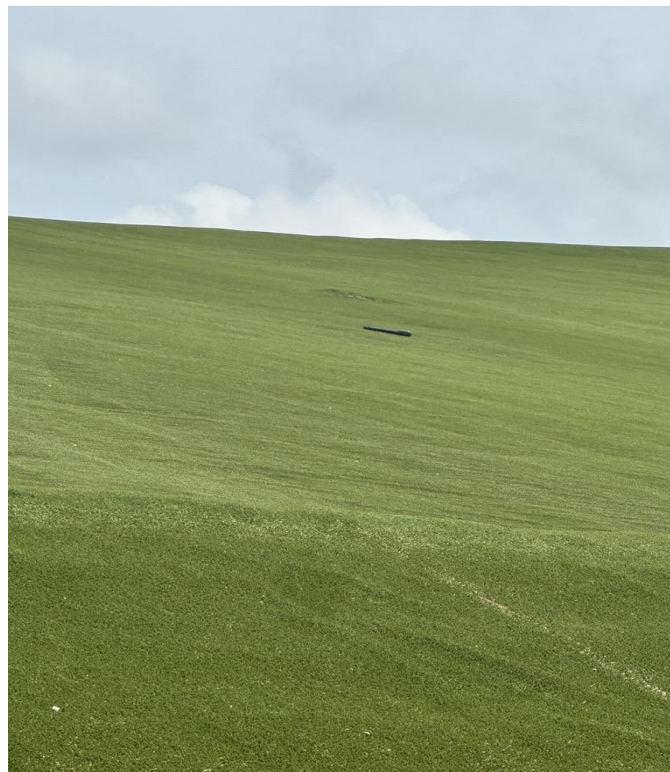
- One damaged pressure relief vent (PRV-1) was observed on the west side of Area 1-2, between LCS-1 and LCS-2. The damage is located near coordinates 36.46144, -92.45128.

Photograph 6: View of west side of Area 1-2, between LCS-1 and LCS-2 showing damaged gas vent.

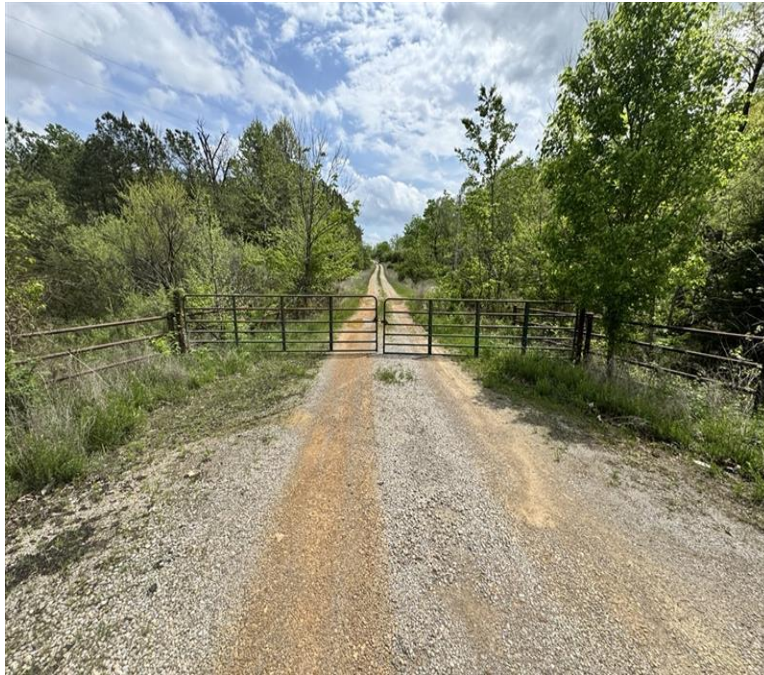
Photograph 7: The signage at the entrance gate has been removed.
