**Subject:** RE: Green Bay Packaging Arkansas Kraft Class 3N Landfill - Cell 6 Construction Quality Assurance

**Subject:** Green Bay Packaging Arkansas Kraft Class 3N Landfill - Cell 6 Construction Quality Assurance

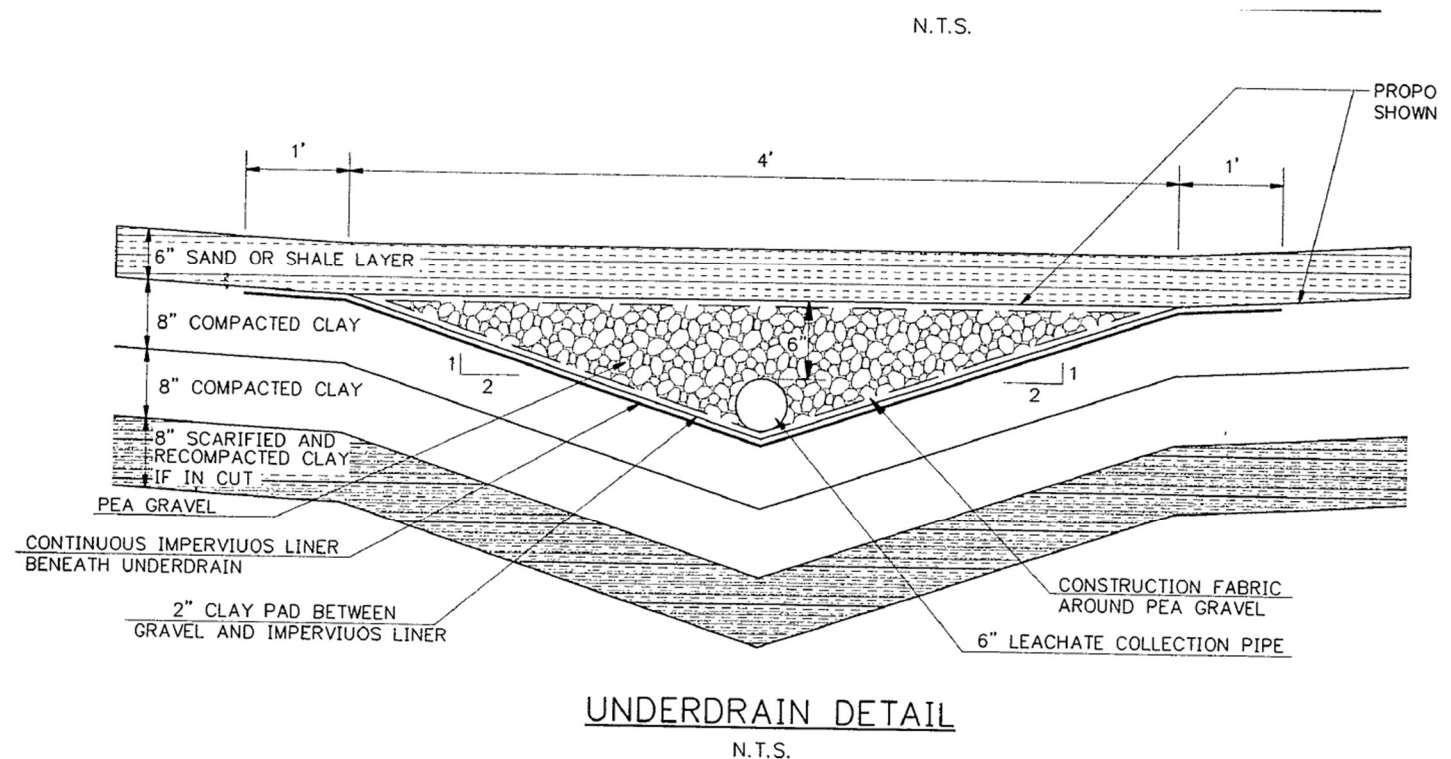
- 5) Geotextile failed the density (it is 9.06 oz/sy and it needs to be 10 oz/sy)
- The permit drawings (DIN #28317) page 8 of 13 (see screenshot below) call for a construction fabric around the leachate collection aggregate. The installer ordered a 10 oz/sy and the mass per unit area came back at a 9.06 which exceeds the requirement of the permit drawings. Therefore, the material was approved for use.

- 7) Doc ID 28317 Pdf page 3 of 13 seems to show they are shallow
- The permit drawings (DIN #28317) page 8 of 13 (see screenshot below) have a callout pointing to the top of clay liner that states "proposed bottom elevations shown on sheet 4". Comparing the as-built top of clay elevations to the permitted elevations on sheet 4 of 13, the as-built top of clay elevations appear to be at or above the permitted elevations.
