**RE: Quarterly Inspection conducted on September 23, 2019**  
**AFIN 66-00226**  
**Permit Number 0267-S1-R1**

**Arkansas Division of Environmental Quality  
Office of Land Resources - Solid Waste Management  
Class 1 Landfill Inspection**

# Arkansas Division of Environmental Quality Official Photograph Sheet

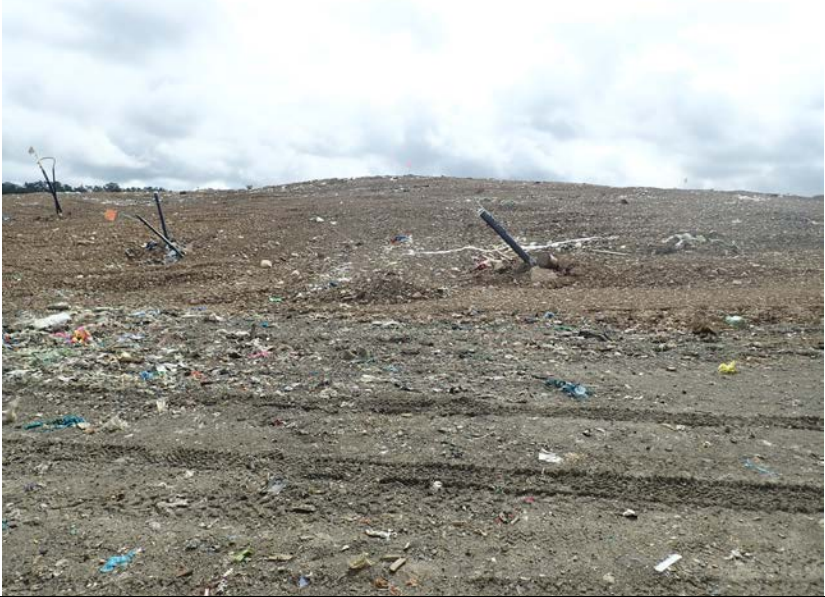
| <b>Photo #</b> | 1 | <b>Of</b> | 4 | | <b>Date</b> | 9/23/2019 | <b>Time</b> | 1130 |

| Category 2 (continued) | | | | | | | | | | | | |
|---|---|---|---|---|---|---|---|---|---|---|---|---|
| X 413(c) | Satisfactory intermediate cover | | | | | Solid waste observed exposed on the northern top of the landfill. (Refer to Photos # 1 - #4.) | | | | | | |

| <b>Description</b> | View of exposed solid waste observed on the northern portion on top of the landfill, facing southeast. | | | | | | | |

The Fort Smith Landfill is in the process of covering the area of concern. This area of the landfill has been our active wet weather area during the large amount of rains we have had. We will recover the area to comply with the rules of Regulation 22.

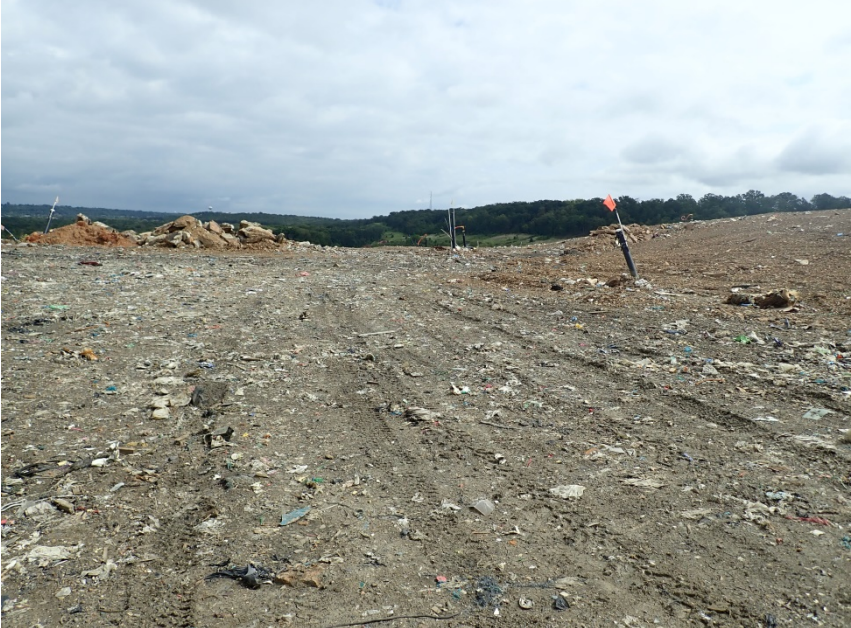
| <b>Photo #</b> | 2 | <b>Of</b> | 4 | | <b>Date</b> | 9/23/2019 | <b>Time</b> | 1130 |

| <b>Description</b> | View of exposed solid waste observed on the northern portion on top of the landfill, facing east. | | | | | | | |

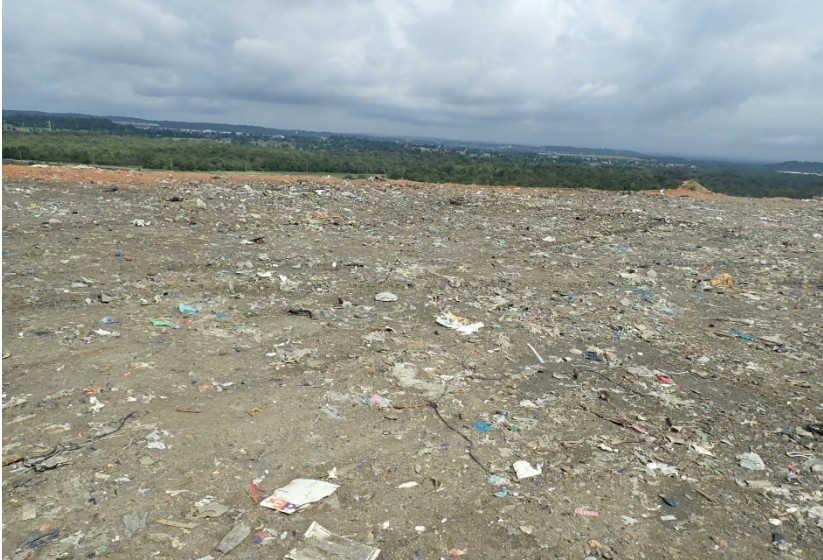
| <b>Photo #</b> | 3 | <b>Of</b> | 4 | | <b>Date</b> | 9/23/2019 | <b>Time</b> | 1130 |

| <b>Description</b> | View of exposed solid waste observed on the northern portion on top of the landfill, facing northeast. | | | | | | | |

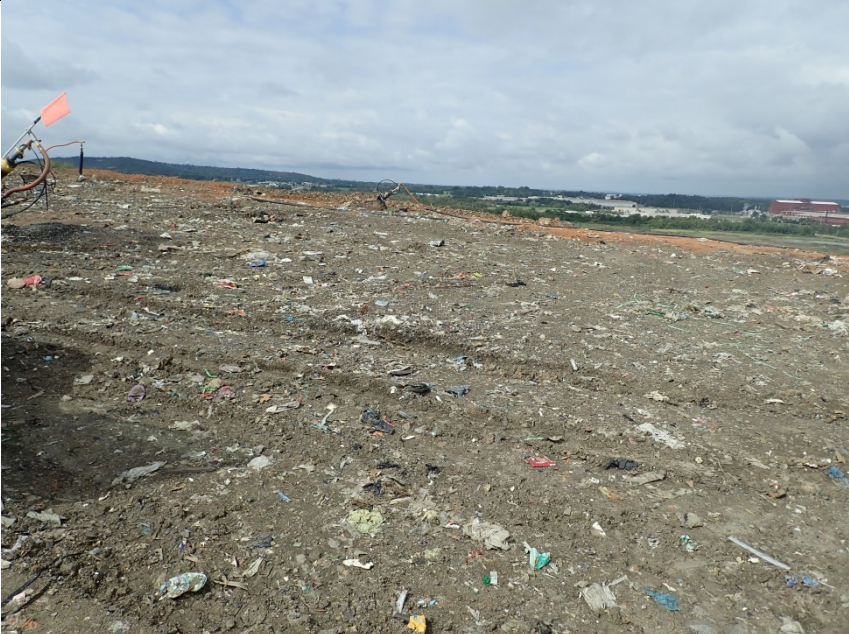
| <b>Photo #</b> | 4 | <b>Of</b> | 4 | | <b>Date</b> | 9/23/2019 | <b>Time</b> | 1130 |

| <b>Description</b> | View of exposed solid waste observed on the northern portion on top of the landfill, facing north. | | | | | | | |
