**RE: Quarterly Inspection conducted on September 17, 2020**  
**AFIN 66-00226**  
**Permit Number 0267-S1-R1**

**Division of Environmental Quality**  
**Office of Land Resources - Solid Waste Management**  
**Class 1 Landfill Inspection**

| <b>Site Name</b> | City of Fort Smith Class 1 Landfill | <b>County</b> | Sebastian | <b>AFIN</b> | 66-00226 |

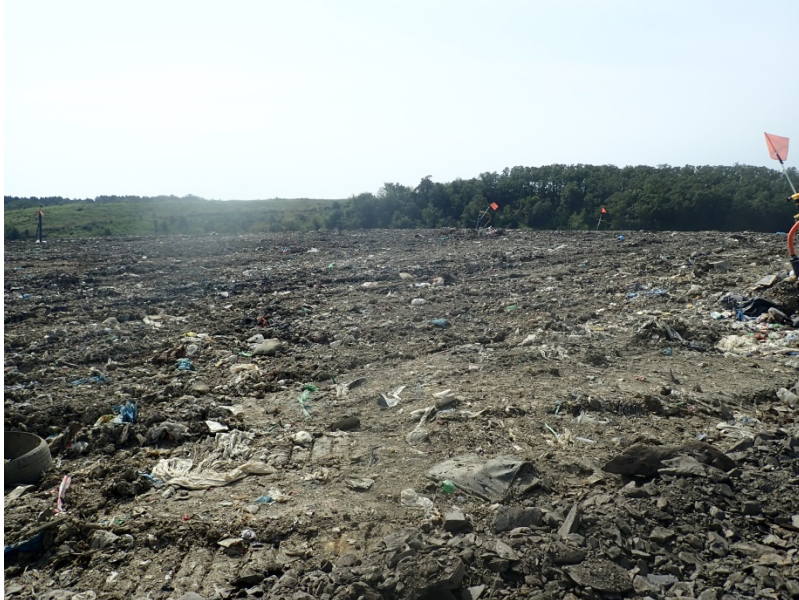
| <b>Photo #</b> | 1 | <b>Of</b> | 4 | <b>Date</b> | 9/17/2020 |

| | Regulation | Item Description | Comments |
|---|---|---|---|
| X | 413(c) | Satisfactory intermediate cover | Solid waste observed exposed on the northeastern top of the landfill. (Refer to Photos # 1 - #4.) |

| <b>Description</b> | View of exposed solid waste observed on the northern portion on top of the landfill, facing southeast. | | | | |

You should immediately initiate actions to correct the alleged violations cited. A written response of the corrective actions taken, or to be taken, must be submitted within thirty (30) calendar days from the date on this letter to the attention of Jason Gilkey. The response may include, but is not limited to, photographs, copies of disposal receipts, records, or analytical results, as applicable. If you have any questions regarding the alleged violations, please do not hesitate to contact me at (501) 993-7188 [jason.gilkey@adeq.state.ar.us](mailto:jason.gilkey@adeq.state.ar.us).

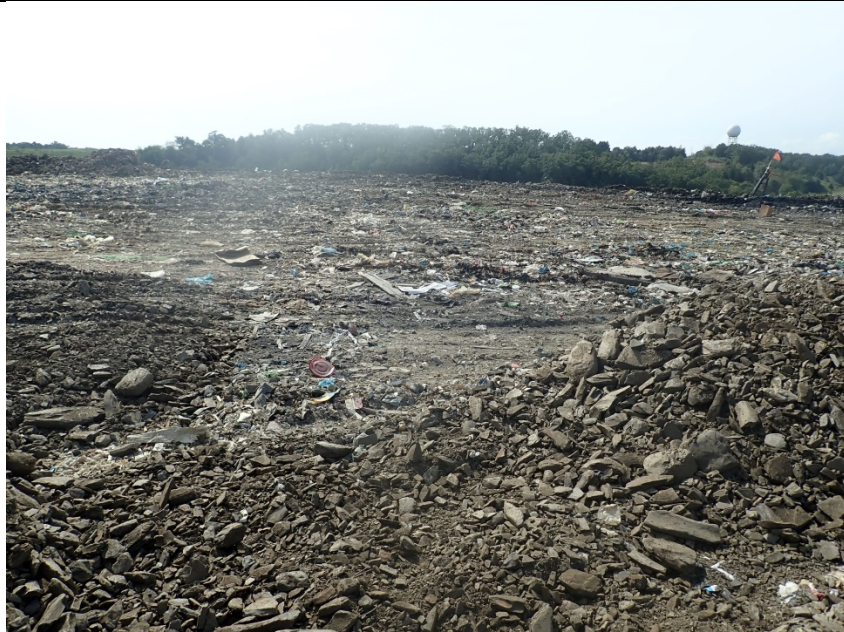
| <b>Photo #</b> | 2 | <b>Of</b> | 4 | <b>Date</b> | 9/17/2020 |

| <b>Description</b> | View of exposed solid waste observed on the northern portion on top of the landfill, facing south. | | | | |

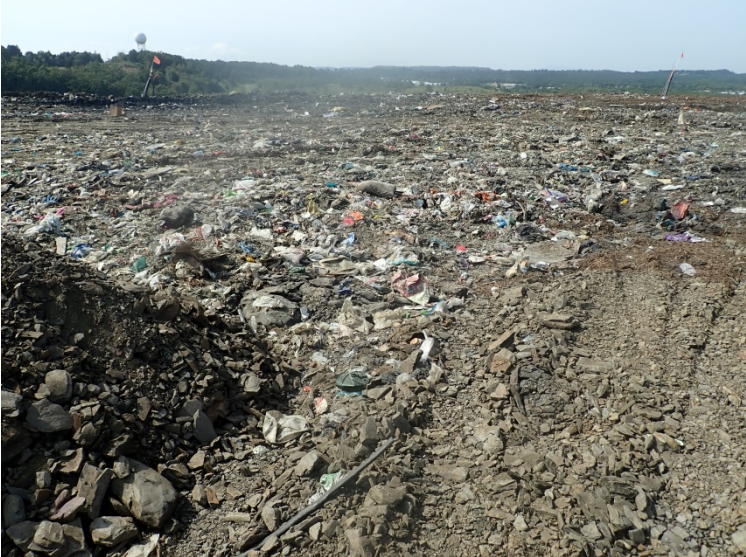
| <b>Photo #</b> | 3 | <b>Of</b> | 4 | <b>Date</b> | 9/17/2020 |

| <b>Description</b> | View of exposed solid waste observed on the northern portion on top of the landfill, facing southwest. | | | | |

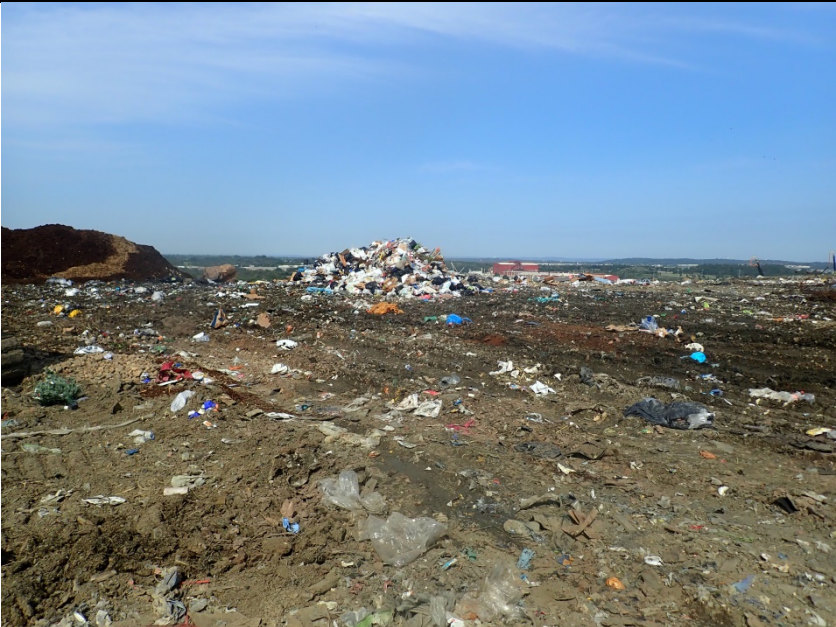
| <b>Photo #</b> | 4 | <b>Of</b> | 4 | <b>Date</b> | 9/17/2020 |

| <b>Description</b> | View of exposed solid waste observed on the northern portion on top of the landfill, facing north. | | | | |
