**RE: Inspection conducted on December 14, 2021**  
**AFIN 66-00226**  
**Permit Number 0267-S1-R1**

**Office of Land Resources  
Regulated Waste Operations  
Class 1 Landfill Inspection Form**

| <b>Site Name</b> | City of Fort Smith Class 1 Landfill | <b>County</b> | Sebastian | <b>AFIN</b> | 66-00226 |

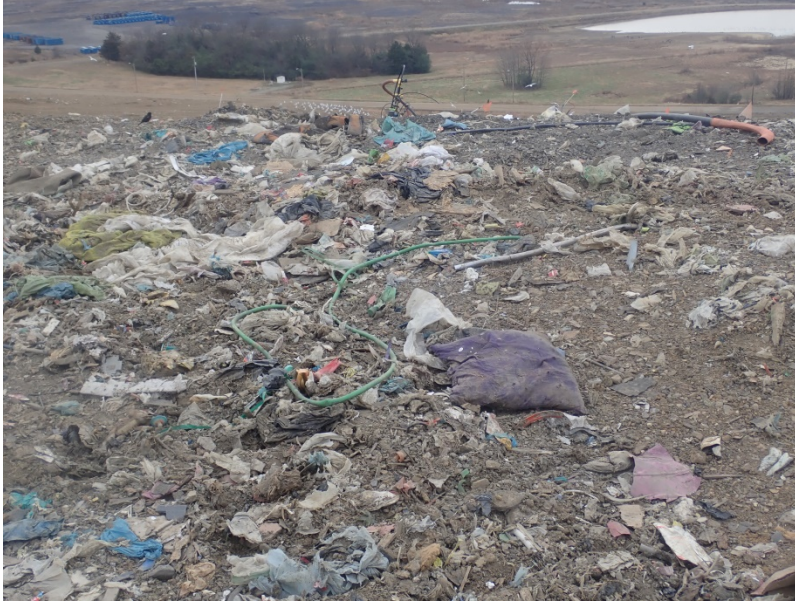
| <b>Photo #</b> | 1 | <b>Of</b> | 4 | | <b>Date</b> | 12/14/2021 | <b>Time</b> | 0958 |

| | <b>Regulation</b> | <b>Item Description</b> | <b>Comments</b> |
|---|---|---|---|
| X | 413(a)(b)(c) | Satisfactory Daily/Alternate/Intermediate Cover | Solid waste exposed on the northeastern top of the landfill observed. (Refer to Photos #1 - #4.) |

| <b>Description</b> | View of exposed solid waste observed on the top northern portion of the landfill. | | | | | | | |

You should immediately initiate actions to correct the alleged violations cited. A written response of the corrective actions taken, or to be taken, must be submitted within thirty (30) calendar days from the date on this letter to the attention of Jason Gilkey. The response may include, but is not limited to, photographs, copies of disposal receipts, records, or analytical results, as applicable. If you have any questions regarding the alleged violations, please do not hesitate to contact me at (501) 993-7188 or [jason.gilkey@adeq.state.ar.us](mailto:jason.gilkey@adeq.state.ar.us).

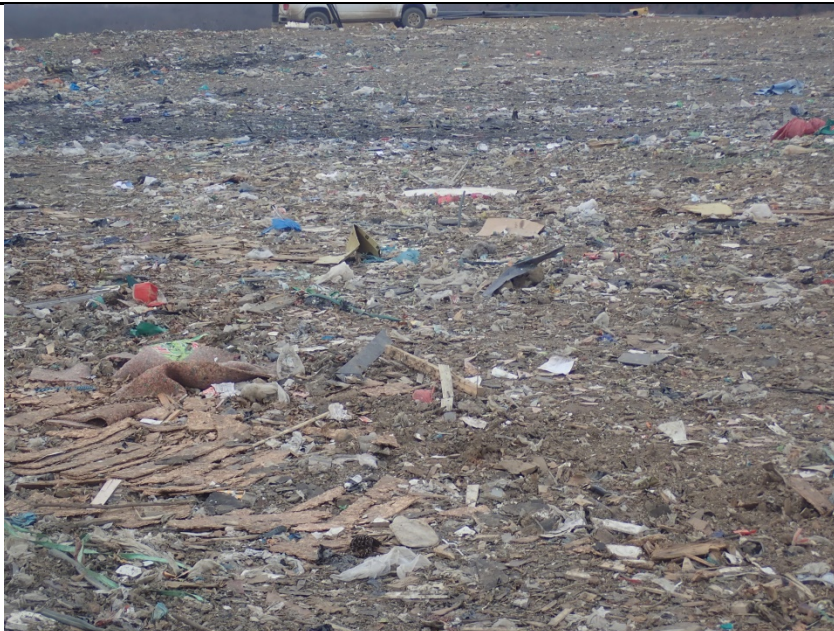
| <b>Photo #</b> | 2 | <b>Of</b> | 4 | | <b>Date</b> | 12/14/2021 | <b>Time</b> | 0958 |

| <b>Description</b> | Another view of exposed solid waste observed on the top northern portion of landfill. | | | | | | | |

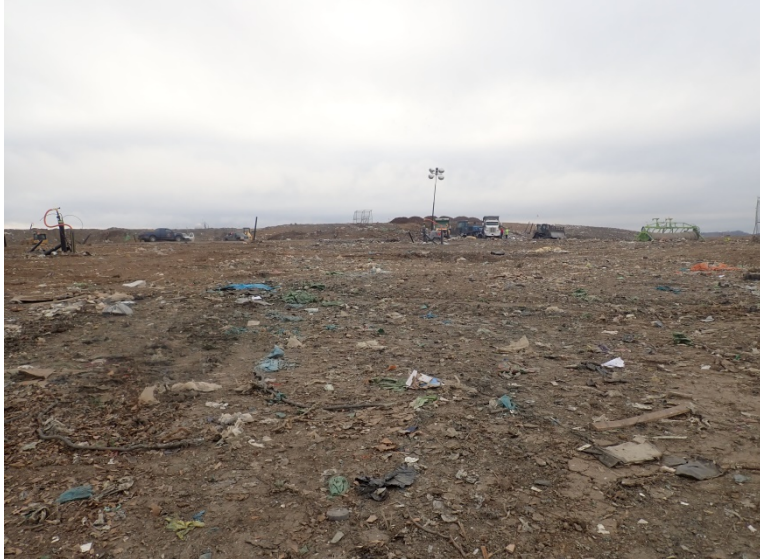
| <b>Photo #</b> | 3 | <b>Of</b> | 4 | <b>Date</b> | 12/14/2021 |

| <b>Description</b> | Another view of exposed solid waste observed on the northern portion on top of the landfill. | | | | |

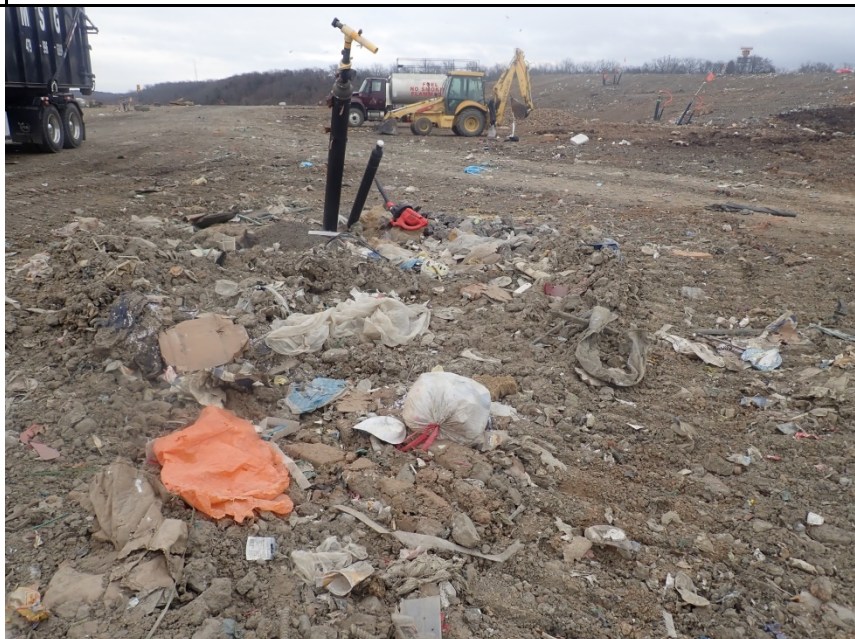
| <b>Photo #</b> | 4 | <b>Of</b> | 4 | <b>Date</b> | 12/14/2021 |

| <b>Description</b> | Another view of exposed solid waste observed on the top northern portion of the landfill. | | | | |
