**RE: Inspection conducted on September 23, 2022**  
**AFIN 66-00226**  
**Permit Number 0267-S1-R1**

**Office of Land Resources  
Regulated Waste Operations  
Class 1 Landfill Inspection Form**

| <b>Site Name</b> | City of Fort Smith Class 1 Landfill | <b>County</b> | Sebastian | <b>AFIN</b> | 66-00226 |

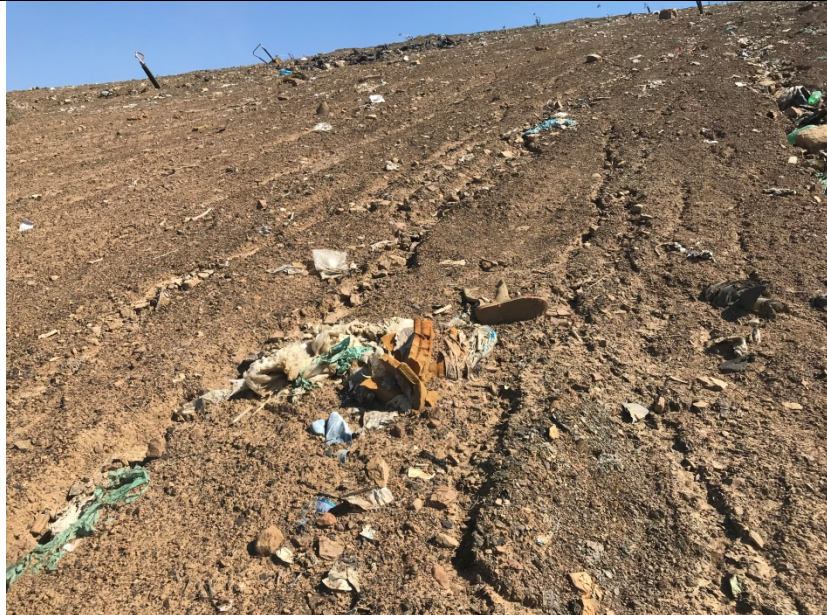
| <b>Photo #</b> | 1 | <b>Of</b> | 4 | | <b>Date</b> | 9/23/2022 | <b>Time</b> | 1444 |

| | <b>Regulation</b> | <b>Item Description</b> | <b>Comments</b> |
|---|---|---|---|
| X | 413(c) | Satisfactory Intermediate Cover | Solid waste exposed on the northern slope of the landfill observed due to the lack of adequate intermediate cover. (Refer to Photos #1 - #4.) |

| <b>Description</b> | A view of exposed solid waste on the northern slope of the landfill. | | | | | | | |

You should immediately initiate actions to correct the alleged violations cited. A written response of the corrective actions taken, or to be taken, must be submitted within thirty (30) calendar days from the date on this letter to the attention of Jason Gilkey. The response may include, but is not limited to, photographs, copies of disposal receipts, records, or analytical results, as applicable. If you have any questions regarding the alleged violations, please do not hesitate to contact me at (501) 993-7188 or [jason.gilkey@adeq.state.ar.us](mailto:jason.gilkey@adeq.state.ar.us).

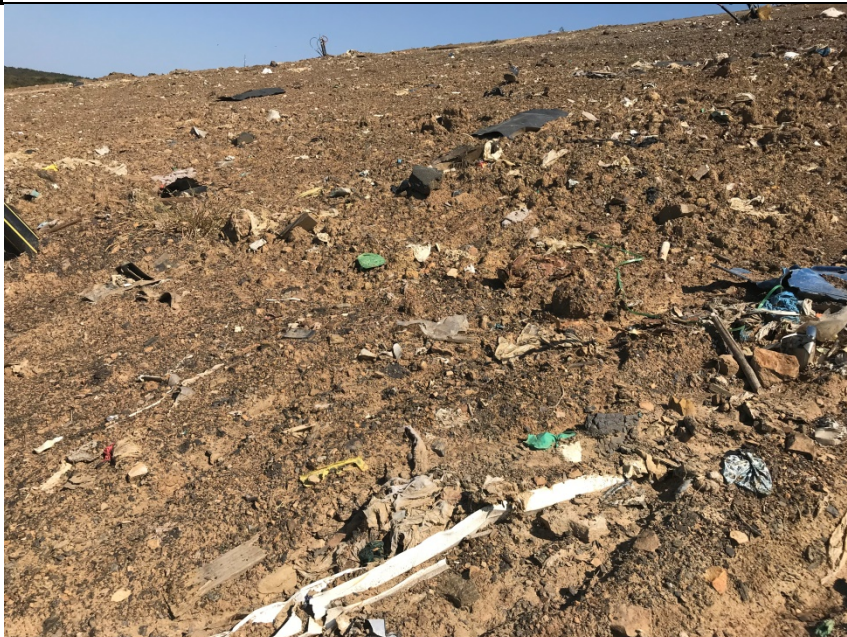
| <b>Photo #</b> | 2 | <b>Of</b> | 4 | | <b>Date</b> | 9/23/2022 | <b>Time</b> | 1445 |

| <b>Description</b> | Another view of exposed solid waste on the northern slope of the landfill. | | | | | | | |

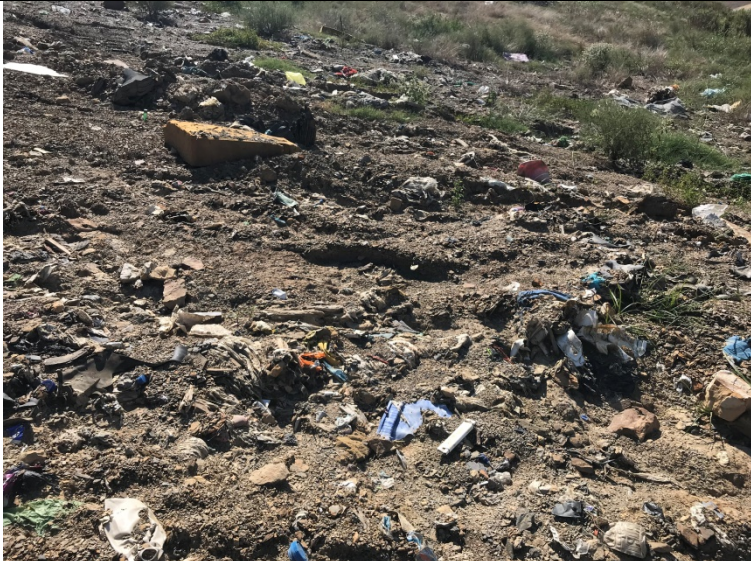
| <b>Photo #</b> | 3 | <b>Of</b> | 4 | | <b>Date</b> | 9/23/2022 | <b>Time</b> | 1447 |

| <b>Description</b> | Another view of exposed solid waste on the northern slope of the landfill. | | | | | | | |

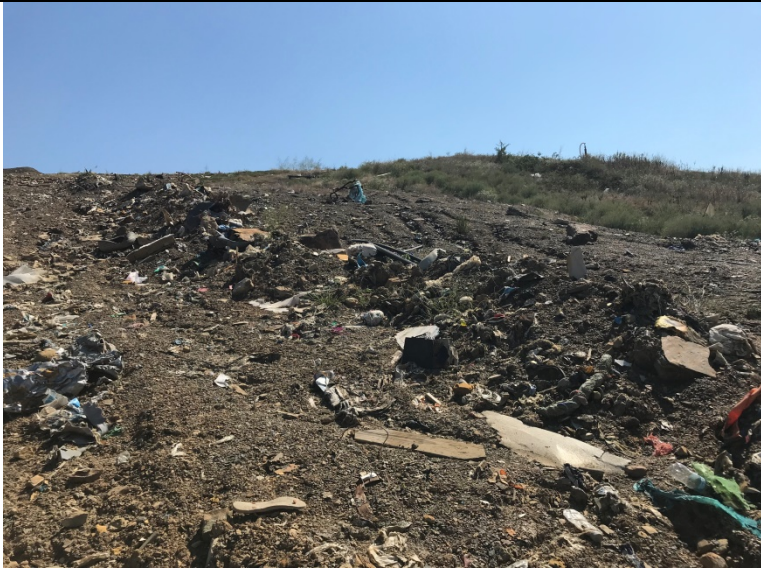
| <b>Photo #</b> | 4 | <b>Of</b> | 4 | | <b>Date</b> | 9/23/2022 | <b>Time</b> | 1447 |

| <b>Description</b> | Another view of exposed solid waste on the northern slope of the landfill. | | | | | | | |
