**RE: Inspection conducted on December 28, 2022**  
**AFIN 66-00226**  
**Permit Number 0267-S1-R1**

**Office of Land Resources  
Regulated Waste Operations  
Class 1 Landfill Inspection Form**

| <b>Site Name</b> | City of Fort Smith Class 1 Landfill | <b>County</b> | Sebastian | <b>AFIN</b> | 66-00226 |

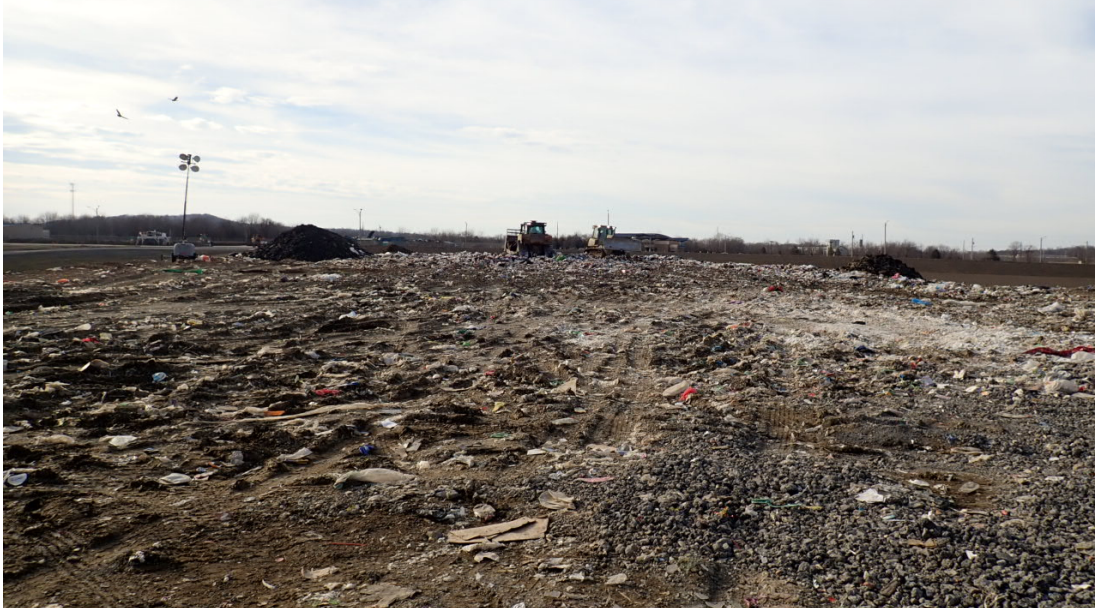
| <b>Photo #</b> | 1 | <b>Of</b> | 4 | | <b>Date</b> | 12/28/2022 | <b>Time</b> | 1455 |

| | <b>Regulation</b> | <b>Item Description</b> | <b>Comments</b> |
|---|---|---|---|
| X | 413(c) | Satisfactory Intermediate Cover | Solid waste observed exposed on the top and the northern slope of the landfill due to inadequate intermediate cover. (Refer to Photos #1 - #4.) |

| <b>Description</b> | Exposed solid waste observed on the top of the landfill due to inadequate intermediate cover. | | | | | | | |

You should immediately initiate actions to correct the alleged violations cited. A written response of the corrective actions taken, or to be taken, must be submitted within thirty (30) calendar days from the date on this letter to the attention of Jason Gilkey. The response may include, but is not limited to, photographs, copies of disposal receipts, records, or analytical results, as applicable. If you have any questions regarding the alleged violations, please do not hesitate to contact me at (501) 993-7188 or [jason.gilkey@adeq.state.ar.us](mailto:jason.gilkey@adeq.state.ar.us).

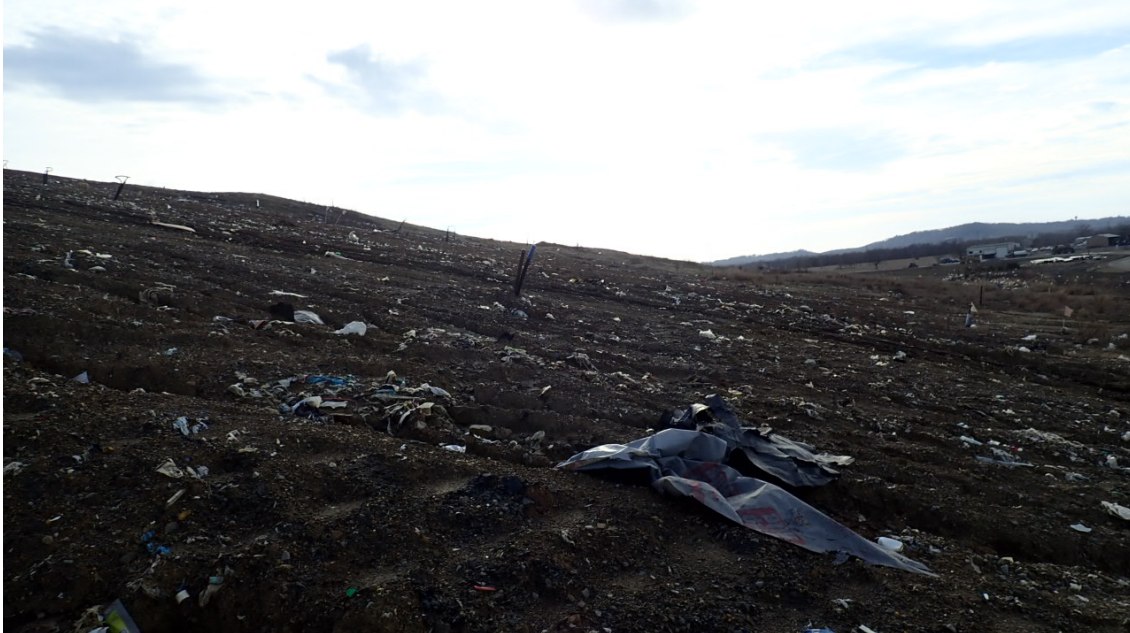
| <b>Photo #</b> | 2 | <b>Of</b> | 4 | | <b>Date</b> | 12/28/2022 | <b>Time</b> | 1521 |

| <b>Description</b> | Exposed solid waste observed on the northern slope of the landfill due to inadequate intermediate cover. | | | | | | | |

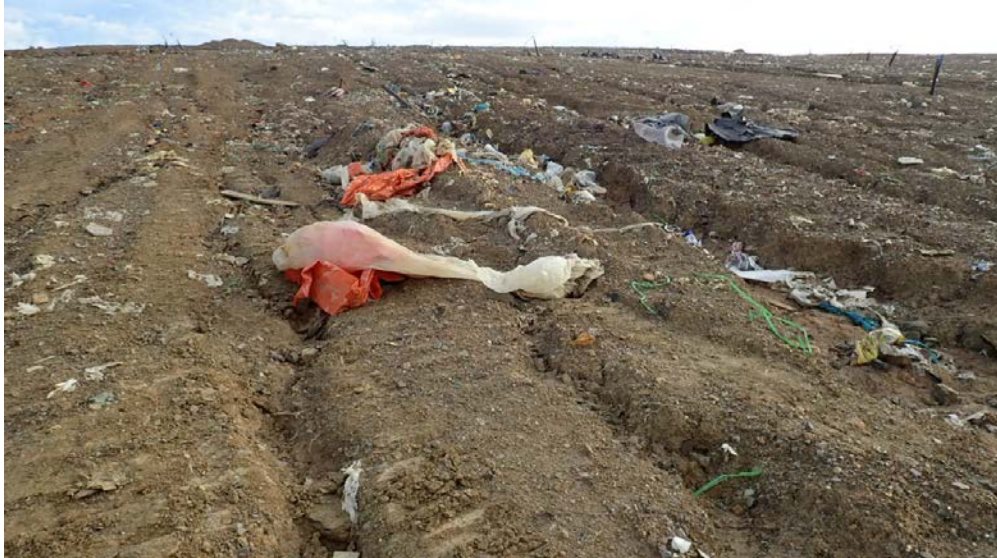
| <b>Photo #</b> | 3 | <b>Of</b> | 4 | | <b>Date</b> | 12/28/2022 | <b>Time</b> | 1520 |

| <b>Description</b> | Exposed solid waste observed on the northern slope of the landfill due to inadequate intermediate cover. | | | | | | | |

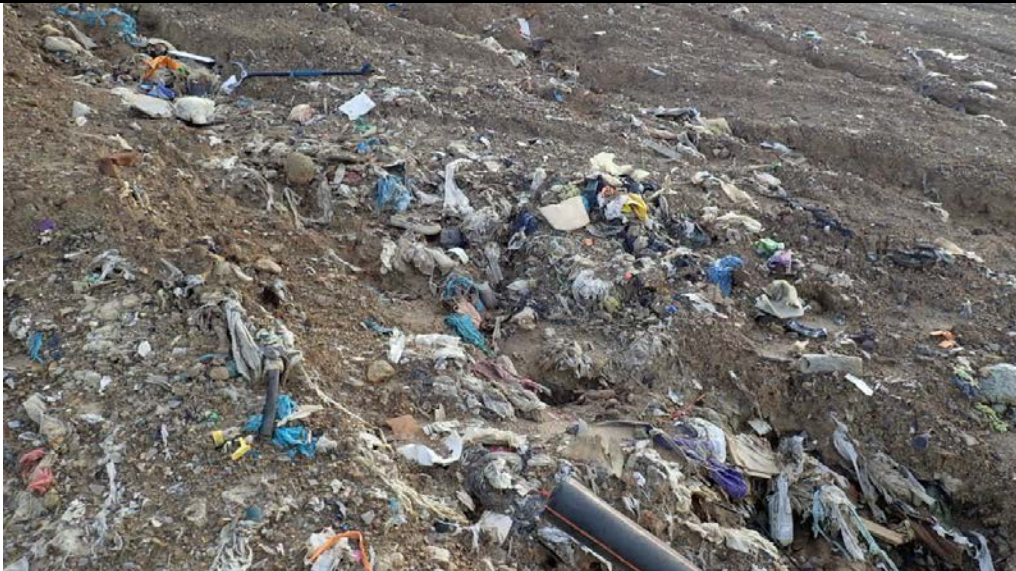
| <b>Photo #</b> | 4 | <b>Of</b> | 4 | | <b>Date</b> | 12/28/2022 | <b>Time</b> | 1520 |

| <b>Description</b> | Exposed solid waste observed on the northern slope of the landfill due to inadequate intermediate cover. | | | | | | | |
