**RE: Inspection conducted on March 23, 2023**  
**AFIN 66-00226**  
**Permit Number 0267-S1-R1**

**Office of Land Resources  
Regulated Waste Operations  
Class 1 Landfill Inspection Form**

| <b>Site Name</b> | City of Fort Smith Class 1 Landfill | <b>County</b> | Sebastian | <b>AFIN</b> | 66-00226 |

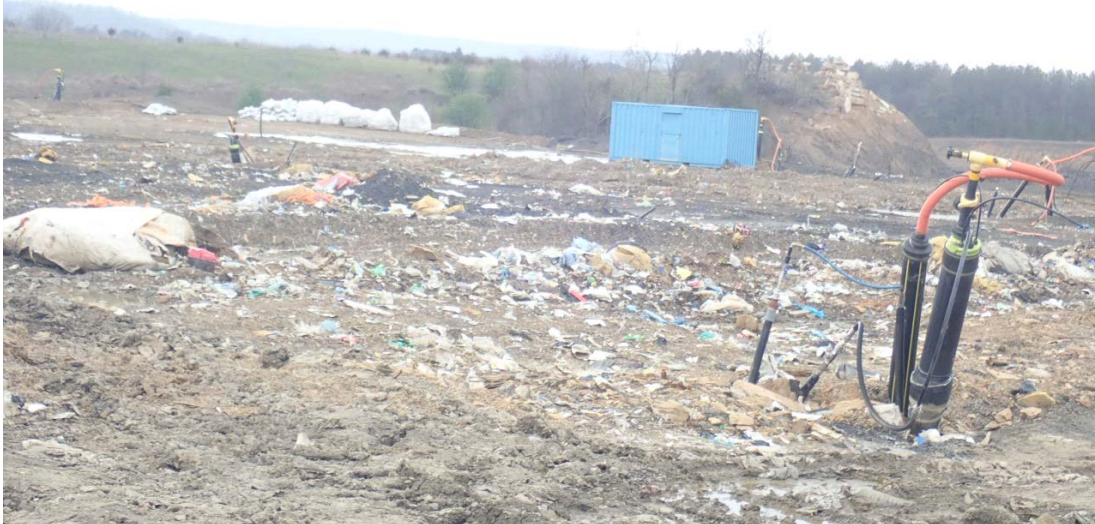
| <b>Photo #</b> | 1 | <b>Of</b> | 4 | | <b>Date</b> | 3/23/2023 | <b>Time</b> | 1251 |

| | <b>Regulation</b> | <b>Item Description</b> | <b>Comments</b> |
|---|---|---|---|
| X | 413(c) | Satisfactory Intermediate Cover | Solid waste observed exposed on the top, western side, and northern slope of the landfill due to inadequate intermediate cover. (Refer to Photos #1 - #4.) |

| <b>Description</b> | Exposed solid waste observed on the top of the landfill due to inadequate intermediate cover. | | | | | | | |

You should immediately initiate actions to correct the alleged violations cited. A written response of the corrective actions taken, or to be taken, must be submitted within thirty (30) calendar days from the date on this letter to the attention of Jason Gilkey. The response may include, but is not limited to, photographs, copies of disposal receipts, records, or analytical results, as applicable. If you have any questions regarding the alleged violations, please do not hesitate to contact me at (501) 993-7188 or [jason.gilkey@adeq.state.ar.us](mailto:jason.gilkey@adeq.state.ar.us).

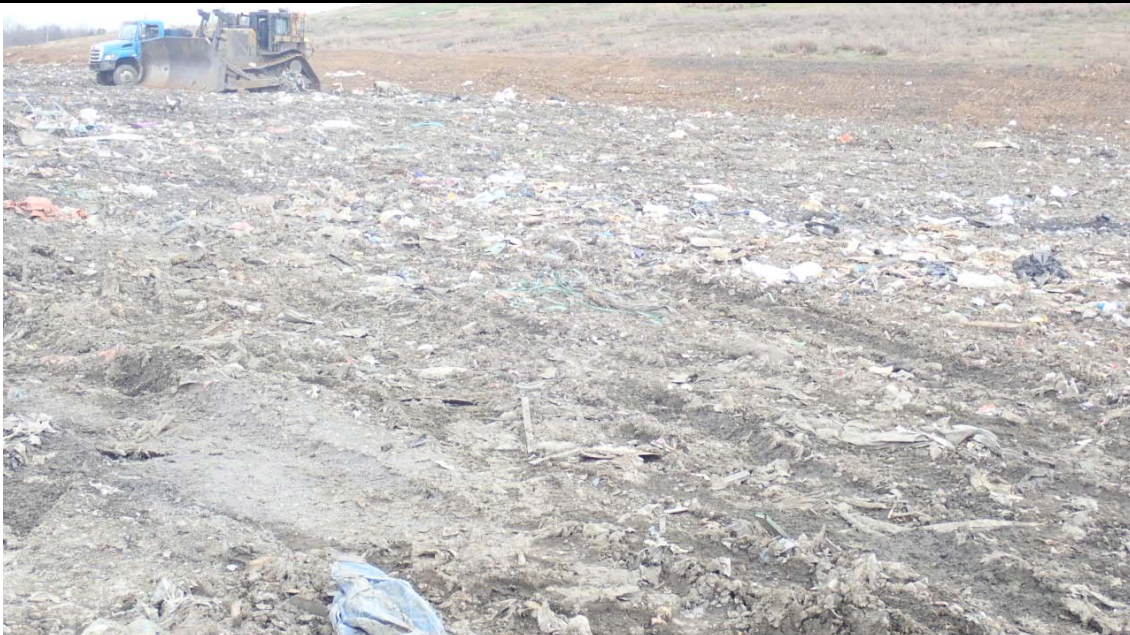
| <b>Photo #</b> | 2 | <b>Of</b> | 4 | | <b>Date</b> | 3/23/2023 | <b>Time</b> | 1259 |

| <b>Description</b> | Exposed solid waste observed on the western side of the landfill due to inadequate intermediate cover. | | | | | | | |

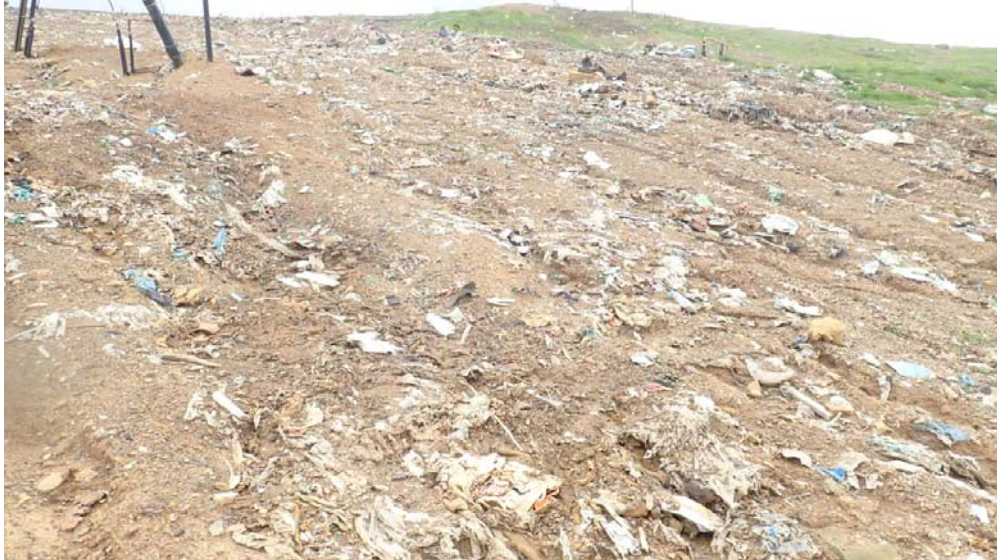
| <b>Photo #</b> | 3 | <b>Of</b> | 4 | | <b>Date</b> | 3/23/2023 | <b>Time</b> | 1304 |

| <b>Description</b> | Exposed solid waste observed on the northern slope of the landfill due to inadequate intermediate cover. | | | | | | | |

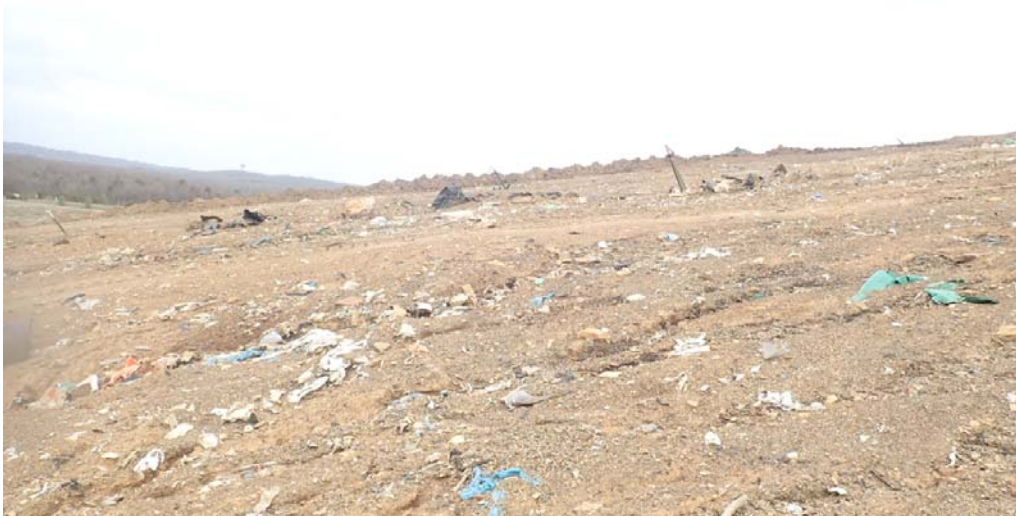
| <b>Photo #</b> | 4 | <b>Of</b> | 4 | | <b>Date</b> | 3/23/2023 | <b>Time</b> | 1306 |

| <b>Description</b> | Another view of exposed solid waste observed on the northern slope of the landfill due to inadequate intermediate cover. | | | | | | | |
