**DIVISION OF  
ENVIRONMENTAL QUALITY**

**RE: Inspection conducted on June 5, 2023**  
**AFIN 66-00226**  
**Permit Number 0267-S1-R1**

**Division of Environmental Quality  
Office of Land Resources  
Class 1 Landfill Inspection Form**

# Division of Environmental Quality Official Photograph Sheet

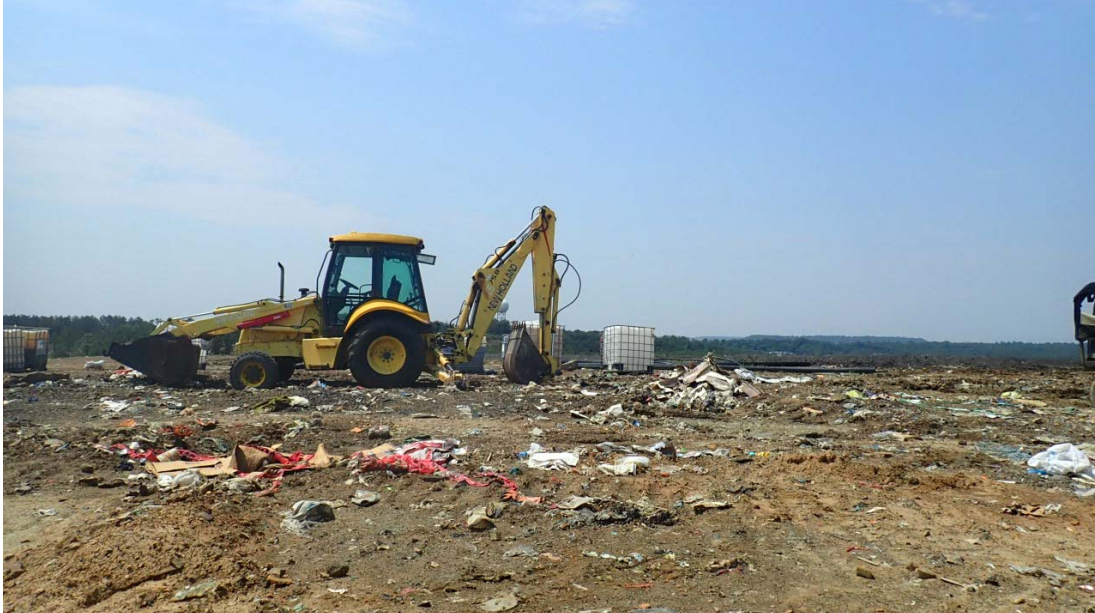
| <b>Photo #</b> | 1 | <b>Of</b> | 4 | <b>Date</b> | 6/5/2023 |

| | <b>Regulation</b> | <b>Item Description</b> | <b>Comments</b> |
|---|---|---|---|
| X | 413(c) | Satisfactory Intermediate Cover | Solid waste observed exposed on the top, western side, and northern slope of the landfill due to inadequate intermediate cover. (Refer to Photos #1 - #4.) |

| <b>Description</b> | Exposed solid waste observed on the top of the landfill due to inadequate intermediate cover. | | | | |

You should immediately initiate actions to correct the alleged violations cited. A written response of the corrective actions taken, or to be taken, must be submitted within thirty (30) calendar days from the date on this letter to the attention of Jason Gilkey. The response may include, but is not limited to, photographs, copies of disposal receipts, records, or analytical results, as applicable. If you have any questions regarding the alleged violations, please do not hesitate to contact me at (501) 993-7188 or [jason.gilkey@adeq.state.ar.us](mailto:jason.gilkey@adeq.state.ar.us).

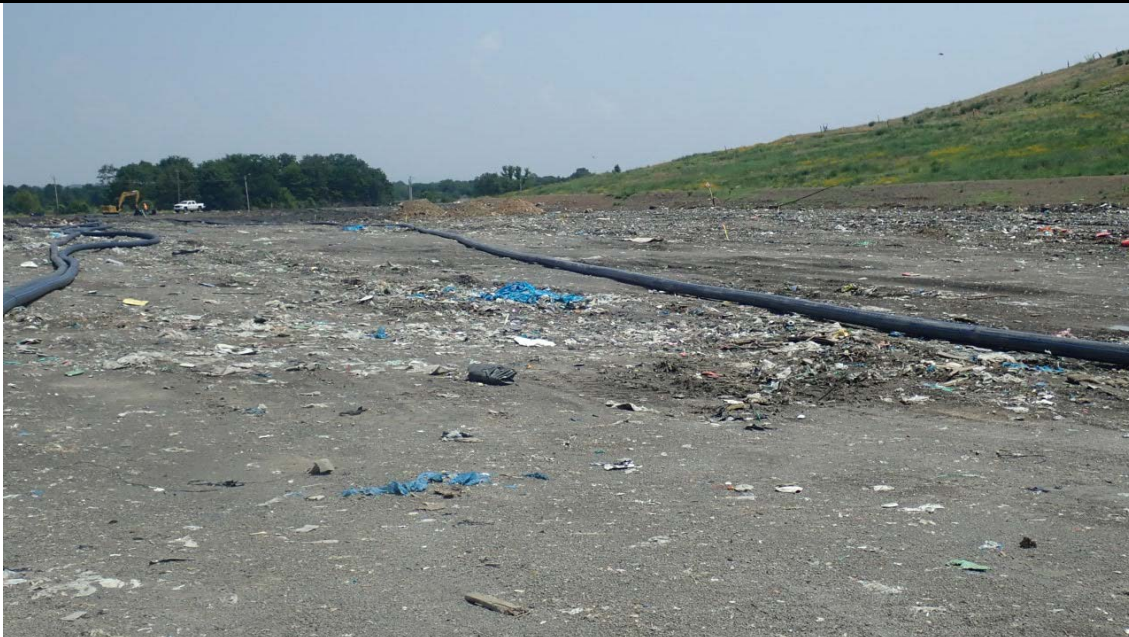
| <b>Photo #</b> | 2 | <b>Of</b> | 4 | <b>Date</b> | 6/5/2023 |

| <b>Description</b> | Exposed solid waste observed on the western side of the landfill due to inadequate intermediate cover. | | | | |

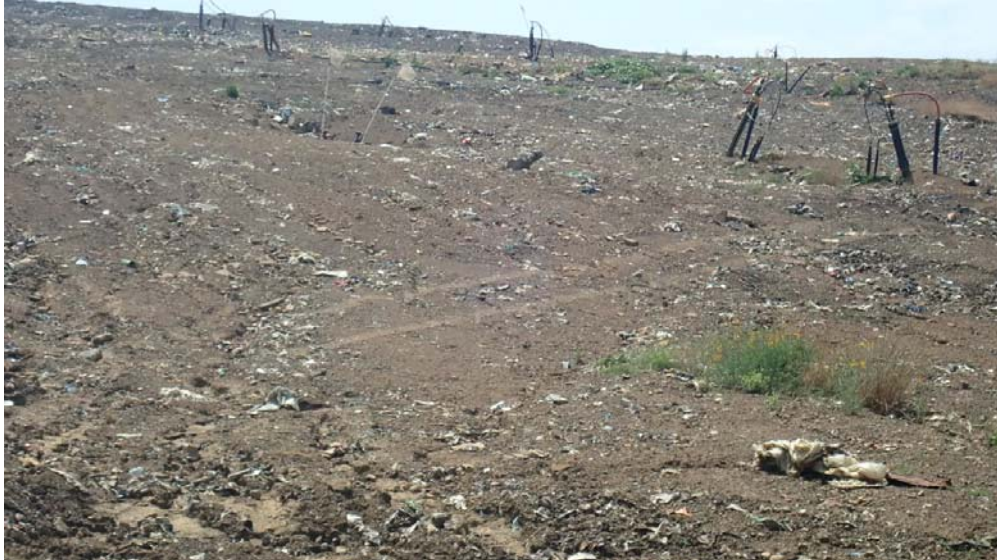
| <b>Photo #</b> | 3 | <b>Of</b> | 4 | | <b>Date</b> | 6/5/2023 | <b>Time</b> | 1202 |

| <b>Description</b> | Exposed solid waste observed on the northern slope of the landfill due to inadequate intermediate cover. | | | | | | | |

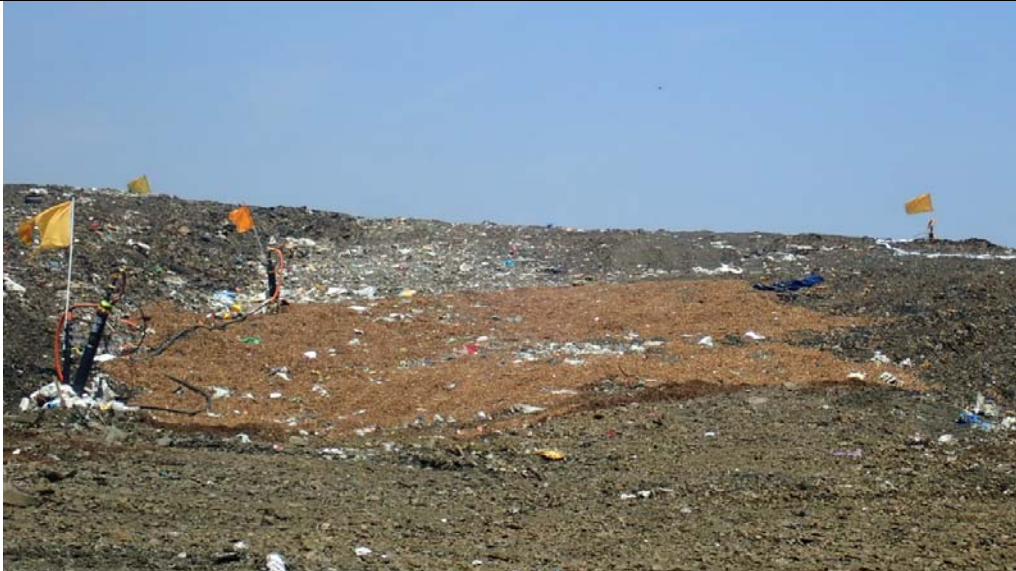
| <b>Photo #</b> | 4 | <b>Of</b> | 4 | | <b>Date</b> | 6/5/2023 | <b>Time</b> | 1154 |

| <b>Description</b> | Another view of exposed solid waste observed on the northern slope of the landfill due to inadequate intermediate cover. | | | | | | | |
