**DIVISION OF  
ENVIRONMENTAL QUALITY**

**RE: Inspection conducted on September 25, 2023**  
**AFIN 66-00226**  
**Permit Number 0267-S1-R1**

**Division of Environmental Quality  
Office of Land Resources  
Class 1 Landfill Inspection Form**

| <b>Site Name</b> | City of Fort Smith Class 1 Landfill | <b>County</b> | Sebastian | <b>AFIN</b> | 66-00226 |

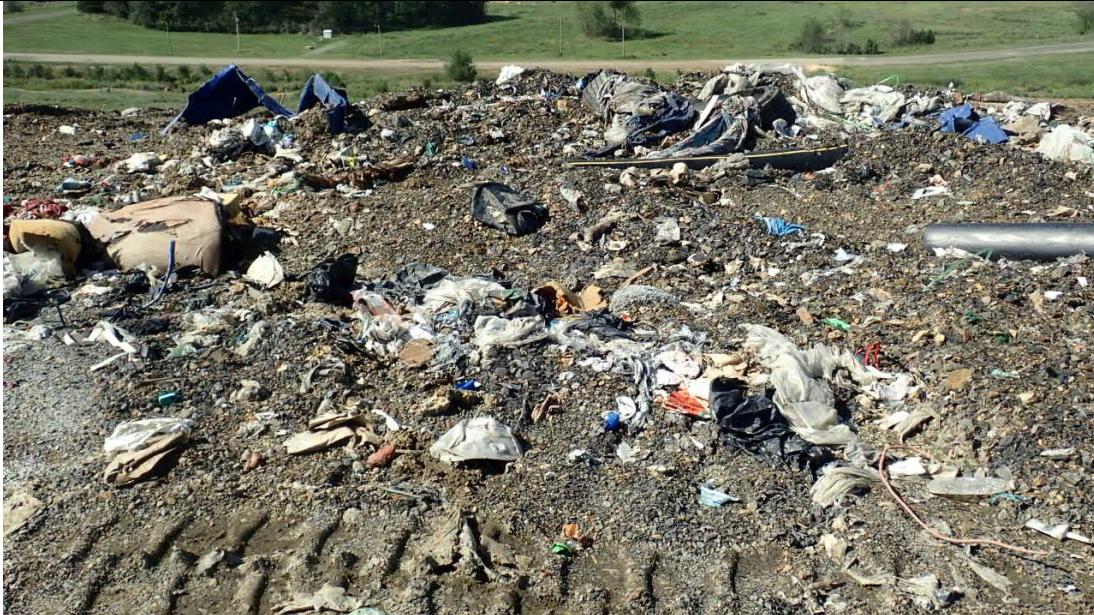
| <b>Photo #</b> | 1 | <b>Of</b> | 4 | | <b>Date</b> | 9/25/2023 | <b>Time</b> | 1502 |

| | <b>Regulation</b> | <b>Item Description</b> | <b>Comments</b> |
|---|---|---|---|
| X | 413(c) | Satisfactory Intermediate Cover | Solid waste observed exposed in interim cover areas on the top, western side, and northern slope of the landfill. (Refer to Photos #1 - #4.) |

| <b>Description</b> | Exposed solid waste observed in intermediate cover on the top of the landfill. | | | | | | | |

You should immediately initiate actions to correct the alleged violations cited. A written response of the corrective actions taken, or to be taken, must be submitted within thirty (30) calendar days from the date on this letter to the attention of Jason Gilkey. The response may include, but is not limited to, photographs, copies of disposal receipts, records, or analytical results, as applicable. If you have any questions regarding the alleged violations, please do not hesitate to contact me at (501) 993-7188 or [jason.gilkey@adeq.state.ar.us](mailto:jason.gilkey@adeq.state.ar.us).

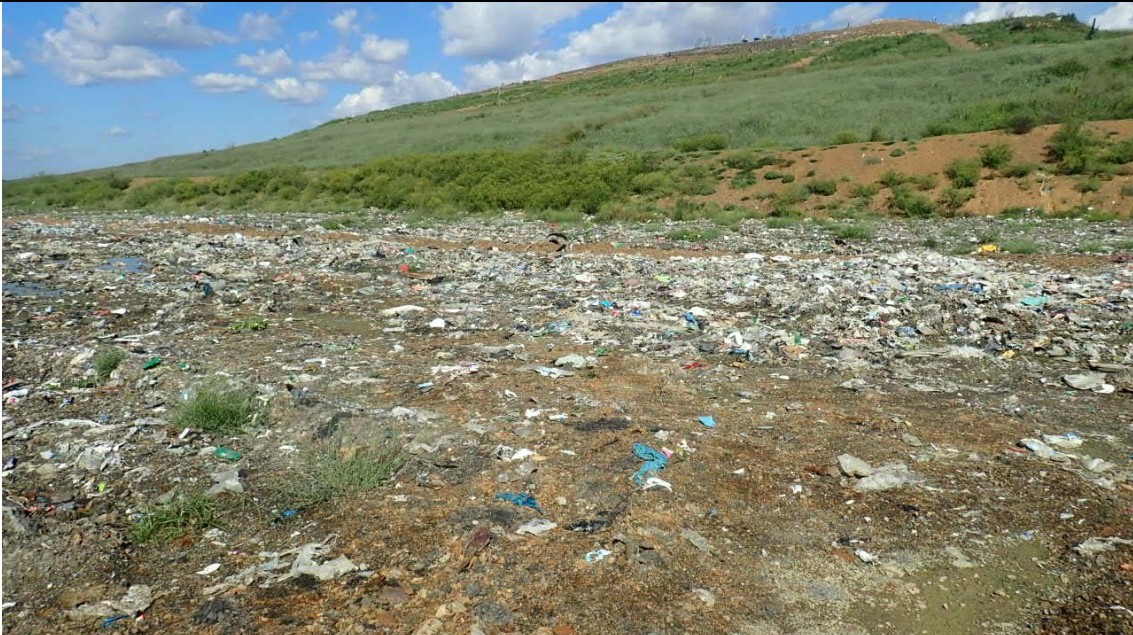
| <b>Photo #</b> | 2 | <b>Of</b> | 4 | | <b>Date</b> | 9/25/2023 | <b>Time</b> | 1512 |

| <b>Description</b> | Exposed solid waste observed in intermediate cover on the western side of the landfill. | | | | | | | |

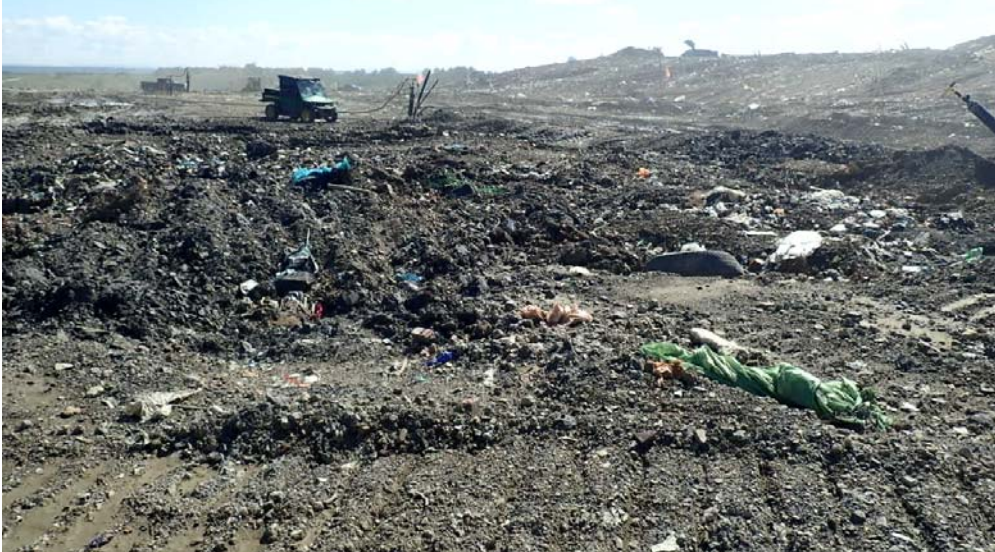
| <b>Photo #</b> | 3 | <b>Of</b> | 4 | | <b>Date</b> | 9/25/2023 | <b>Time</b> | 1503 |

| <b>Description</b> | Exposed solid waste observed in intermediate cover on the northern slope of the landfill. | | | | | | | |

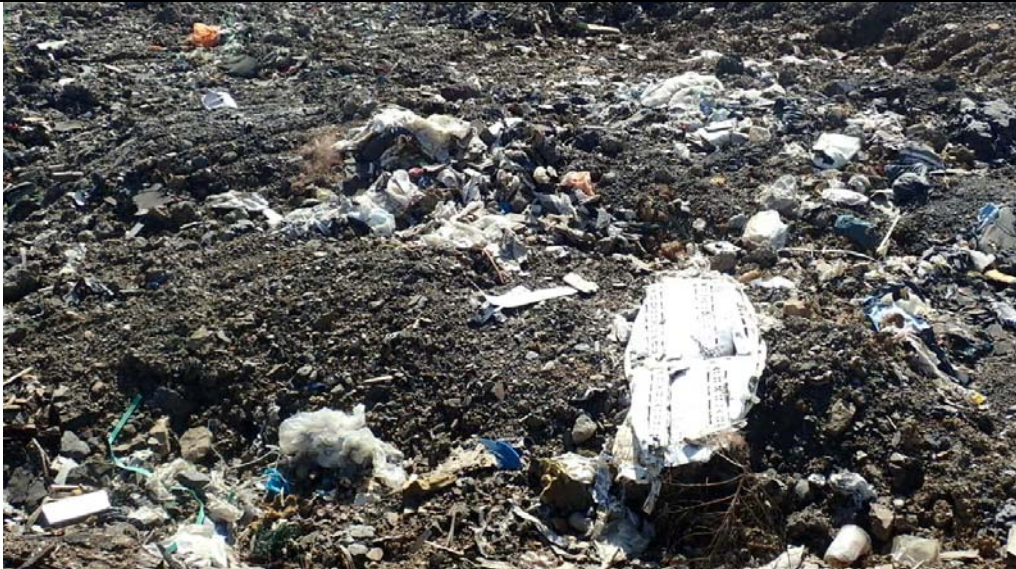
| <b>Photo #</b> | 4 | <b>Of</b> | 4 | | <b>Date</b> | 9/25/2023 | <b>Time</b> | 1503 |

| <b>Description</b> | Another view of exposed solid waste observed in intermediate cover on the northern slope of the landfill. | | | | | | | |
