**DIVISION OF  
ENVIRONMENTAL QUALITY**

**RE: Inspection conducted on December 21, 2023**  
**AFIN 66-00226**  
**Permit Number 0267-S1-R1**

**Division of Environmental Quality  
Office of Land Resources  
Class 1 Landfill Inspection Form**

| <b>Site Name</b> | City of Fort Smith Class 1 Landfill | <b>County</b> | Sebastian | <b>AFIN</b> | 66-00226 |

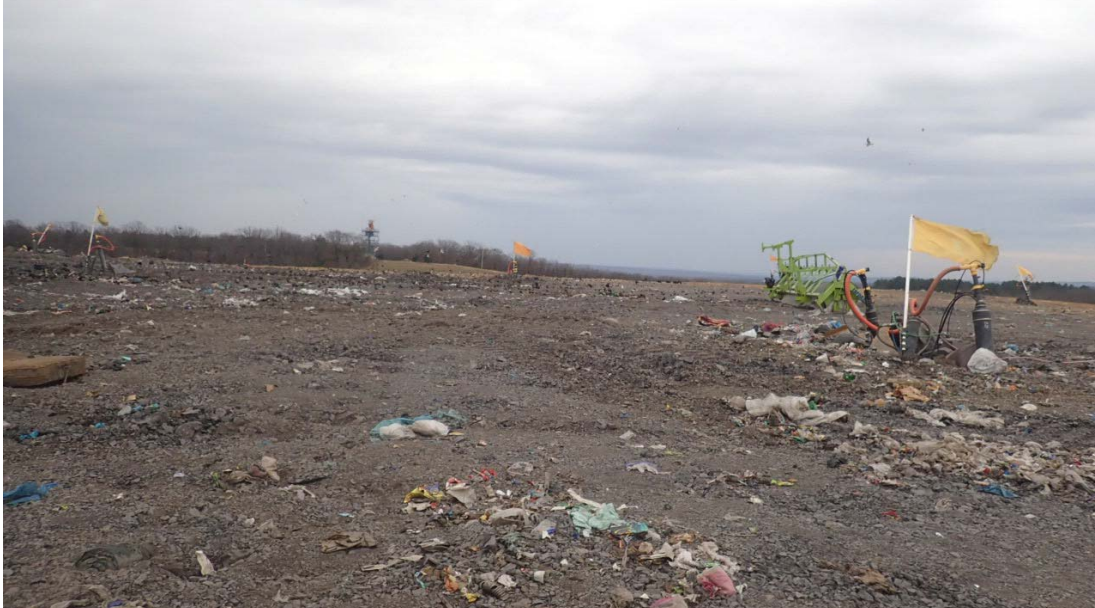
| <b>Photo #</b> | 1 | <b>Of</b> | 4 | <b>Date</b> | 12/21/2023 |

| | <b>Regulation</b> | <b>Item Description</b> | <b>Comments</b> |
|---|---|---|---|
| X | 413(c) | Satisfactory Intermediate Cover | Solid waste observed exposed in interim cover areas on the top, western, northern and eastern slopes of the landfill. (Refer to Photos #1 - #4.) |

| <b>Description</b> | Exposed solid waste observed in intermediate cover on the top of the landfill. | | | | |

You should immediately initiate actions to correct the alleged violations cited. A written response of the corrective actions taken, or to be taken, must be submitted within thirty (30) calendar days from the date on this letter to the attention of Jason Gilkey. The response may include, but is not limited to, photographs, copies of disposal receipts, records, or analytical results, as applicable. If you have any questions regarding the alleged violations, please do not hesitate to contact me at (501) 993-7188 or [jason.gilkey@adeq.state.ar.us](mailto:jason.gilkey@adeq.state.ar.us).

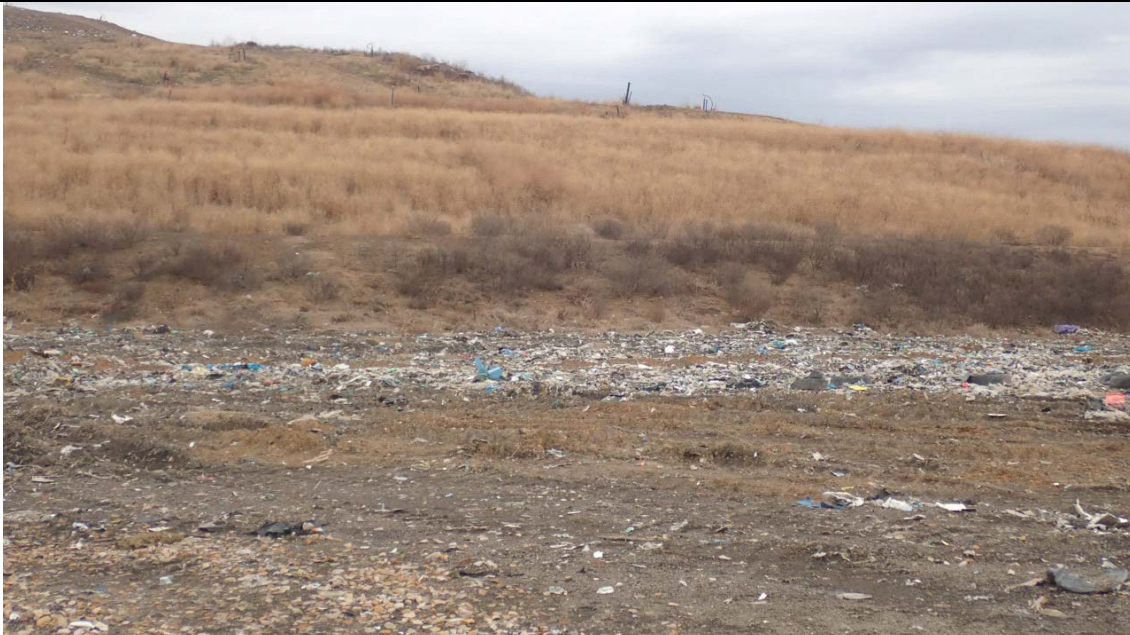
| <b>Photo #</b> | 2 | <b>Of</b> | 4 | <b>Date</b> | 12/21/2023 |

| <b>Description</b> | Exposed solid waste observed in intermediate cover on the western side of the landfill. | | | | |

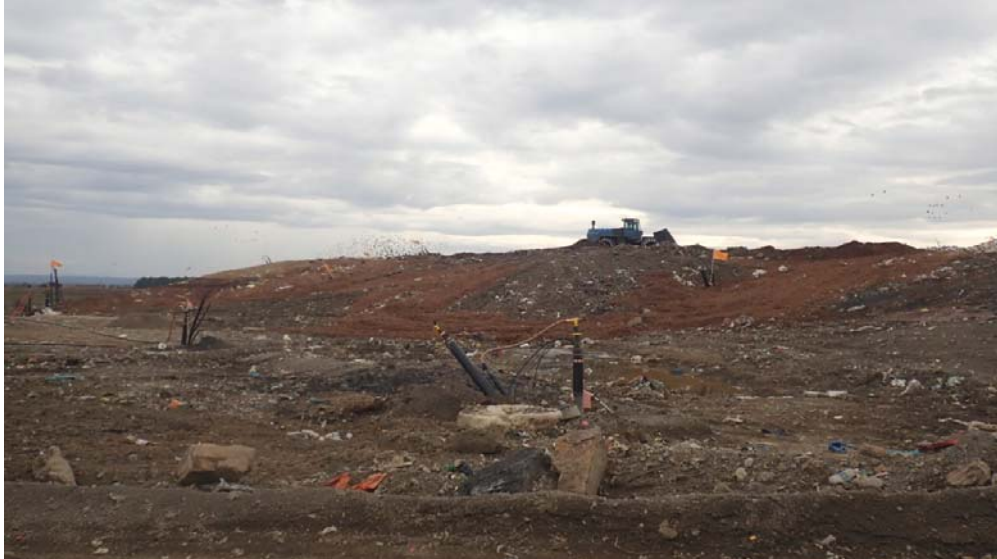
| <b>Photo #</b> | 3 | <b>Of</b> | 4 | | <b>Date</b> | 12/21/2023 | <b>Time</b> | 1503 |

| <b>Description</b> | Exposed solid waste observed in intermediate cover on the eastern top of the landfill. | | | | | | | |

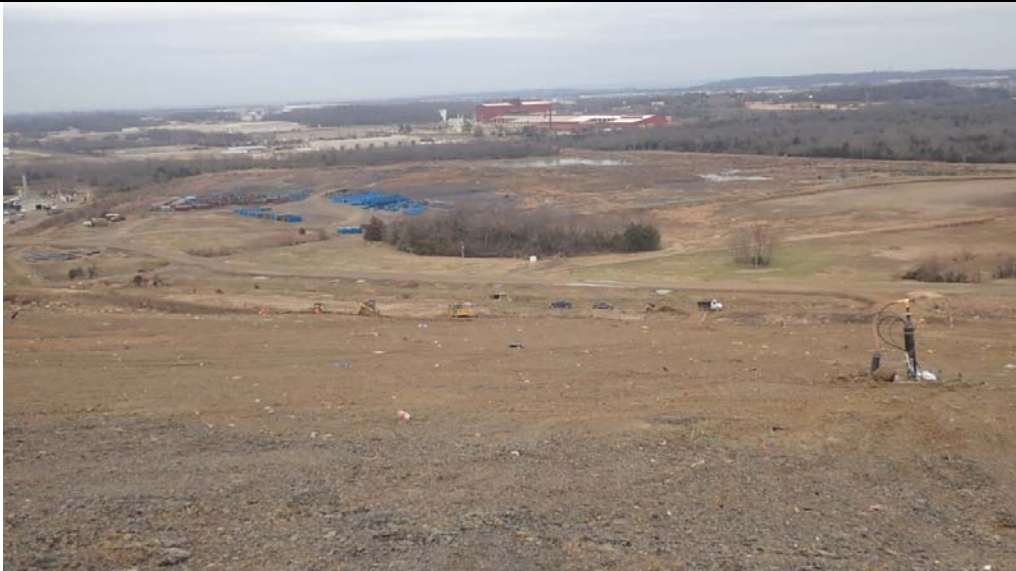
| <b>Photo #</b> | 4 | <b>Of</b> | 4 | | <b>Date</b> | 12/21/2023 | <b>Time</b> | 1503 |

| <b>Description</b> | Another view of exposed solid waste observed on the northern slope of the landfill. | | | | | | | |
