## OFFICE OF WATER QUALITY INSPECTION REPORT

NAME:  
**MAHLE Industrial User of Russellville City Corp**  
LOCATION:  
**2301 E. 16th St.**  
CITY:  
**Russellville**

### Industrial Site Visit

Name of Industry: MAHLE Engine Components USA, Inc.

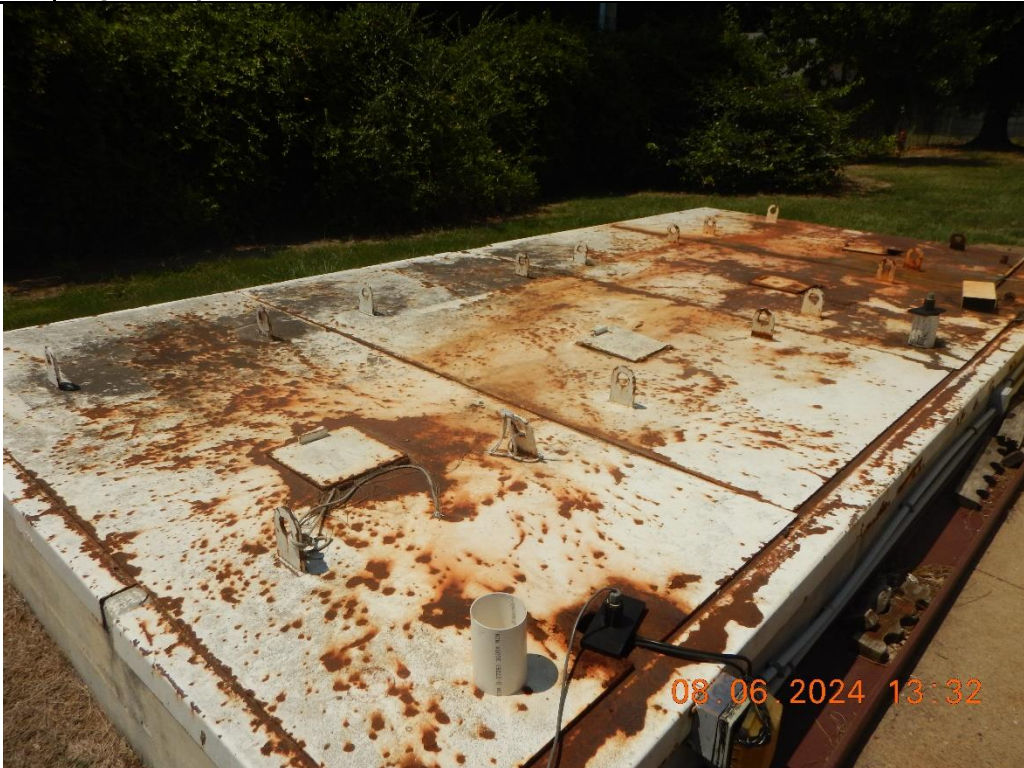
| Office of Water Quality Photographic Evidence Sheet | | | | | |
|---|---|---|---|---|---|
| Witness: | Gracie Morrison | | | Photo #: | 1 |

**Additional Comments:** This facility produces cam-shafts for diesel engines of all sizes. The wastewater is pH adjusted before going to the collection system. Treatment consists of an in-ground tank with 4 baffles. Acetic acid is added to section 2 and pH is continuously monitored in sections 2 and 4 of the tank. A 700-gallon tank of acetic acid is kept in containment on-site. A sand filter is in place for system backwash. Solids are removed by a contractor (Murdock) approximately twice per year.

| Office of Water Quality Photographic Evidence Sheet | | | | | |
|---|---|---|---|---|---|
| Description: | In-ground pretreatment tank with 4 sections | | | | |

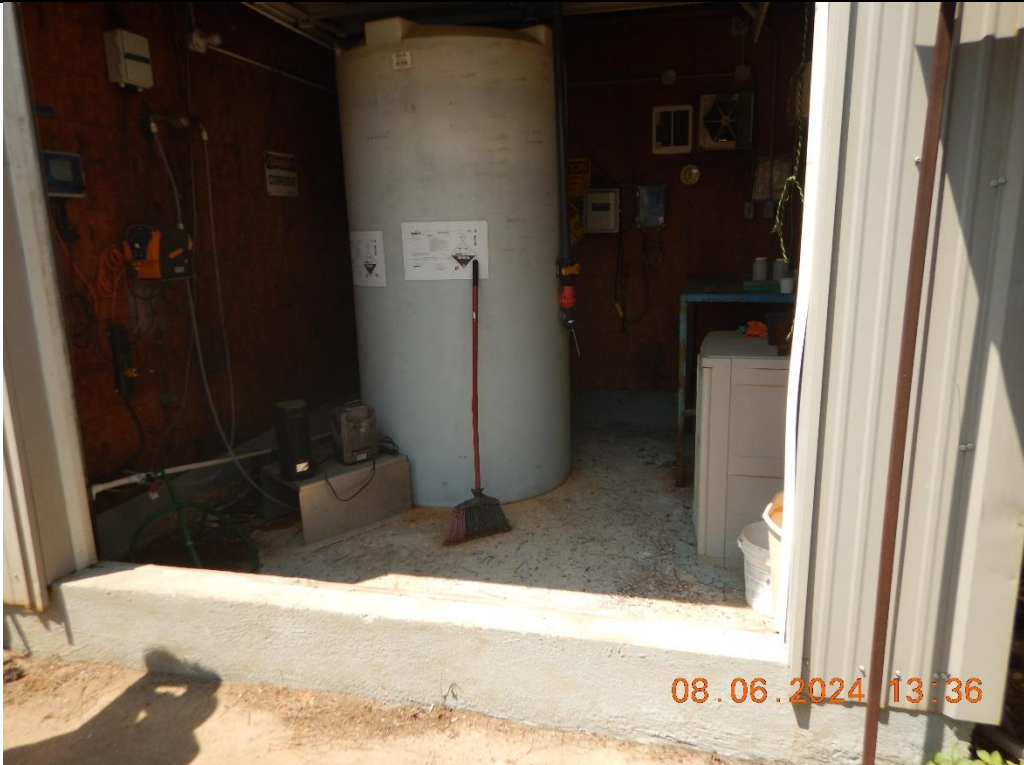
| Witness: | Gracie Morrison | | | Photo #: | 2 |

| Description: | Acetic acid used for pH adjustment in containment | | | | |

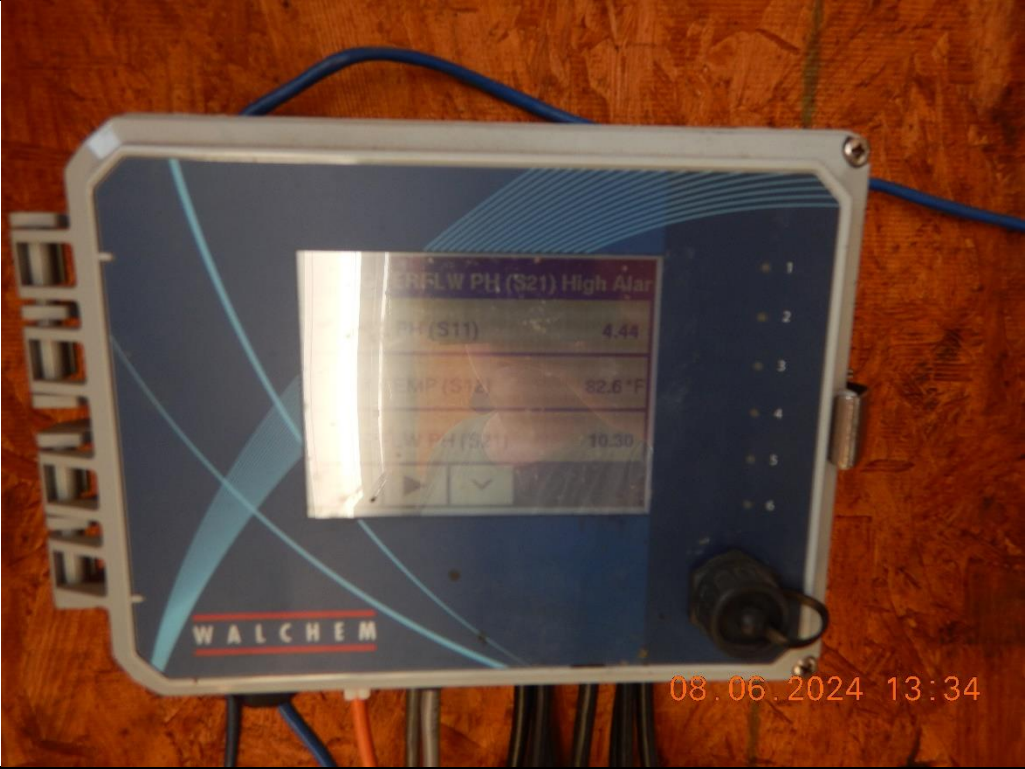
| Office of Water Quality Photographic Evidence Sheet | | | | | | |
|---|--|---|---|---|---|---|
| Witness: | | Gracie Morrison | | | Photo #: | 3 |

| Office of Water Quality Photographic Evidence Sheet | | | | | | |
|---|--|---|---|---|---|---|
| Description: | | Continuous pH monitoring in tank | | | | |

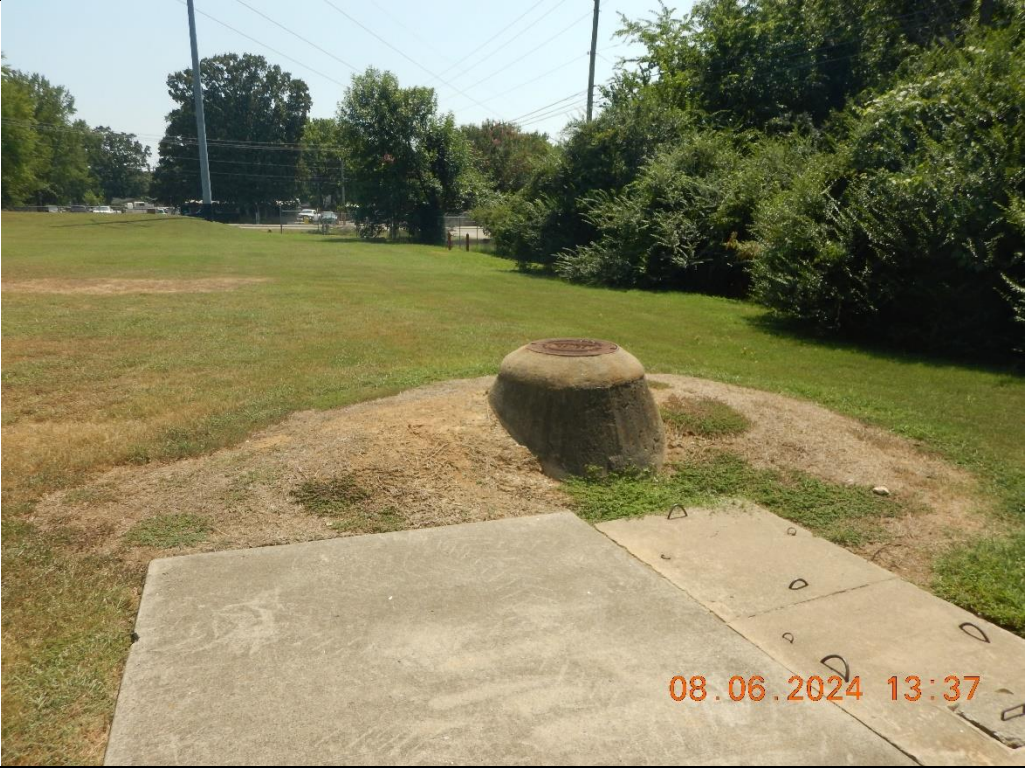
| Office of Water Quality Photographic Evidence Sheet | | | | | | |
|---|--|---|---|---|---|---|
| Witness: | | Gracie Morrison | | | Photo #: | 4 |

| Office of Water Quality Photographic Evidence Sheet | | | | | | |
|---|--|---|---|---|---|---|
| Description: | | Manhole/sampling point for this IU | | | | |
