**DIVISION OF  
ENVIRONMENTAL  
QUALITY**

RE: City Corporation Inspection (Pope County) – PDS# 133114, 133115, 133116  
AFIN: 58-00105 Permit No.: AR0021768

| <b>ENVIRONMENTAL<br/>QUALITY</b> | <b>OFFICE OF WATER QUALITY<br/>INSPECTION REPORT</b> | | |

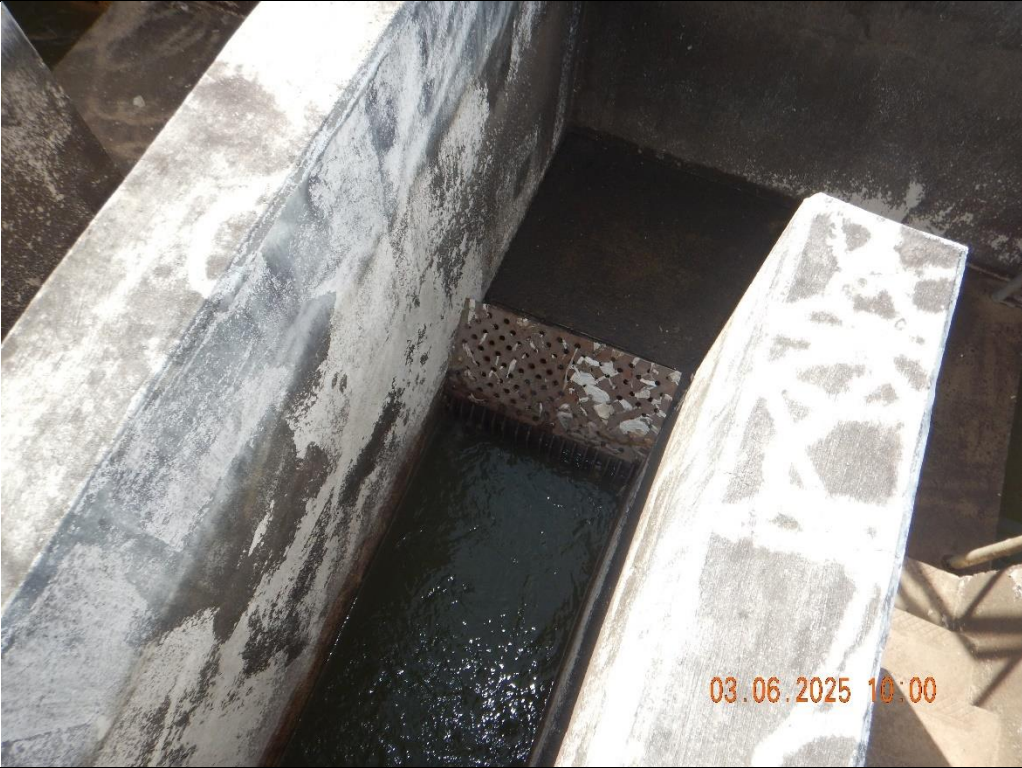
| Office of Water Quality Photographic Evidence Sheet | | | | | | |
|---|--|---|---|---|---|---|
| Witness: | | <b>None- no other regulatory personnel</b> | | | Photo #: | <b>1</b> |

| Office of Water Quality Photographic Evidence Sheet | | | | | | |
|---|--|---|---|---|---|---|
| Description: | | <b>Influent bar screens</b> | | | | |

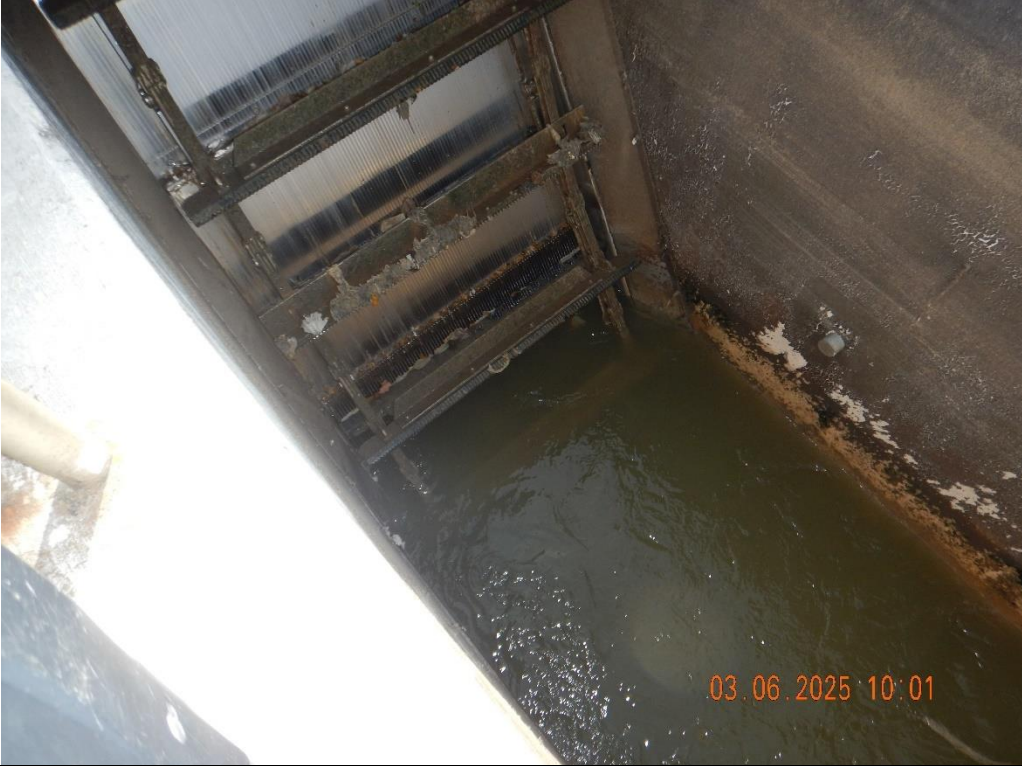
| Office of Water Quality Photographic Evidence Sheet | | | | | |
|---|---|---|---|---|---|
| Witness: | <b>None</b> | | | Photo #: | <b>3</b> |

| Office of Water Quality Photographic Evidence Sheet | | | | | |
|---|---|---|---|---|---|
| Description: | <b>Additional screening.</b> | | | | |

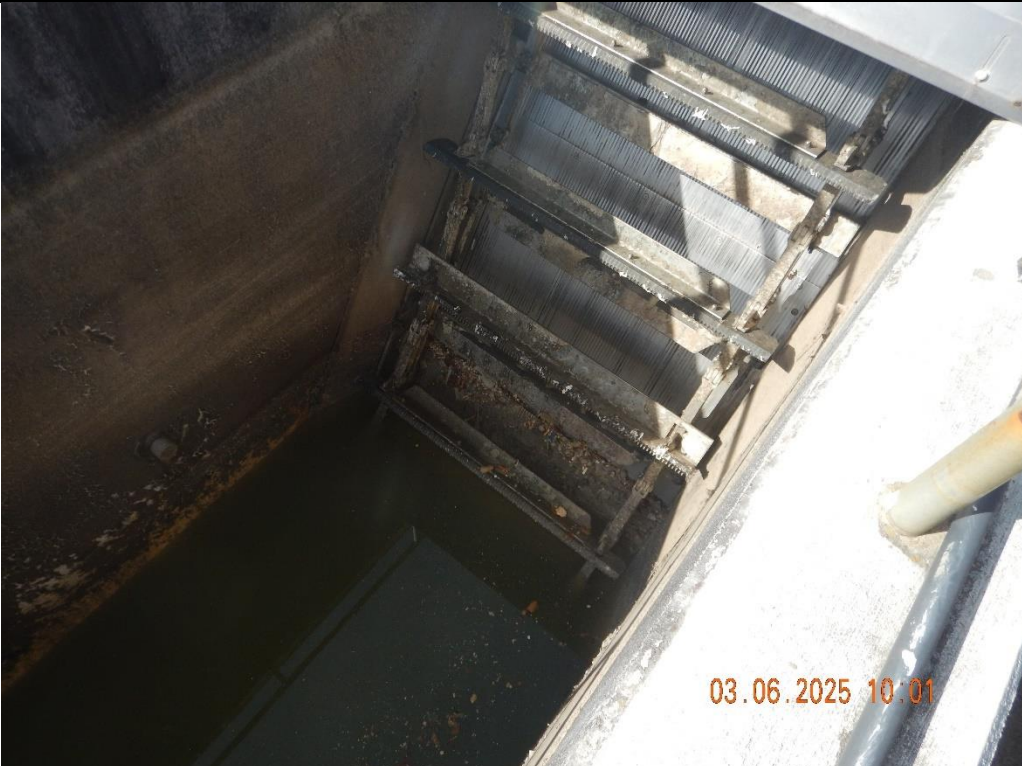
| Office of Water Quality Photographic Evidence Sheet | | | | | |
|---|---|---|---|---|---|
| Witness: | <b>None</b> | | | Photo #: | <b>4</b> |

| Office of Water Quality Photographic Evidence Sheet | | | | | |
|---|---|---|---|---|---|
| Description: | <b>West side screening is down due to pending repair in Photo #2.</b> | | | | |

Response – With mechanical bar screens in place downstream of the bar screen in question, it was decided that the failed screen could be removed without causing any loss in screening ability at the head works. Maintenance work order 16-27086 was created to remove the bar screen, with a scheduled completion date of May 3, 2025 (see attachment). Plant personnel were aware of the issue with the west grit removal system and have been waiting for influent flows to decrease to a point where it is possible to keep water within the east chamber of the grit basin to be able to access the west. Maintenance work order 16-27087 was created to drain the west grit basin and make the necessary repairs to the grit bucket conveyor system. The scheduled date of completion is May 2, 2025 (See attachment).

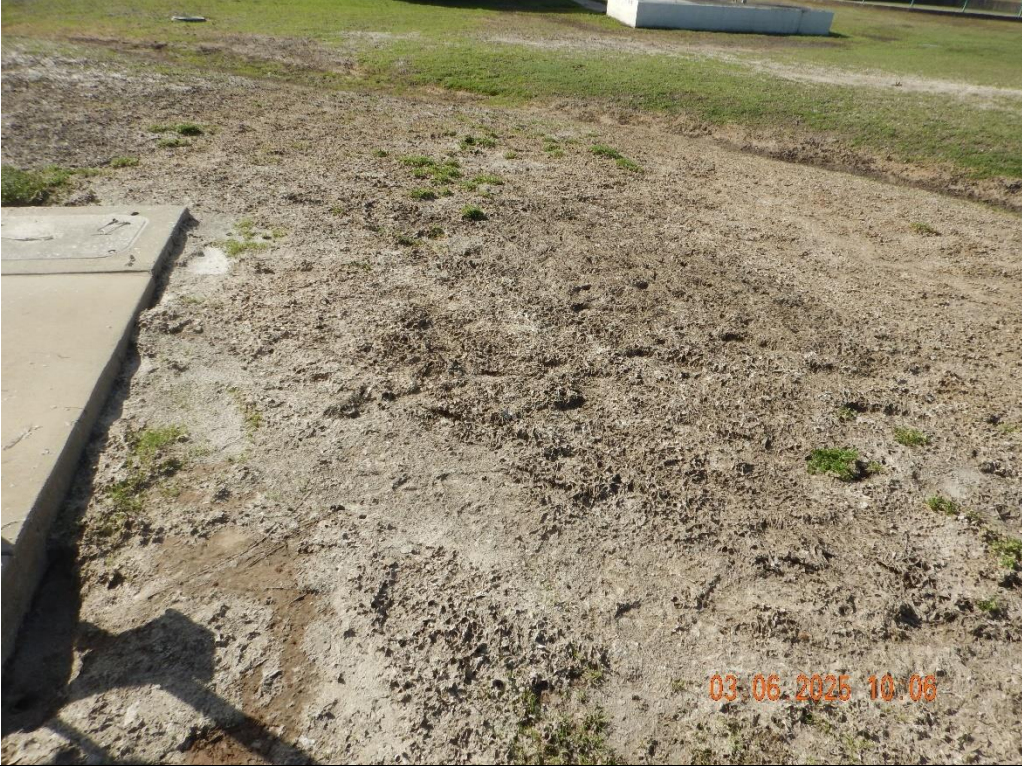
| Office of Water Quality Photographic Evidence Sheet | | | | | |
|---|---|---|---|---|---|
| Description: | <b>Recent SSO at headworks. The facility reported on February 14, 2025.</b> | | | | |

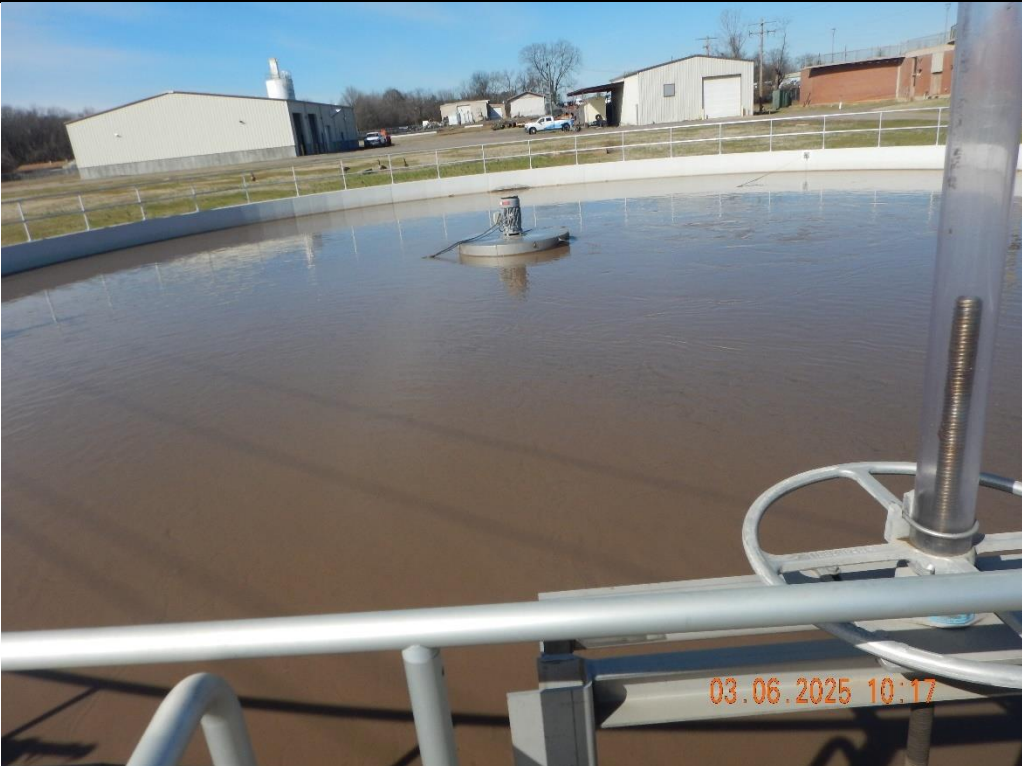
| Office of Water Quality Photographic Evidence Sheet | | | | | |
|---|---|---|---|---|---|
| Description: | <b>Anaerobic selector</b> | | | | |

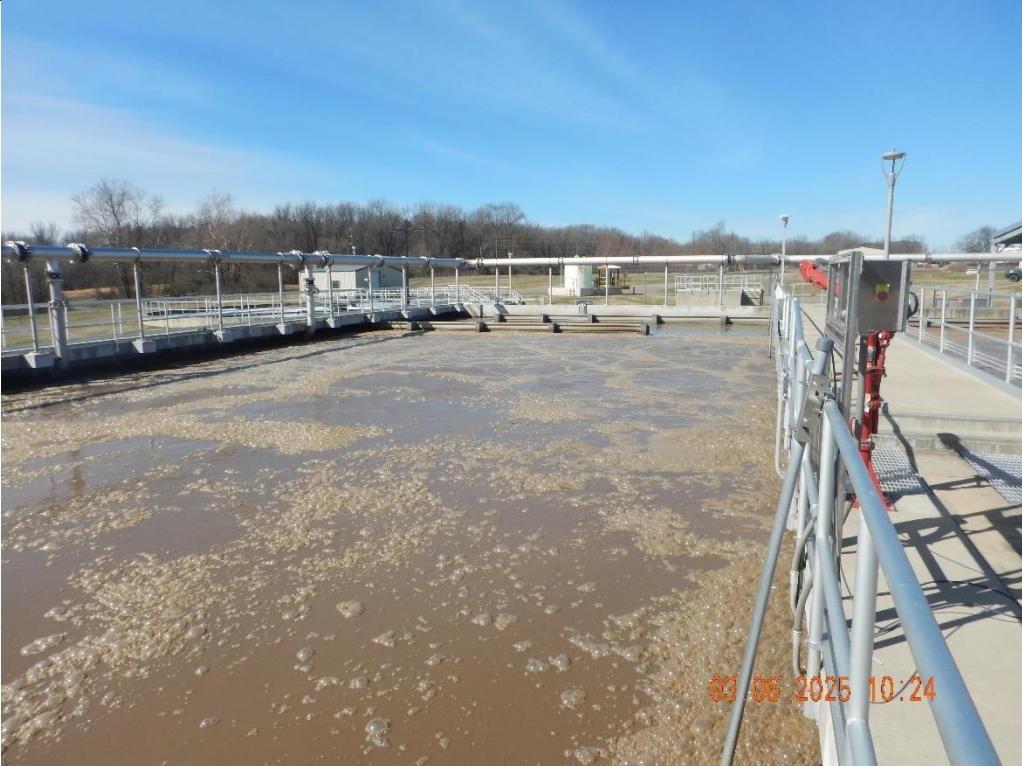
| Office of Water Quality Photographic Evidence Sheet | | | | | |
|---|---|---|---|---|---|
| Description: | <b>4 activated sludge basins. Each with an anaerobic, aerobic, and additional air (if needed) zone.</b> | | | | |

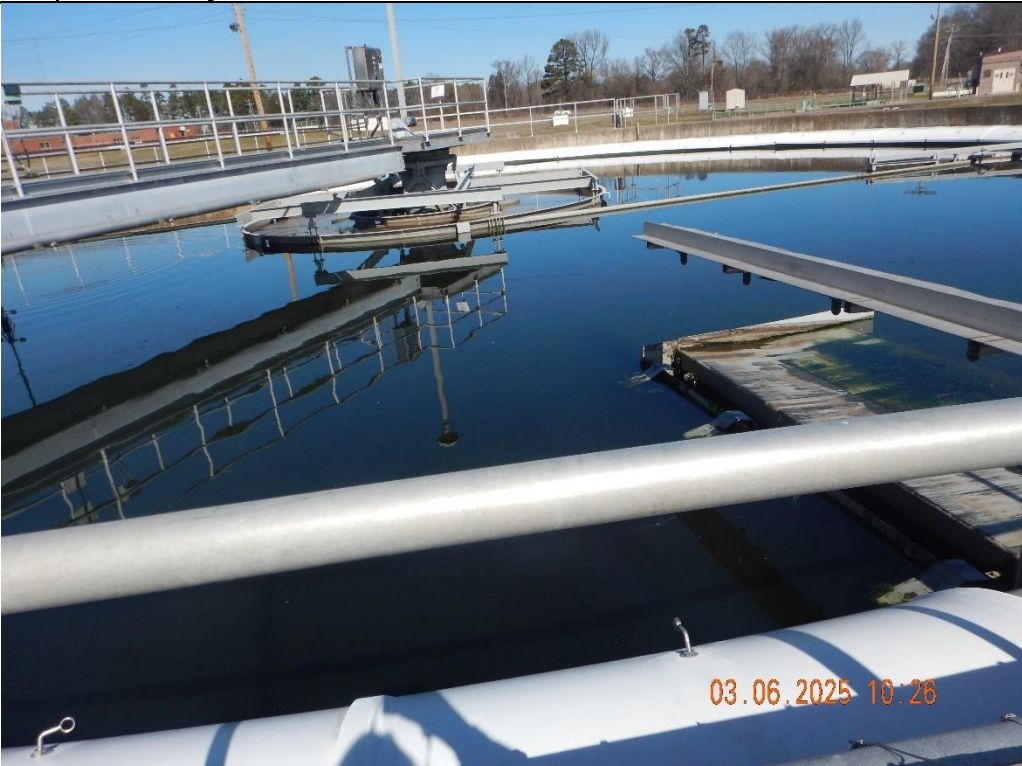
| Office of Water Quality Photographic Evidence Sheet | | | | | |
|---|---|---|---|---|---|
| Description: | <b>3 secondary clarifiers</b> | | | | |

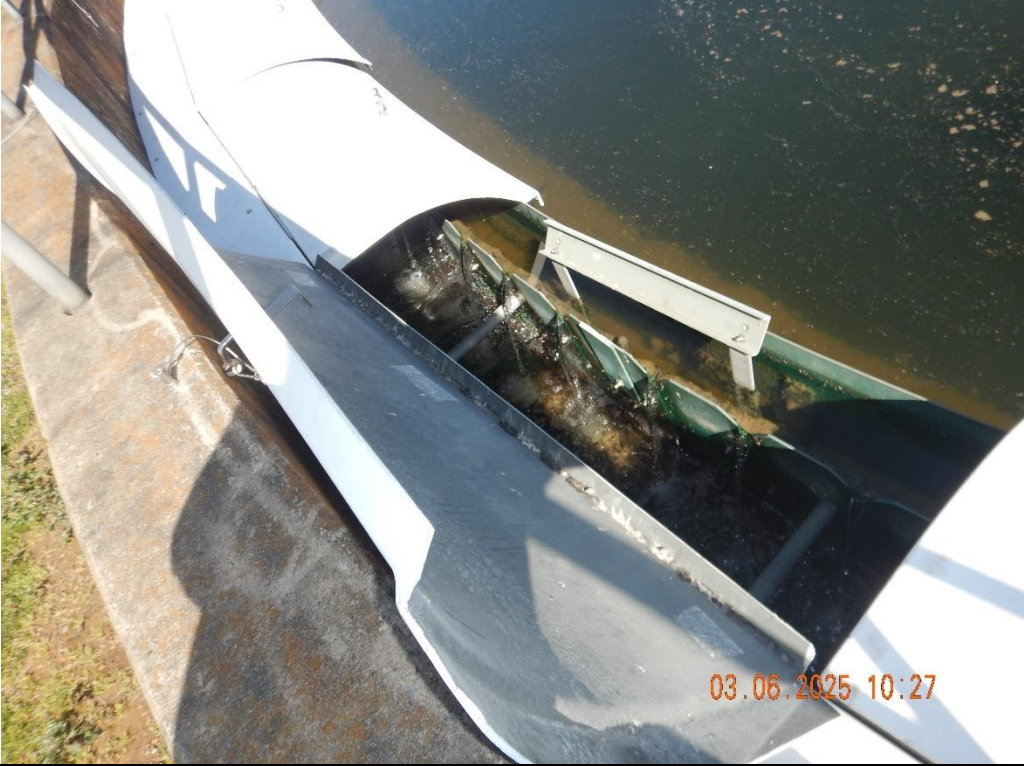
| Office of Water Quality Photographic Evidence Sheet | | | | | |
|---|---|---|---|---|---|
| Witness: | <b>None</b> | | | Photo #: | <b>9</b> |

| Office of Water Quality Photographic Evidence Sheet | | | | | |
|---|---|---|---|---|---|
| Description: | <b>View of secondary clarifier effluent. All three clarifiers with weir covers.</b> | | | | |

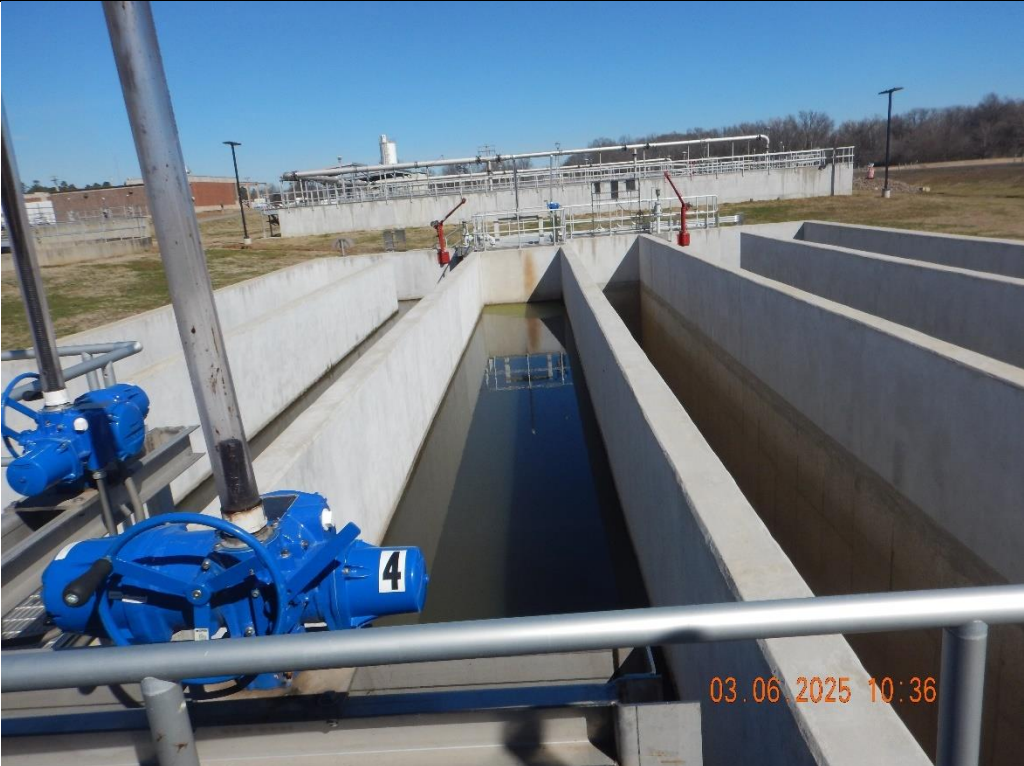
| Office of Water Quality Photographic Evidence Sheet | | | | | |
|---|---|---|---|---|---|
| Witness: | <b>None</b> | | | Photo #: | <b>10</b> |

| Office of Water Quality Photographic Evidence Sheet | | | | | |
|---|---|---|---|---|---|
| Description: | <b>Peracetic acid disinfection</b> | | | | |

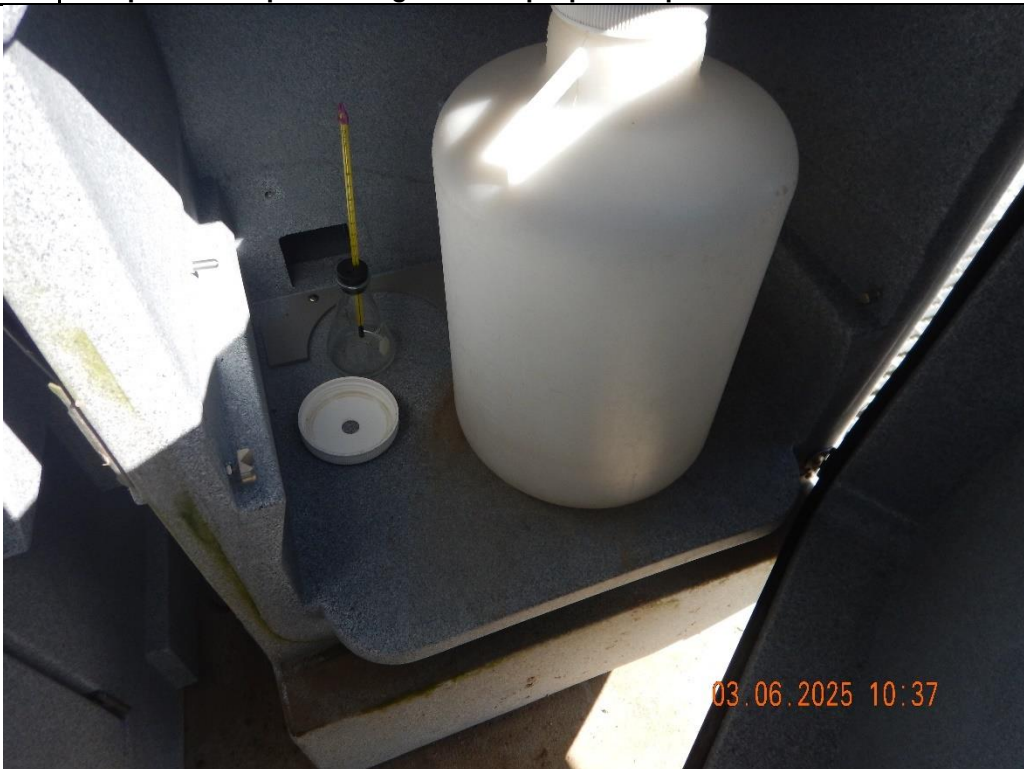
| Office of Water Quality Photographic Evidence Sheet | | | | | |
|---|---|---|---|---|---|
| Witness: | <b>None</b> | | | Photo #: | <b>11</b> |

| Office of Water Quality Photographic Evidence Sheet | | | | | |
|---|---|---|---|---|---|
| Description: | <b>Composite sampler. Refrigerated at proper temperature.</b> | | | | |

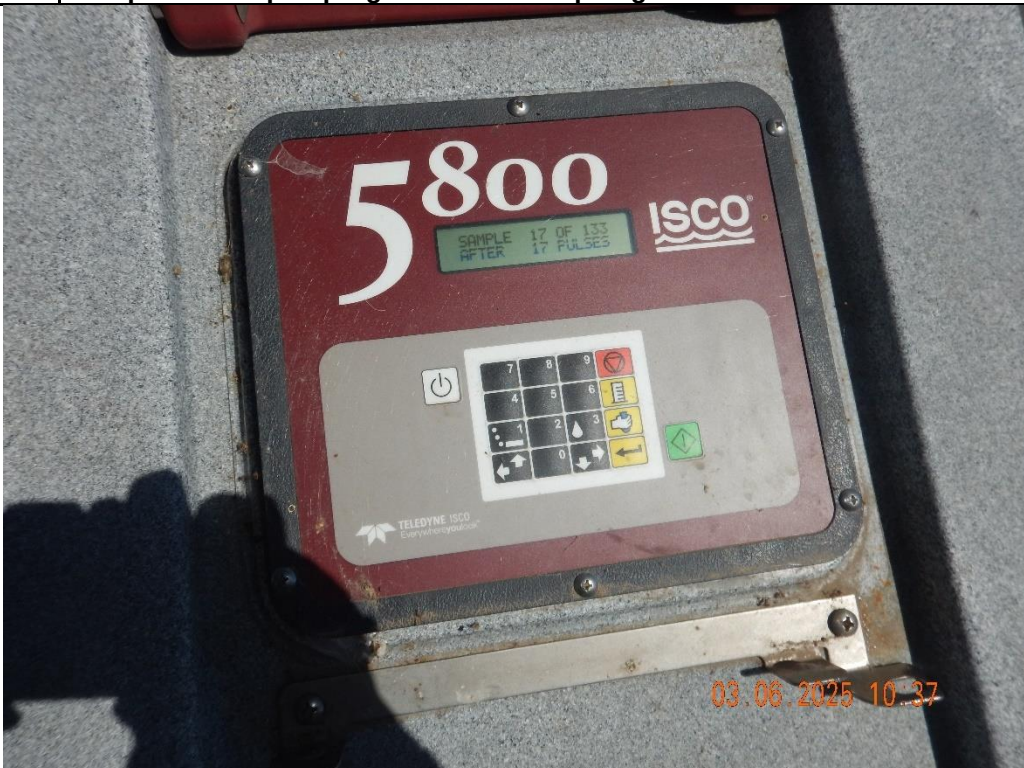
| Office of Water Quality Photographic Evidence Sheet | | | | | |
|---|---|---|---|---|---|
| Witness: | <b>None</b> | | | Photo #: | <b>12</b> |

| Office of Water Quality Photographic Evidence Sheet | | | | | |
|---|---|---|---|---|---|
| Description: | <b>Composite sampler programmed for aliquot grabs.</b> | | | | |

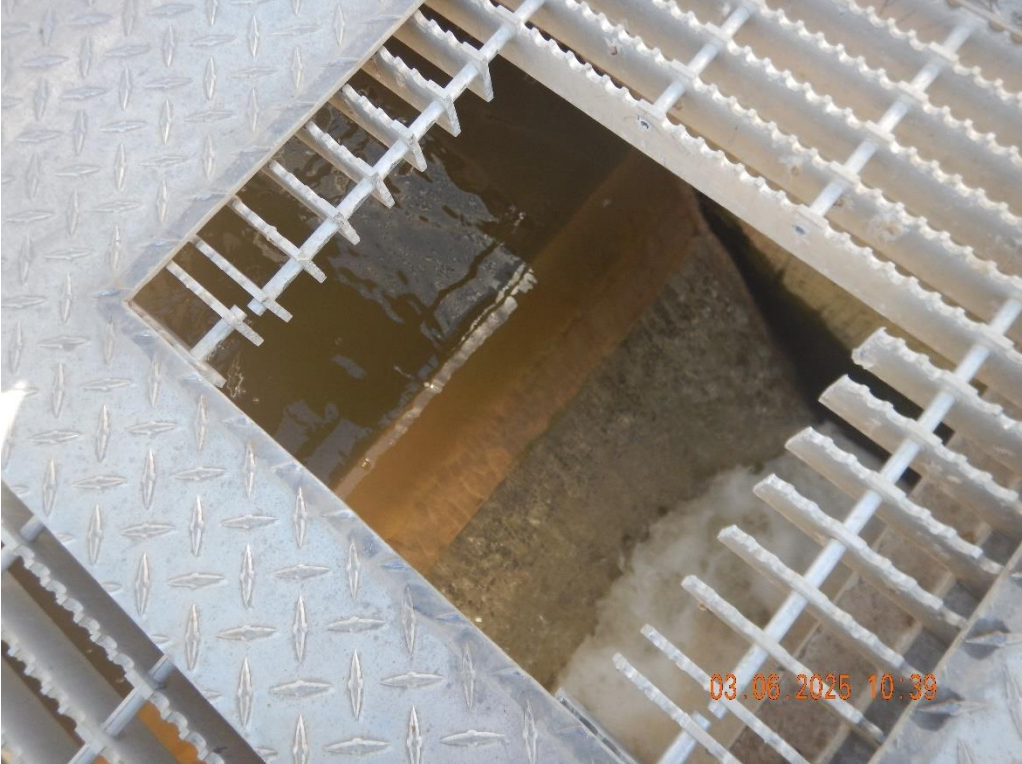
| Office of Water Quality Photographic Evidence Sheet | | | |
|---|---|---|---|
| | | Photo #: | <b>13</b> |

| Office of Water Quality Photographic Evidence Sheet | | | |
|---|---|---|---|
| Description: | <b>View of effluent weir and view of final effluent quality.</b> | | |

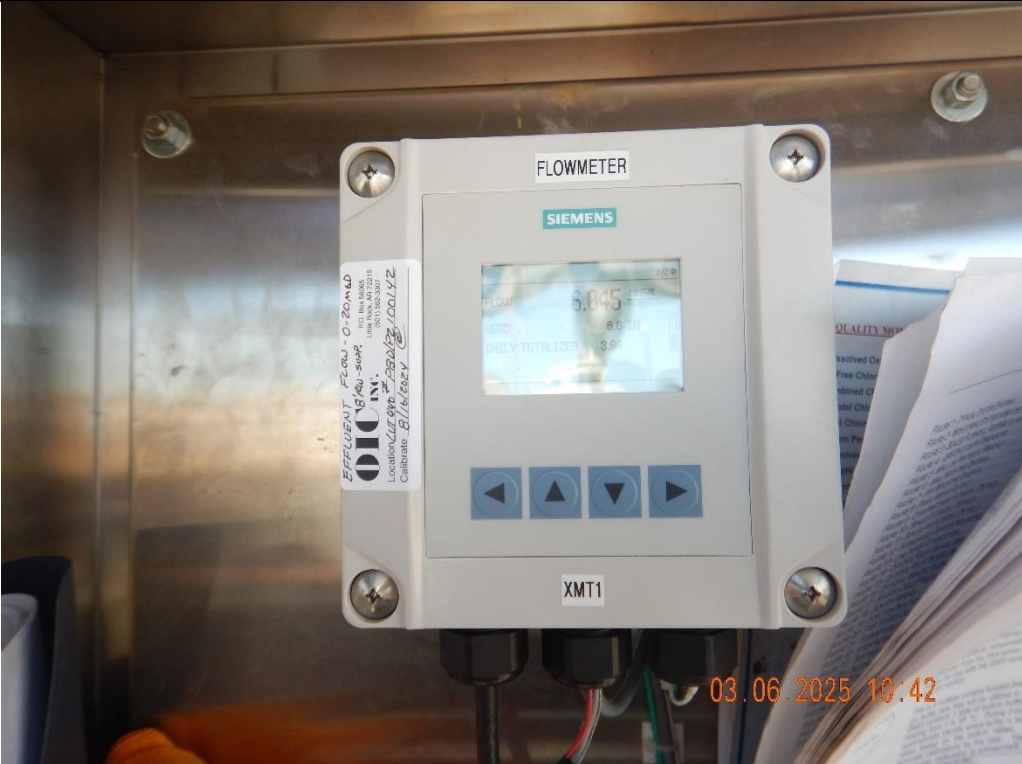
| Office of Water Quality Photographic Evidence Sheet | | | |
|---|---|---|---|
| | | Photo #: | <b>14</b> |

| Office of Water Quality Photographic Evidence Sheet | | | |
|---|---|---|---|
| Description: | <b>Effluent flow meter calibrated 8/16/2024 by OIC, Inc.</b> | | |

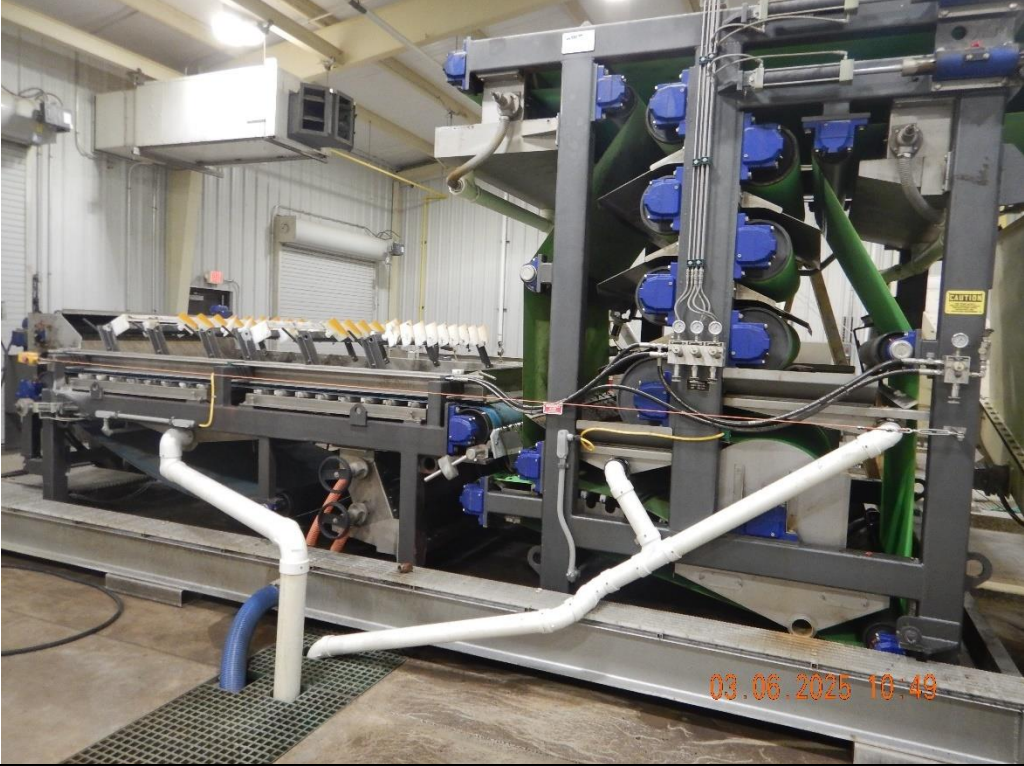
| Office of Water Quality Photographic Evidence Sheet | | | | | |
|---|---|---|---|---|---|
| Witness: | <b>None</b> | | | Photo #: | <b>15</b> |

| Office of Water Quality Photographic Evidence Sheet | | | | | |
|---|---|---|---|---|---|
| Description: | <b>Sludge press</b> | | | | |

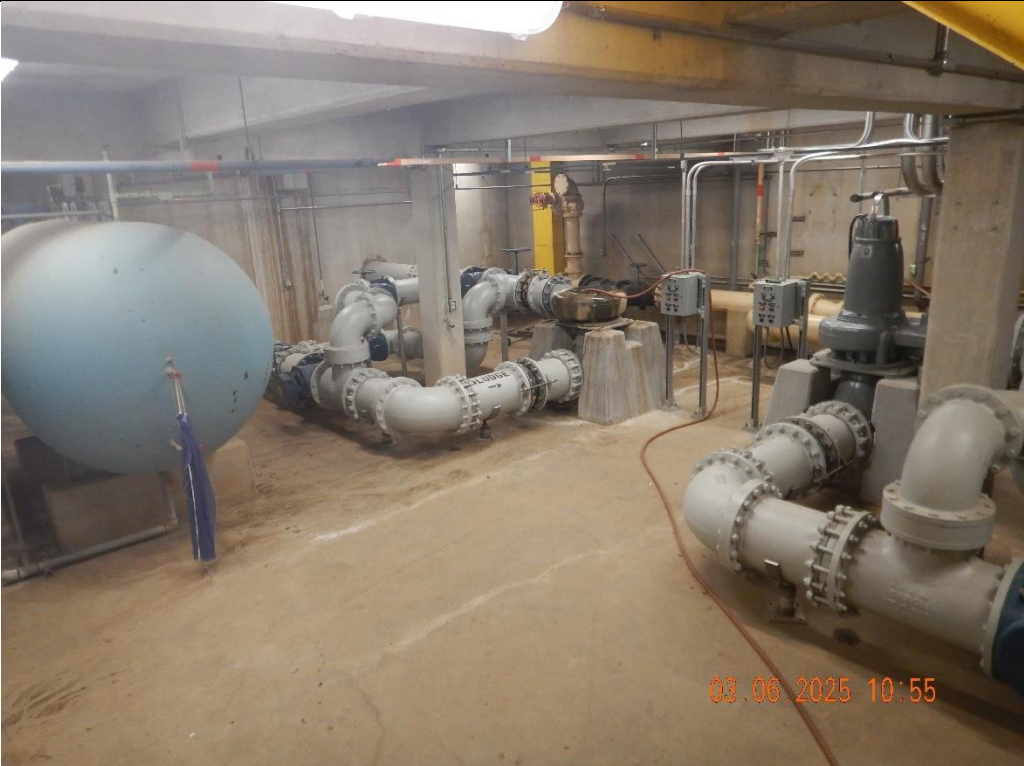
| Office of Water Quality Photographic Evidence Sheet | | | | | |
|---|---|---|---|---|---|
| Witness: | <b>None</b> | | | Photo #: | <b>16</b> |

| Office of Water Quality Photographic Evidence Sheet | | | | | |
|---|---|---|---|---|---|
| Description: | <b>Aerobic sludge tanks with 1 of 2 mixers removed for repair.</b> | | | | |

The east sludge tank mixer pump was removed from service due to overheating alarms and picked up by Jack Tyler Engineering on September 16<sup>th</sup>, 2024 for evaluation. We were notified by JTE on October 18, 2024 that the pump experienced cavitation damage to the lower seal plate and that parts were being sourced. In the meantime, we have been able to keep the east sludge tank partially mixed with the aeration system and have experienced no issues as a result. The pump was returned to us on April 10, 2025 and installed by maintenance personnel on April 15, 2025. However, it was found that the pump is still experiencing some type of internal issue that is causing a high amperage draw. JTE is continuing to troubleshoot the issue and correct, at which time the pump will be put back in service.

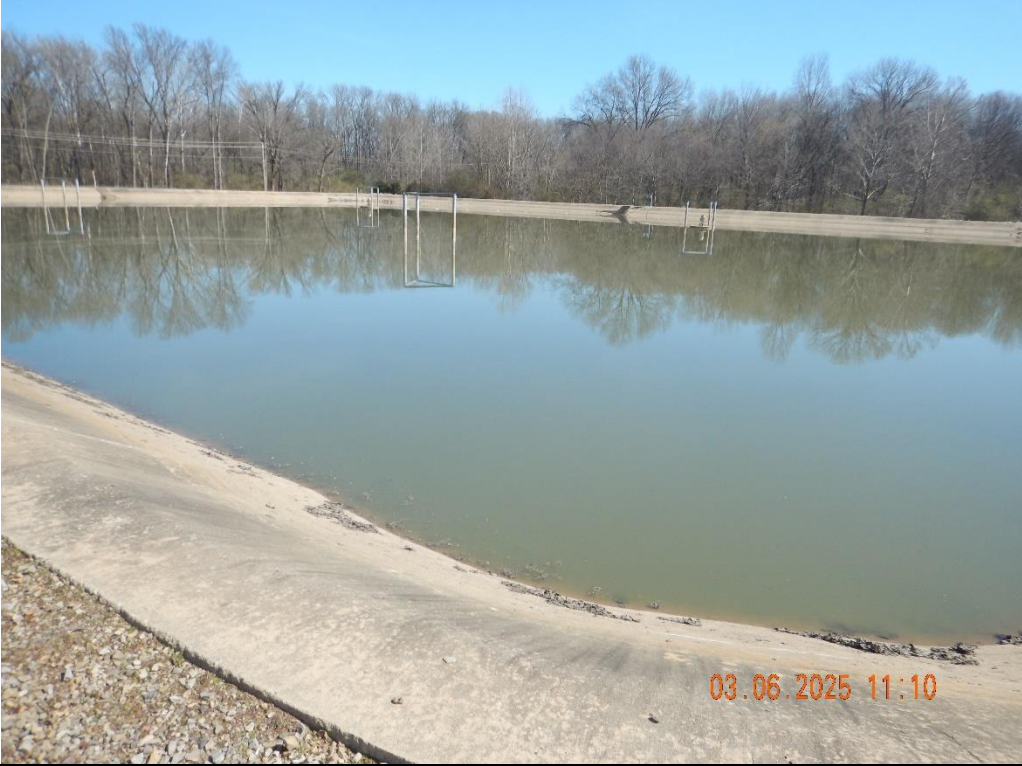
| Office of Water Quality Photographic Evidence Sheet | | | | | |
|---|---|---|---|---|---|
| Witness: | <b>None</b> | | | Photo #: | <b>17</b> |

| Office of Water Quality Photographic Evidence Sheet | | | | | |
|---|---|---|---|---|---|
| Description: | <b>First of three aerated equalization basins</b> | | | | |

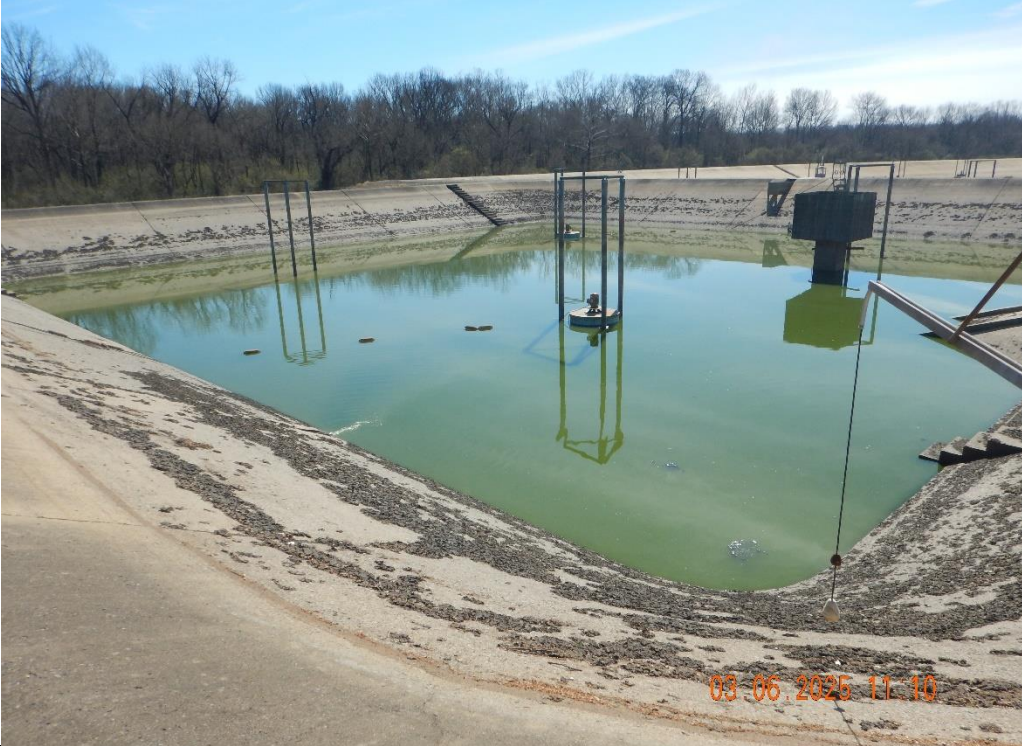
| Office of Water Quality Photographic Evidence Sheet | | | | | |
|---|---|---|---|---|---|
| Witness: | <b>None</b> | | | Photo #: | <b>18</b> |

| Office of Water Quality Photographic Evidence Sheet | | | | | |
|---|---|---|---|---|---|
| Description: | <b>Center equalization basin.</b> | | | | |

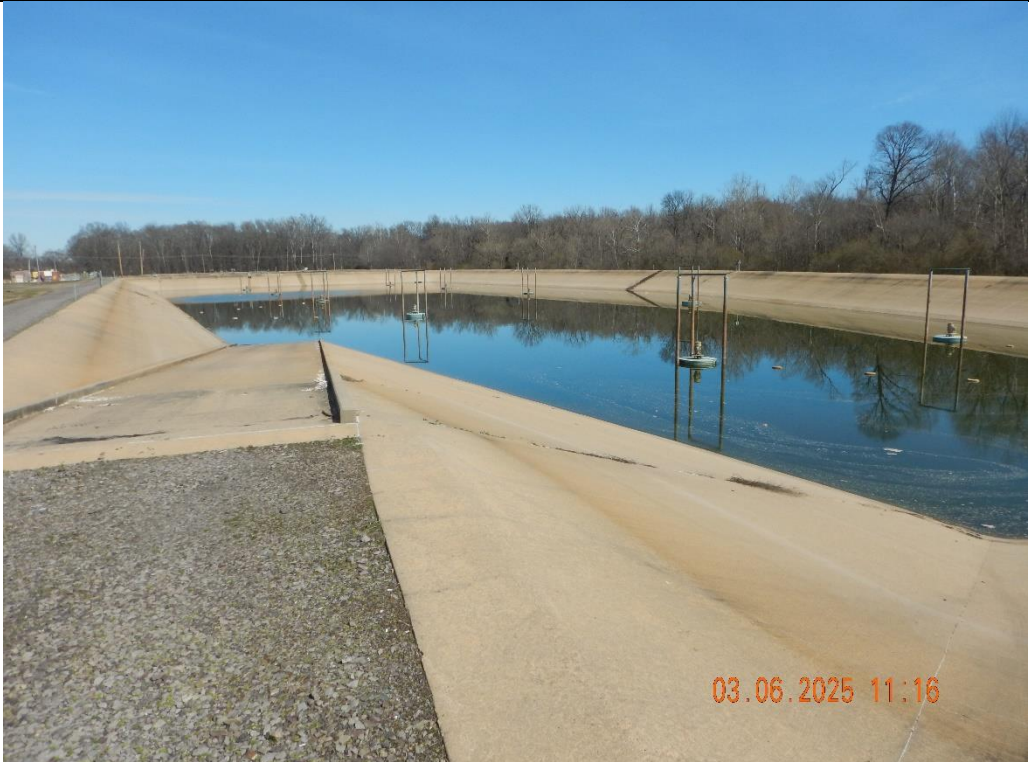
| Office of Water Quality Photographic Evidence Sheet | | | |
|---|---|---|---|
| | | | <b>19</b> |

| Office of Water Quality Photographic Evidence Sheet | | | |
|---|---|---|---|
| Description: | <b>Third equalization basin.</b> | | |

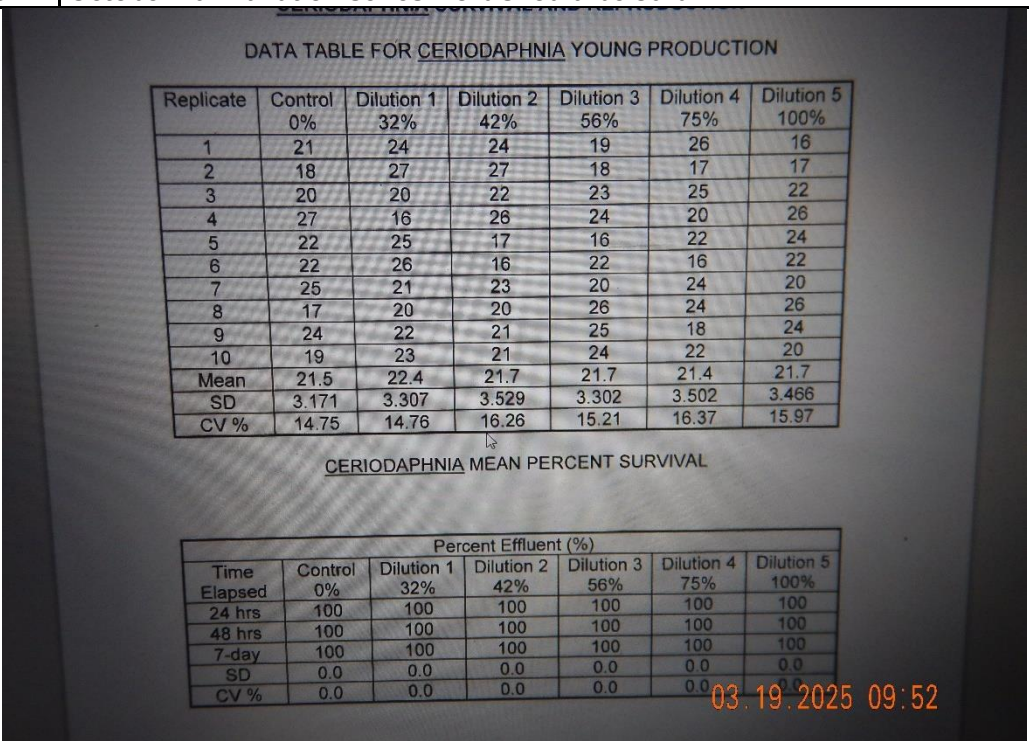
| | | | <b>20</b> |

| b. PROPER DILUTION SERIES FOLLOWED: <u>Report used 0, 32, 42, 56, 75, 100%. Should be 0, 32, 42, 56, 80, 100%.</u> | <input type="checkbox"/> Y <input checked="" type="checkbox"/> N <input type="checkbox"/> NA <input type="checkbox"/> NE |

| Description: | <b>October 2024 dilution series. 75% should be 80%.</b> | | |

- The October 2024 biomonitoring report lists a dilution series of 75%. This should be 80% per Part II.9.A of the permit. The facility should contact the contract lab and inform of the dilution series.
- At the time of inspection, one of the bar screens was needing repair and west grit removal was down. Also, one of two sludge tank mixers was out for repair. Per Part III.B.1.A of the permit, the bar screen and the sludge tank mixer should be repaired and retuned to operation. Per Mr. Kremers, the facility will need to wait for low flow conditions to repair the bar screen. The facility reported a SSO at the headworks on February 14, 2025, which was due to the equalization basins being at capacity at that time.
