RE: City of Bentonville Inspection (Benton County) – PDS #133239  
AFIN: 04-00154 Permit No.: AR0022403

| <b>ENVIRONMENTAL<br/>QUALITY</b> | <b>OFFICE OF WATER QUALITY<br/>INSPECTION REPORT</b> | | | | |

On March 27, 2025, I conducted a Compliance Evaluation Inspection at the above-referenced facility. Mr. Chris Earl, Manager at Bentonville Water Resource Recovery Facility, accompanied me during the inspection. The inspection consisted of a records review and site assessment.

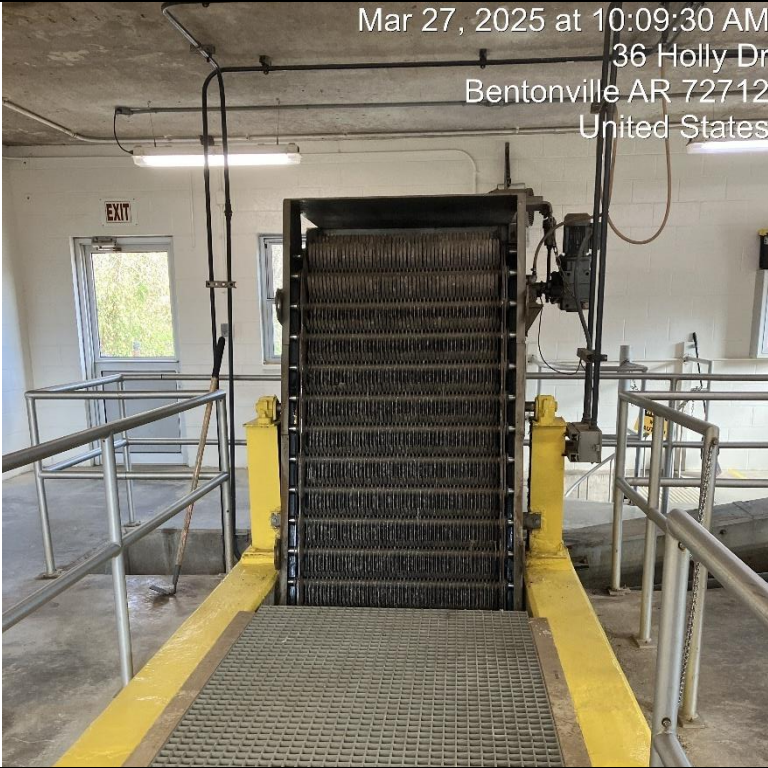
| Office of Water Quality Photographic Evidence Sheet | | | |
|---|---|---|---|
| Description: | <b>Automatic bar screen at headworks.</b> | | |

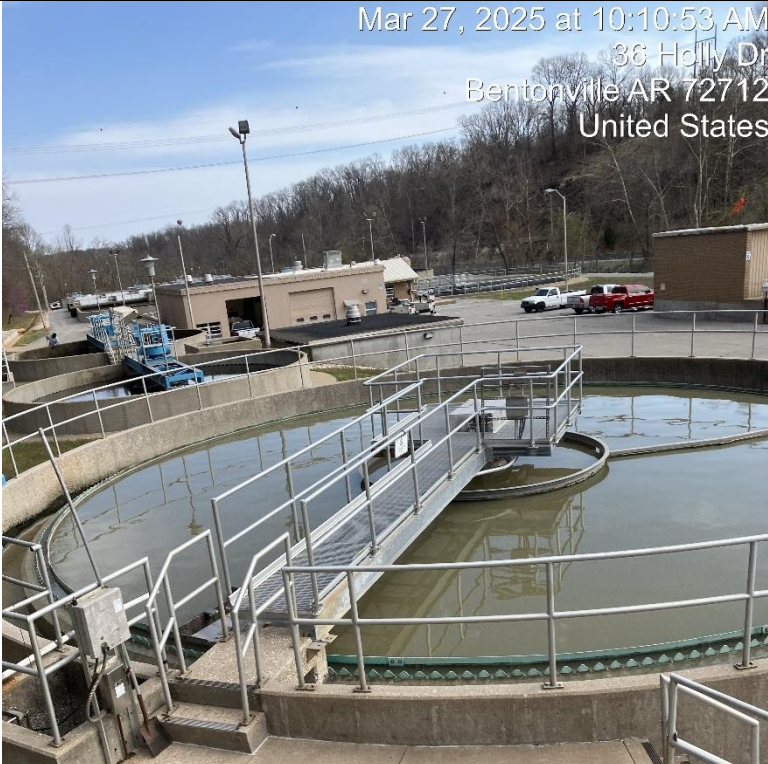
| Office of Water Quality Photographic Evidence Sheet | | | |
|---|---|---|---|
| Description: | <b>This primary clarifier will be decommissioned as part of the upgrade.</b> | | |

Some of the current tanks/clarifiers will be decommissioned but saved for future potential use. Selective wasting will be implemented in the oxidation ditches with the new upgrade – baffles will be stalled roughly 1.5” into the water for this system. Impeller pumps will replace all recycle pumps at the facility. In the anoxic basin, four new anoxic zones will be built, and the submersible mixers will be pulled to be replaced with a bubbling system to be installed at the bottom of the basins in a grid. The facility will also implement a blending unit for short-term treatment, primarily for rainwater that does not need to go through full treatment. The current UV disinfection system will be replaced with an updated, more automatic UV disinfectant system. With the upgrade, the facility will also get two generators to power different ends of the facility. The facility upgrade will start in June 2025 and take approximately 4.5 years to complete.

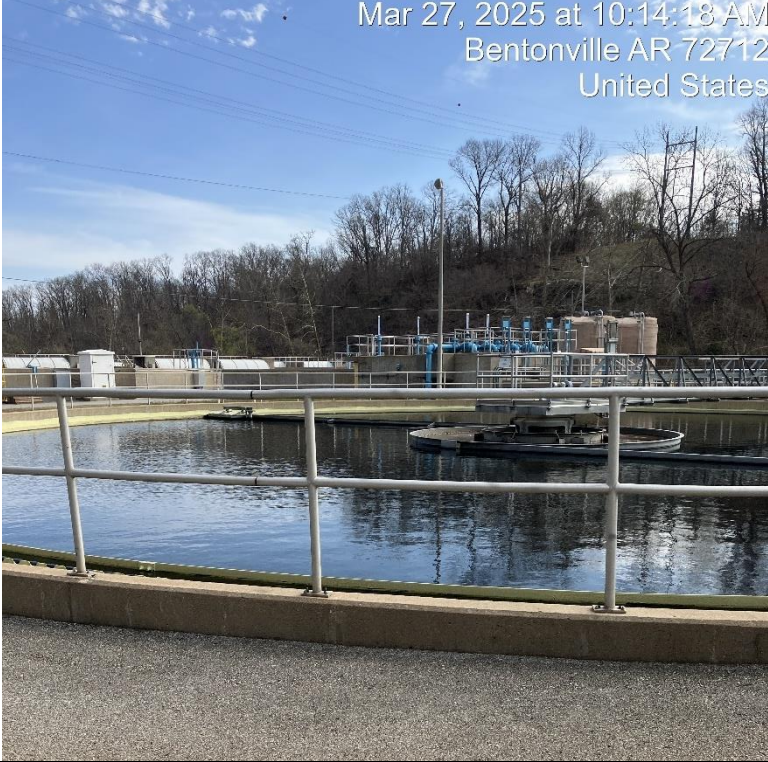
| Office of Water Quality Photographic Evidence Sheet | | | |
|---|---|---|---|
| Description: | <b>Secondary clarifier in good condition.</b> | | |

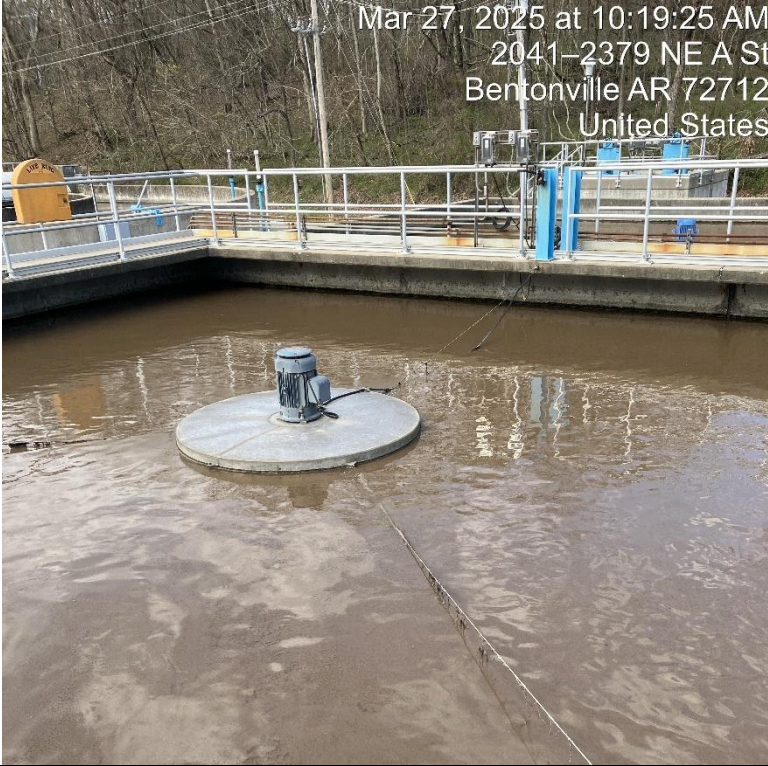
| Office of Water Quality Photographic Evidence Sheet | | | |
|---|---|---|---|
| Description: | <b>Anoxic basin will receive a bubbler system to replace the submersible mixers.</b> | | |

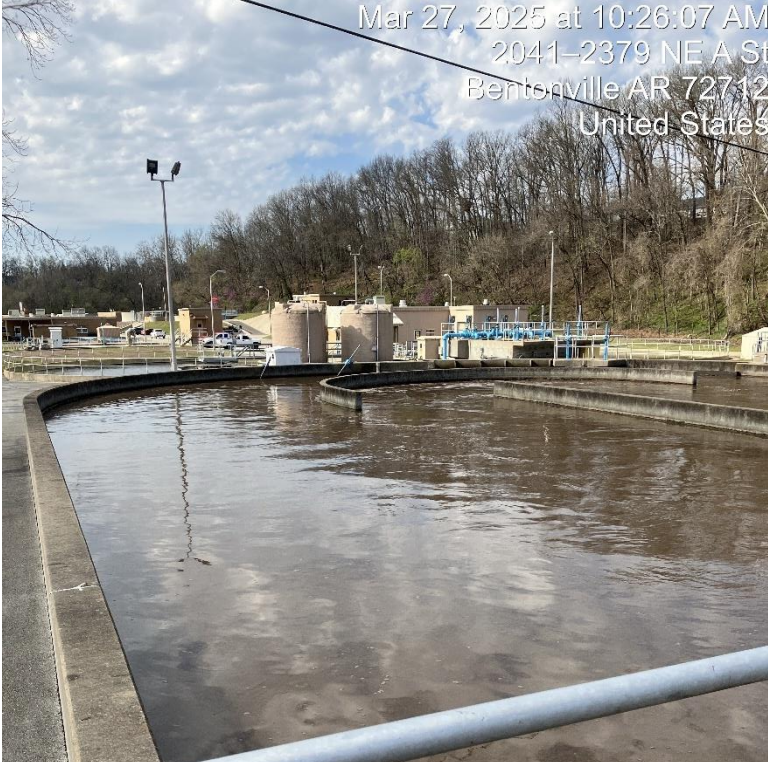
| Office of Water Quality Photographic Evidence Sheet | | | |
|---|---|---|---|
| Description: | <b>Oxidation ditch with good mixing and coloration.</b> | | |

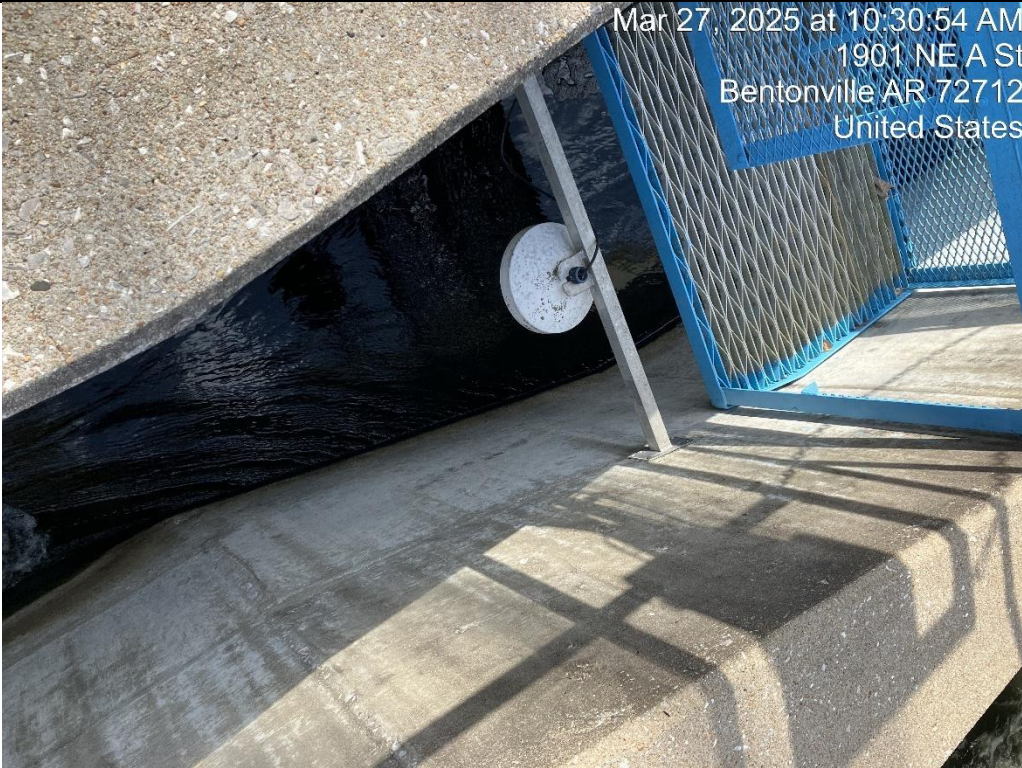
| 1. PRIMARY FLOW MEASUREMENT DEVICE PROPERLY INSTALLED AND MAINTAINED: <u>18" Parshall flume</u> TYPE OF DEVICE: | <input checked="" type="checkbox"/> Y <input type="checkbox"/> N <input type="checkbox"/> NA <input type="checkbox"/> NE |

| Office of Water Quality Photographic Evidence Sheet | | | |
|---|---|---|---|
| Description: | <b>Effluent Parshall flume and flow measurement location.</b> | | |

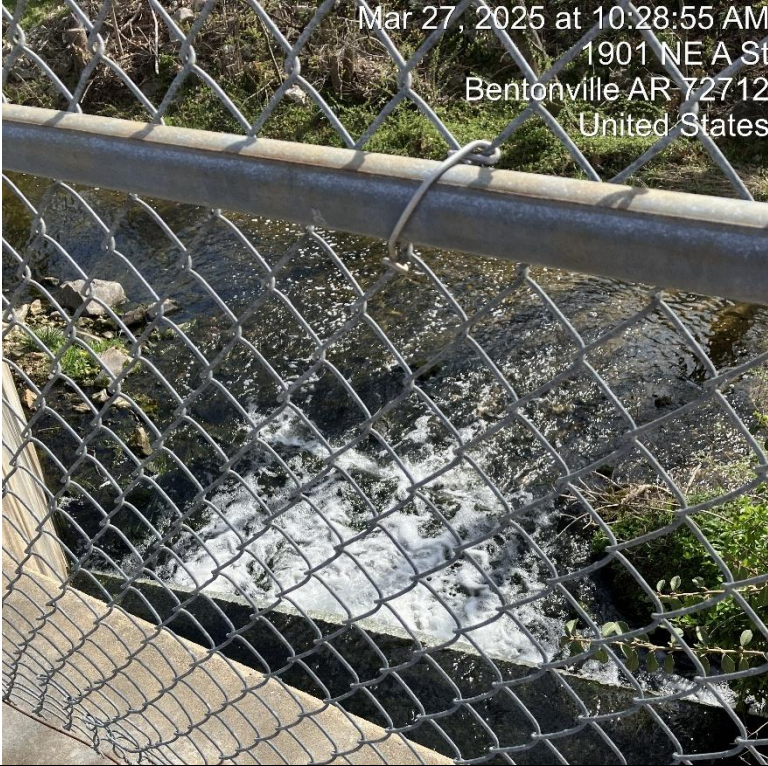
| Office of Water Quality Photographic Evidence Sheet | | | |
|---|---|---|---|
| Description: | <b>Outfall 001.</b> | | |

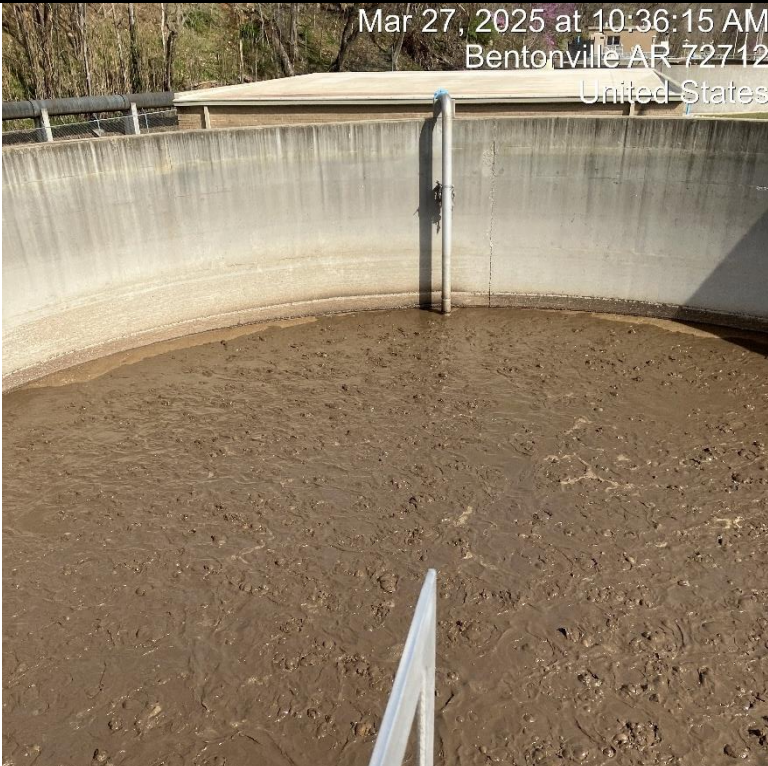
| Office of Water Quality Photographic Evidence Sheet | | | |
|---|---|---|---|
| Description: | <b>One sludge digester.</b> | | |

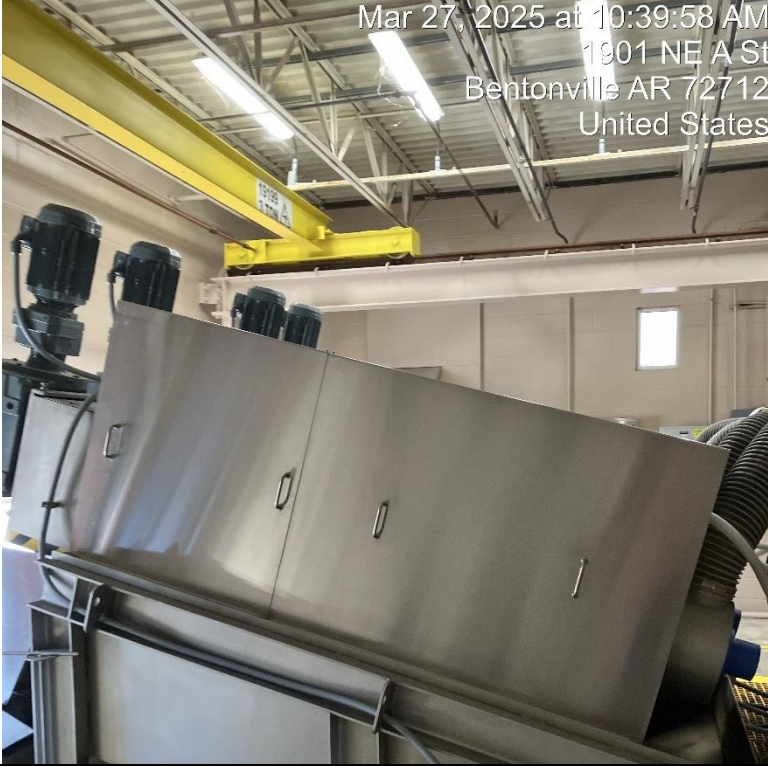
| Office of Water Quality Photographic Evidence Sheet | | | |
|---|---|---|---|
| Description: | <b>Volute Dewatering Press – was not in use during the inspection – in good condition.</b> | | |
