| <b>ENVIRONMENTAL QUALITY</b> | <b>OFFICE OF WATER QUALITY<br/>INSPECTION REPORT</b> | | |
| NAME:<br><b>City of El Dorado -South Plant</b><br>LOCATION:<br><b>325 Quail Crossing</b><br>CITY:<br><b>El Dorado, AR</b> | | FACILITY TYPE:<br><b>1 - Municipal</b> INSPECTOR ID#:<br><b>159580 S - State</b><br>FACILITY EVALUATION RATING:<br><b>4 - Satisfactory</b> INSPECTION TYPE:<br><b>SSO/Collection System</b><br>DATE(S):<br><b>4/9/2025</b> ENTRY TIME:<br><b>09:07</b> EXIT TIME:<br><b>12:41</b> PERMIT EFFECTIVE DATE:<br><b>1/1/2024</b><br>PERMIT EXPIRATION DATE:<br><b>12/31/2028</b> | |

| <b>COLLECTION SYSTEM INSPECTION AND OVERALL RATING</b> | | <input checked="" type="checkbox"/> S <input type="checkbox"/> M <input type="checkbox"/> U <input type="checkbox"/> NA <input type="checkbox"/> NE |

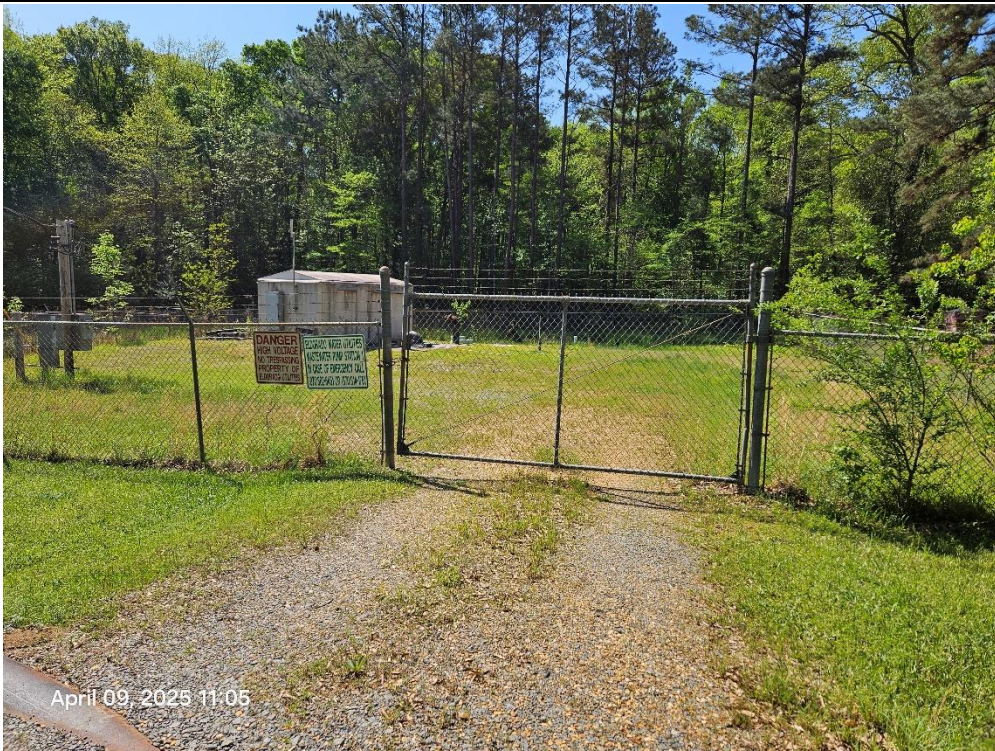
| | | Photo #: | <b>2</b> |

| <p>El Dorado Water Utility (EWU) manages a collection system for the South Plant that consists of five lift stations that send wastewater to the South Plant treatment system.</p> <p>I observed Lift Station #1 to be in good working condition. The fence was locked, and the emergency contact information was posted (see Photo 2). Both pumps were running (see Photo 3). The wet well had an excess of floating solids (see Photo 4) and Mr. McMahan stated this lift station is scheduled to have the solids removed with a vac truck.</p> <p>The gate at Lift Station #2 was secured with a lock and had emergency contact posted (see Photo 5). All three of the pumps were working (see Photo 6) and the wet well had little solids floating (see Photo 7). There was a plastic food wrapper on the bottom of the wet well door, indicating that the water level had been high. There was no evidence of an overflow on the ground.</p> |

| Description: | <b>Lift Station #1</b> | | |

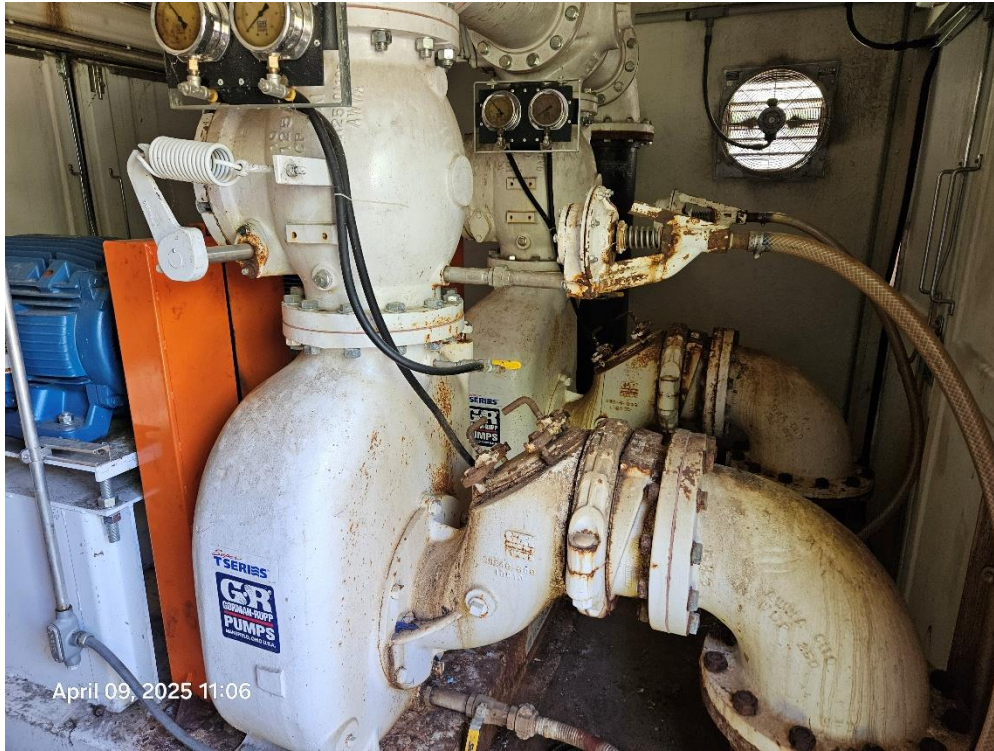
| | | Photo #: | <b>3</b> |

| Description: | <b>Pumps in Lift Station #1</b> | | |

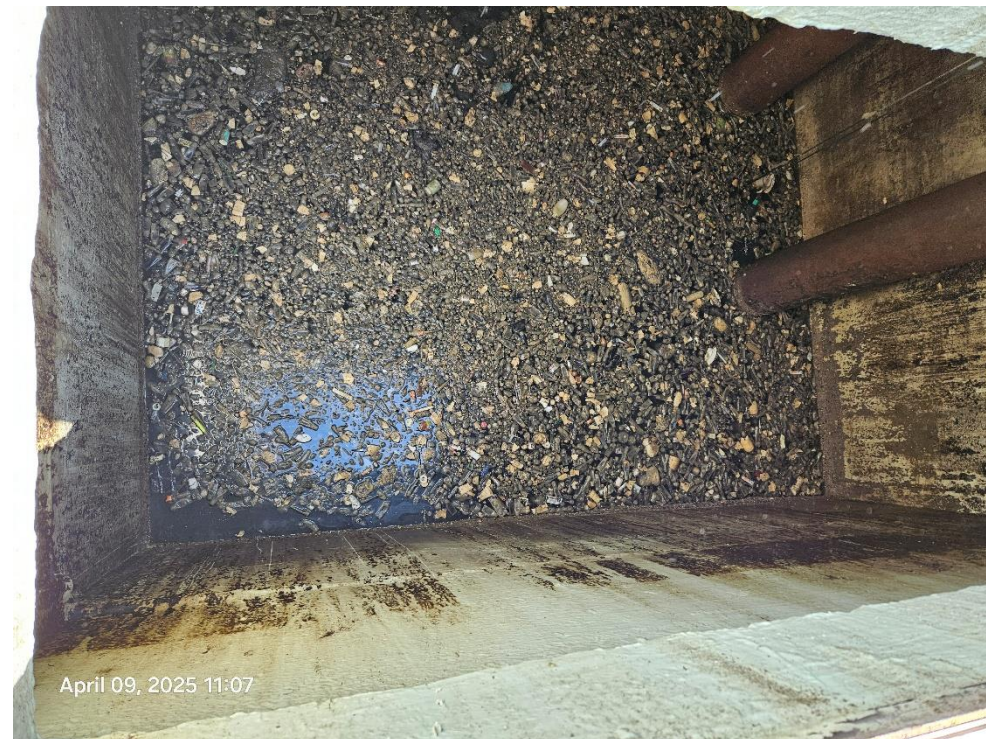
| | | Photo #: | <b>4</b> |

| MINIMAL ACCUMULATION OF GREASE AND SOLIDS IN WET WELLS: <u>This wet well if scheduled to be cleaned out with a vac truck.</u> | <input type="checkbox"/> S <input checked="" type="checkbox"/> M <input type="checkbox"/> U <input type="checkbox"/> NA <input type="checkbox"/> NE |

| Description: | <b>Wet well at Lift Station #1</b> | | |

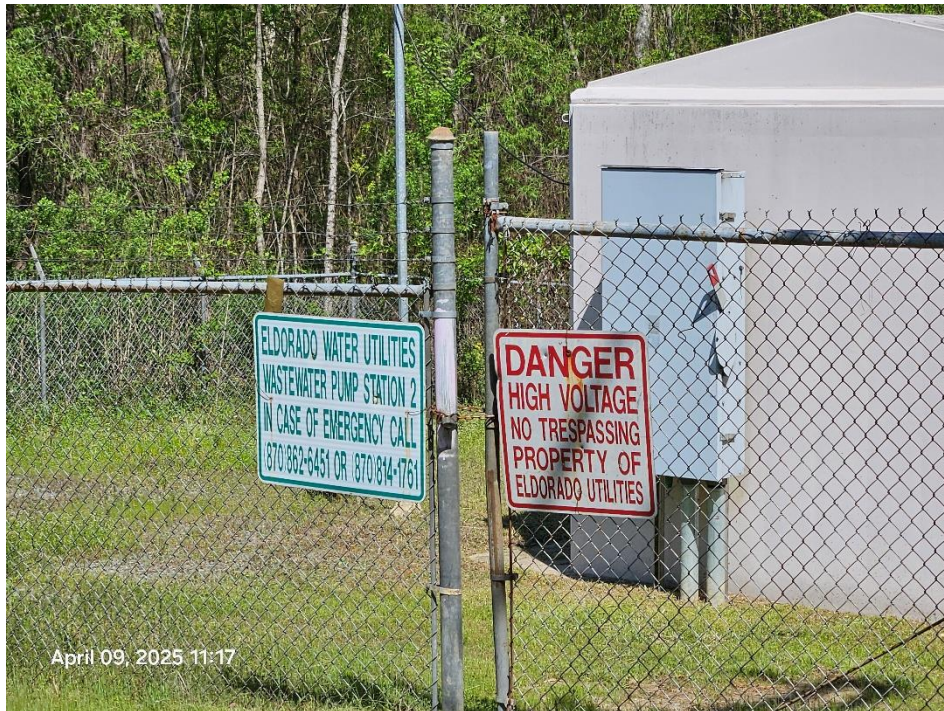
| Description: | <b>Lift Station #2</b> | Photo #: | <b>5</b> |

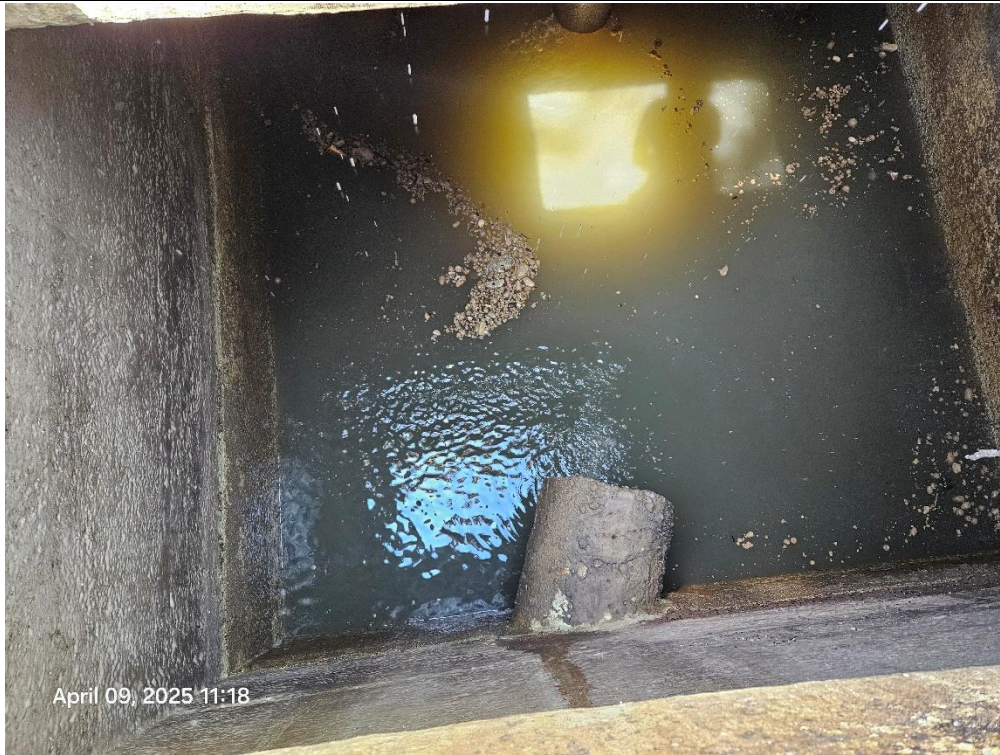
| | | Photo #: | <b>7</b> |

| Description: | <b>Wet well at Lift Station #2</b> | | |

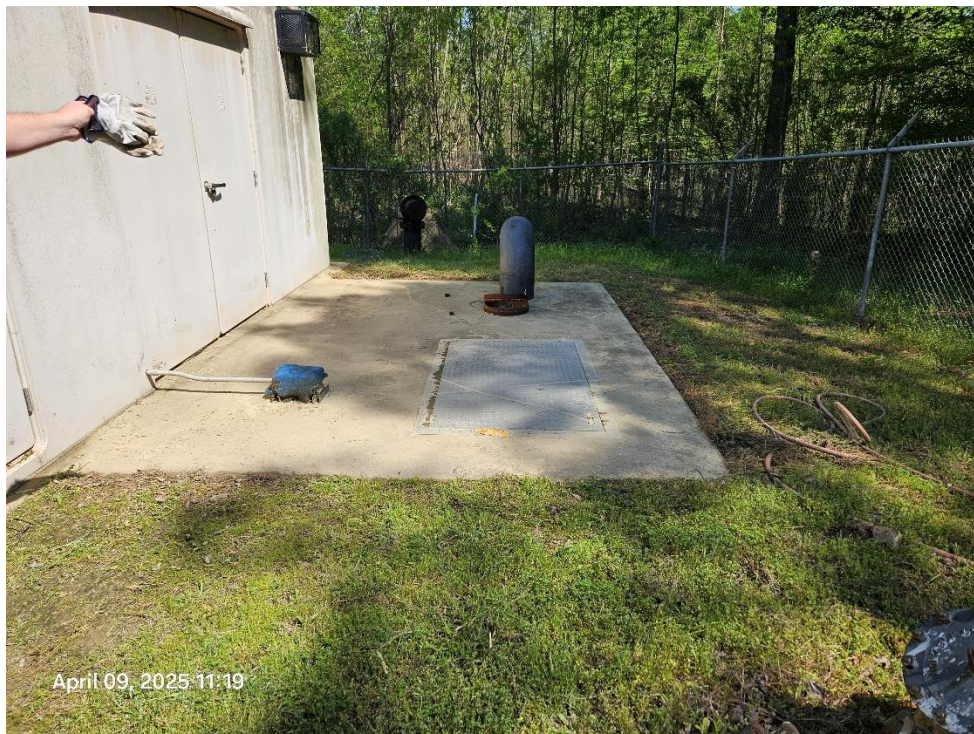
| | | Photo #: | <b>8</b> |

| <b>PUMP STATION VISIT (COMPLETE A SEPARATE CHECKLIST FOR EACH PUMP STATION VISITED)</b> | |
|---|---|
| EVIDENCE OF RECENT OVERFLOWS OR HIGH LEVELS: <b>Plastic food wrapper was on the bottom of the wet well door</b> | <input checked="" type="checkbox"/> Y <input type="checkbox"/> N <input type="checkbox"/> NA <input type="checkbox"/> NE |

| Description: | <b>Plastic food wrapper (orange beside wet well cover) was on the bottom of the wet well cover.</b> | | |
