**DIVISION OF  
ENVIRONMENTAL  
QUALITY**

RE: Hot Springs- Davidson WWTP Inspection (Garland County) – PDS# 133392, 133393  
AFIN: 26-00145 Permit No.: AR0033880

| <b>ENVIRONMENTAL<br/>QUALITY</b> | <b>OFFICE OF WATER QUALITY<br/>INSPECTION REPORT</b> | | | | |

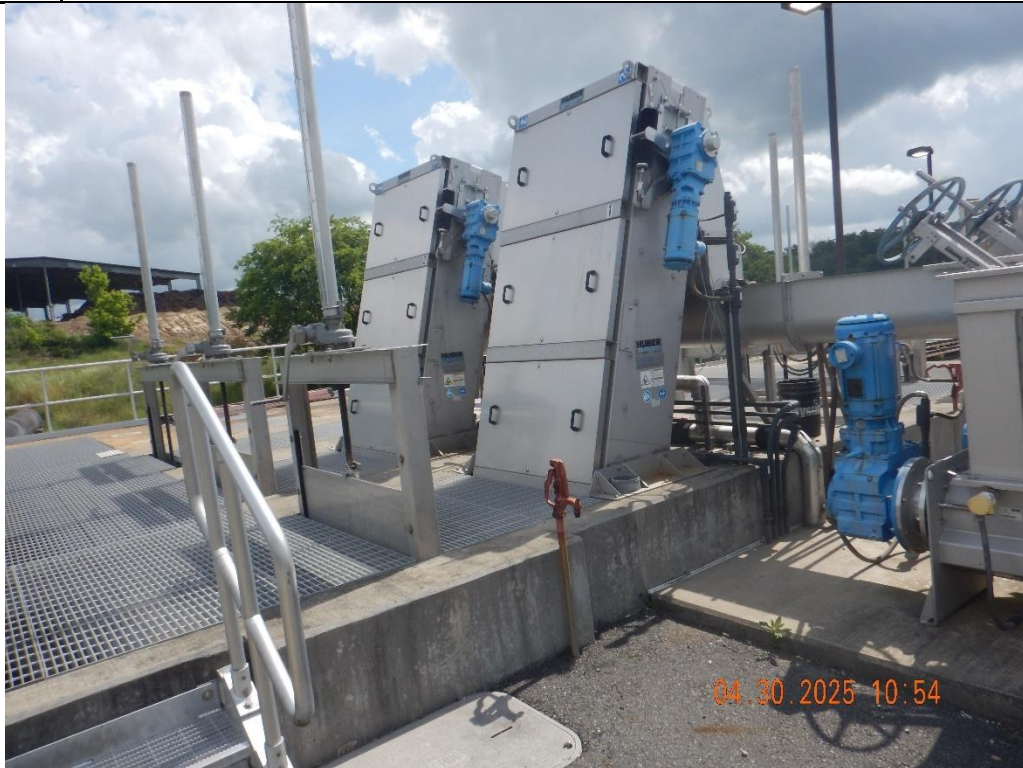
| Description: | <b>Two influent bar screens</b> | | |

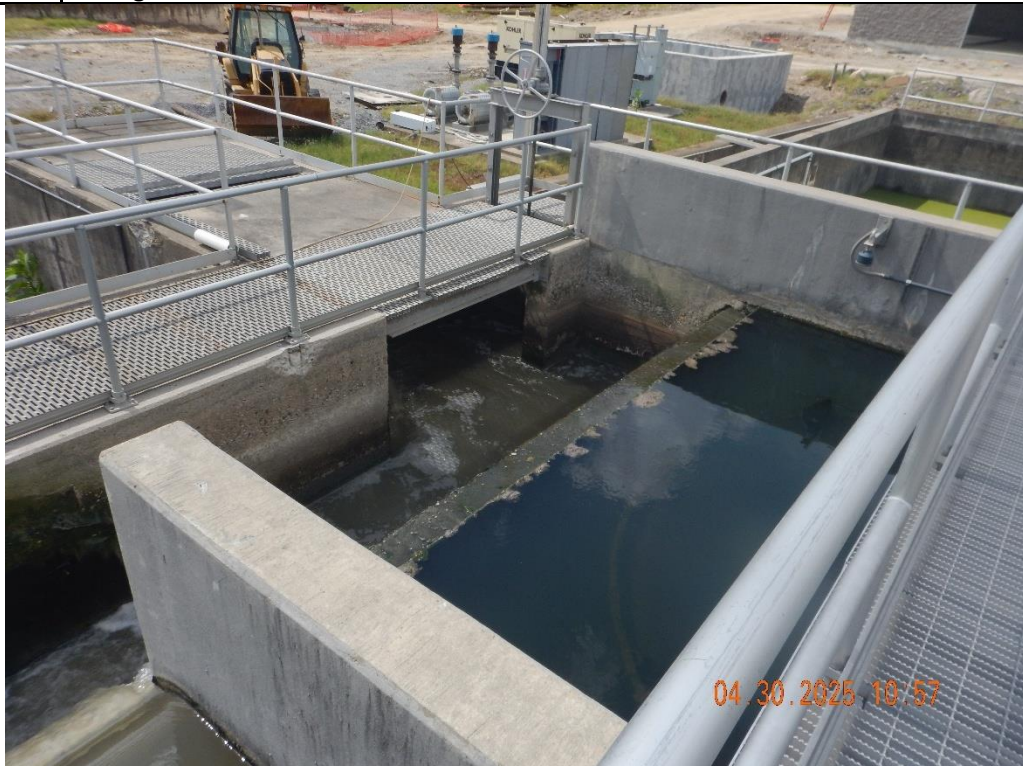
| Description: | <b>Two grit chambers</b> | | |

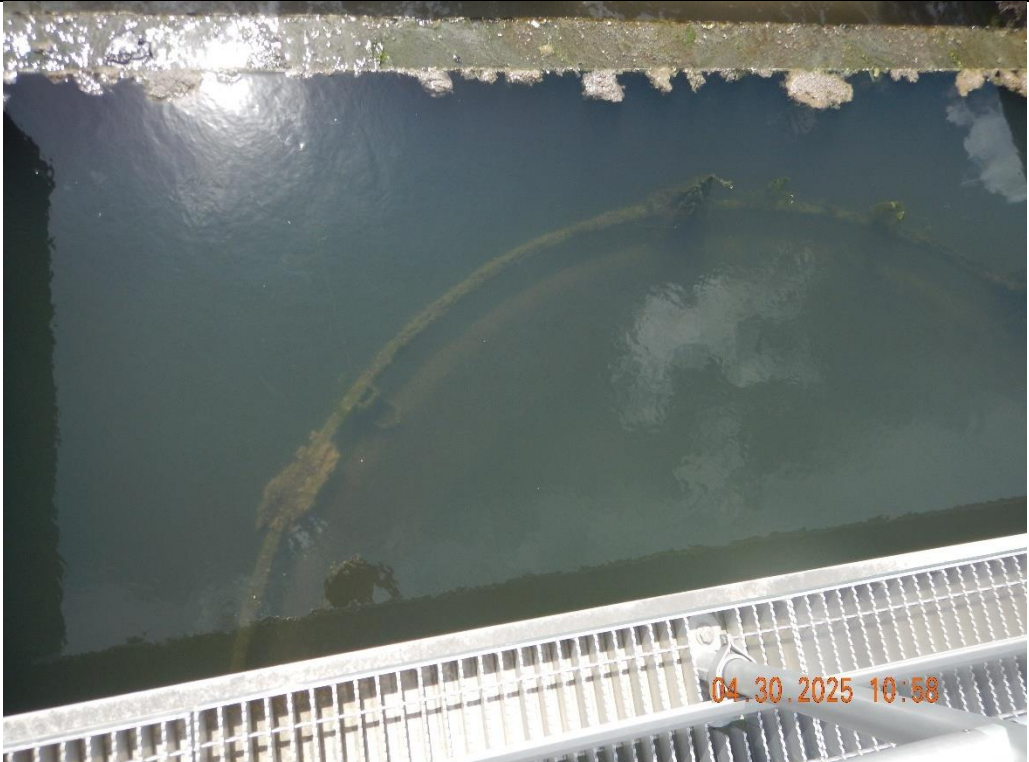
| Office of Water Quality Photographic Evidence Sheet | | | | | |
|---|---|---|---|---|---|
| Witness: | <b>None</b> | | | Photo #: | <b>3</b> |

| Office of Water Quality Photographic Evidence Sheet | | | | | |
|---|---|---|---|---|---|
| Description: | <b>View of one grit chamber offline for maintenance during low influent</b> | | | | |

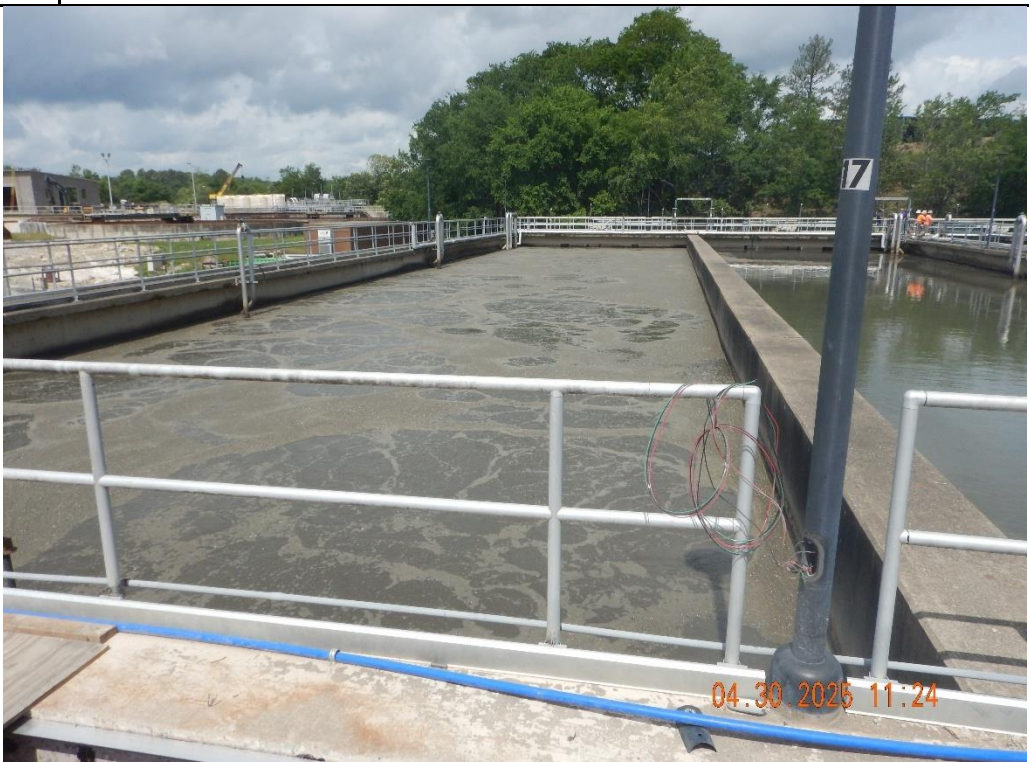
| Office of Water Quality Photographic Evidence Sheet | | | | | |
|---|---|---|---|---|---|
| Witness: | <b>None</b> | | | Photo #: | <b>4</b> |

| Office of Water Quality Photographic Evidence Sheet | | | | | |
|---|---|---|---|---|---|
| Description: | <b>Three aeration basins</b> | | | | |

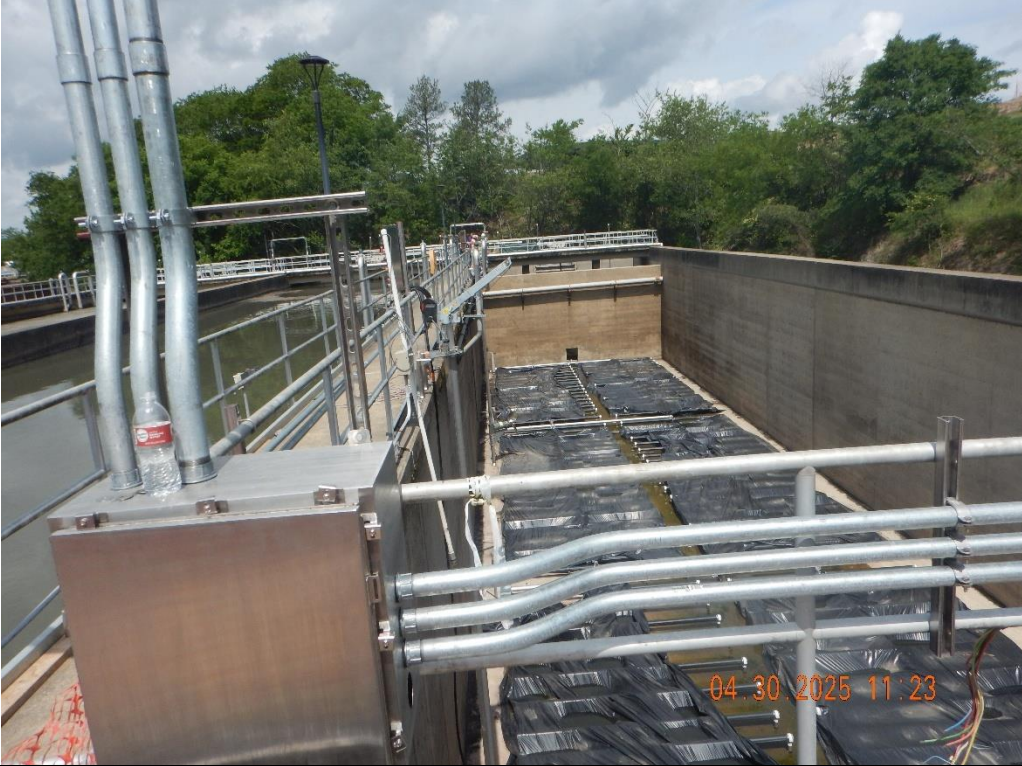
| Office of Water Quality Photographic Evidence Sheet | | | | |
|---|--|---|---|--|
| Witness: <b>None</b> | | Photo #: <b>5</b> | | |

| Office of Water Quality Photographic Evidence Sheet | | | | |
|---|--|---|---|--|
| Description: <b>One aeration basin being modified at time of inspection</b> | | | | |

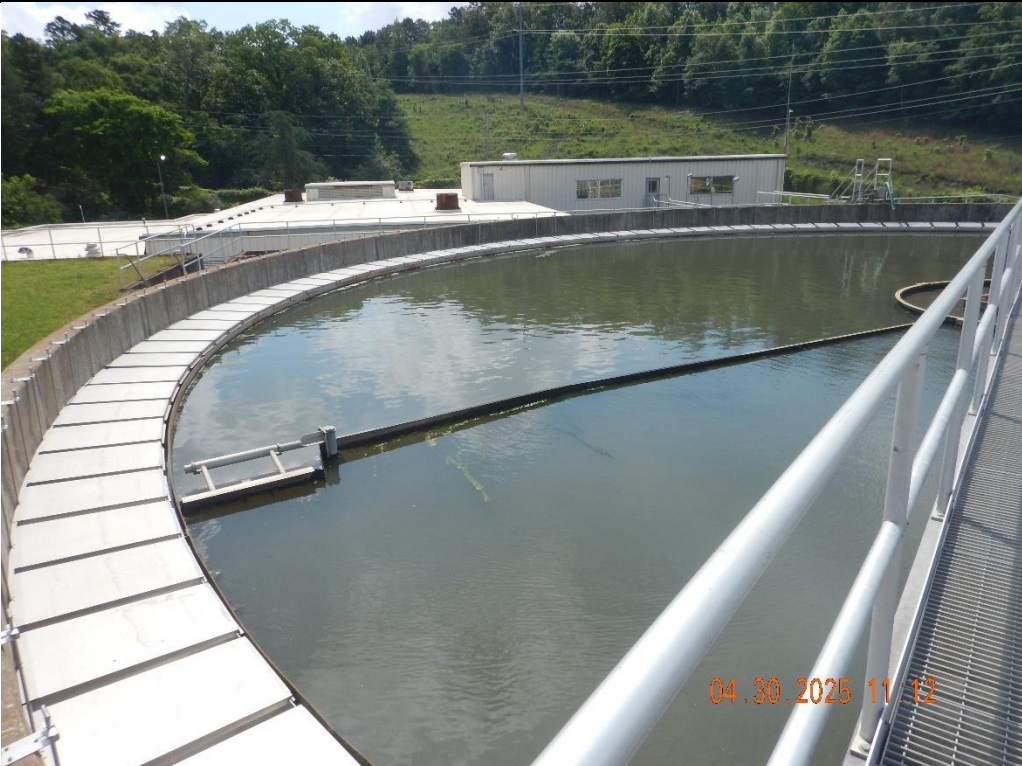
| Office of Water Quality Photographic Evidence Sheet | | | | |
|---|--|---|---|--|
| Witness: <b>None</b> | | Photo #: <b>6</b> | | |

| Office of Water Quality Photographic Evidence Sheet | | | | |
|---|--|---|---|--|
| Description: <b>Five secondary clarifiers</b> | | | | |

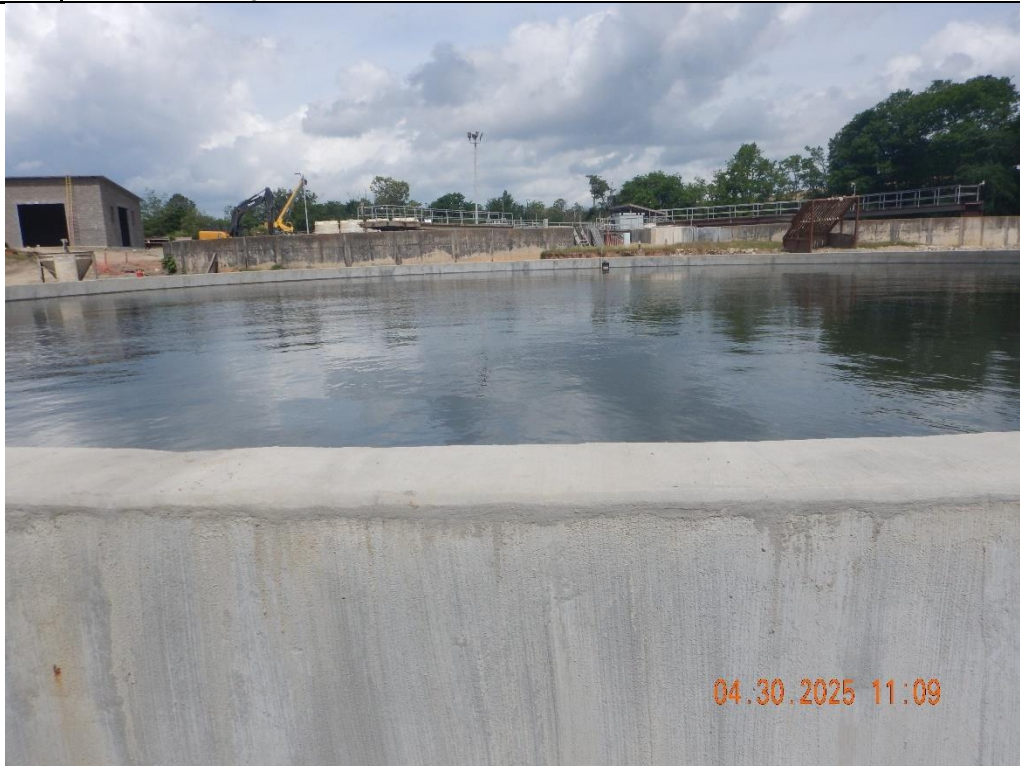
| Office of Water Quality Photographic Evidence Sheet | | | |
|---|---|---|---|
| Description: | <b>New secondary clarifier under construction</b> | | |

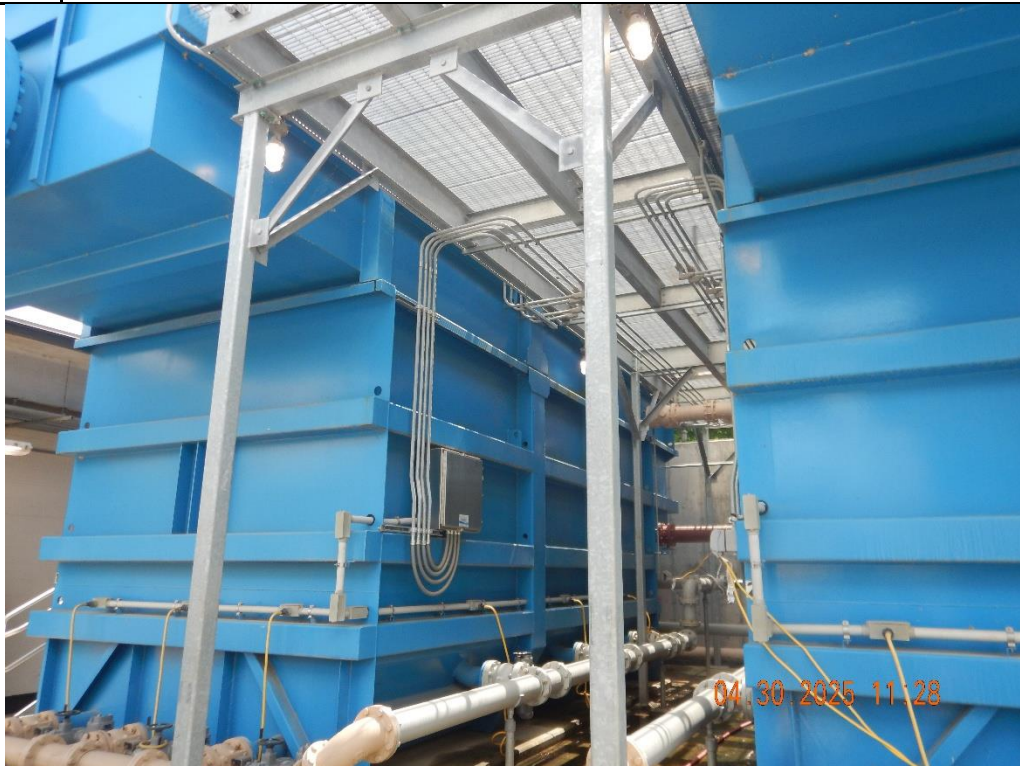
| Description: | <b>Two drum filters</b> | | |

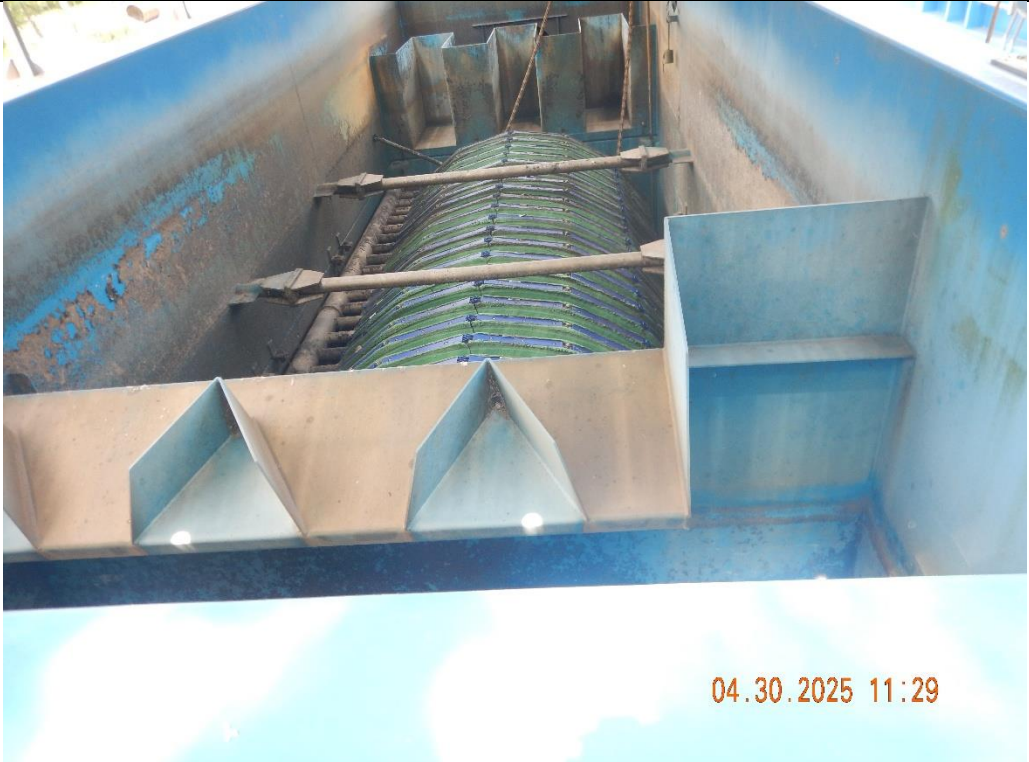
| Office of Water Quality Photographic Evidence Sheet | | | | | |
|---|--|---|--|---|--|
| Witness: <b>None</b> | | | | Photo #: <b>9</b> | |

| Office of Water Quality Photographic Evidence Sheet | | | | | |
|---|--|---|--|---|--|
| Description: <b>Drum filter offline for maintenance during low influent</b> | | | | | |

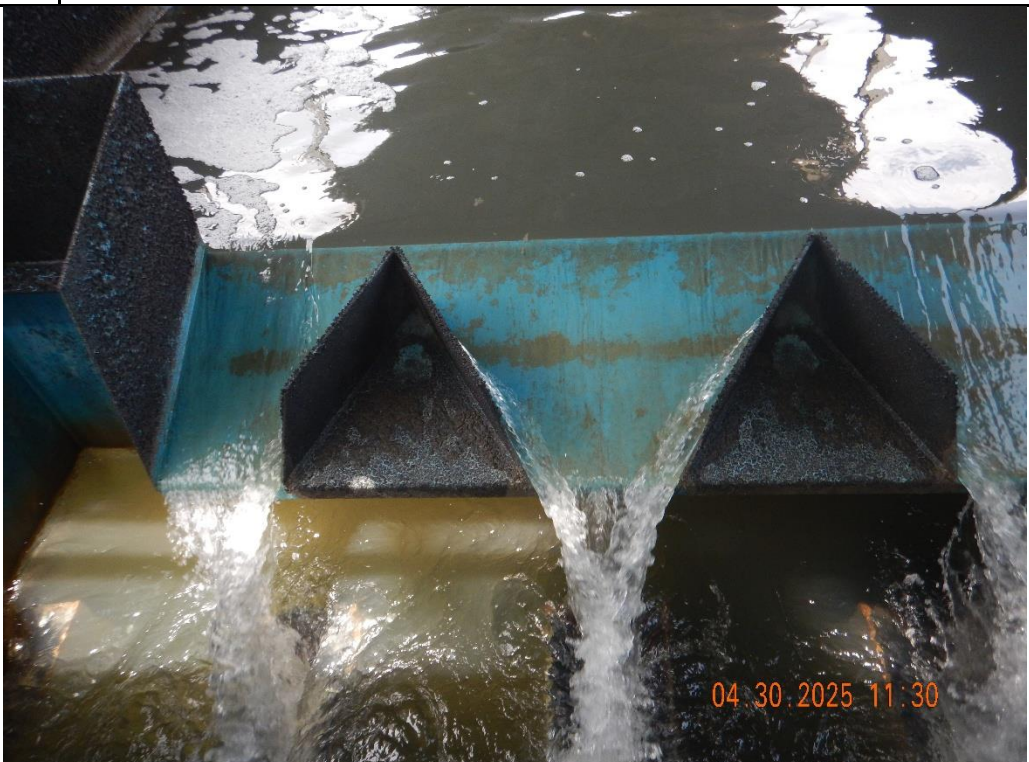
| Office of Water Quality Photographic Evidence Sheet | | | | | |
|---|--|---|--|---|--|
| Witness: <b>None</b> | | | | Photo #: <b>10</b> | |

| Office of Water Quality Photographic Evidence Sheet | | | | | |
|---|--|---|--|---|--|
| Description: <b>Drum filter effluent</b> | | | | | |

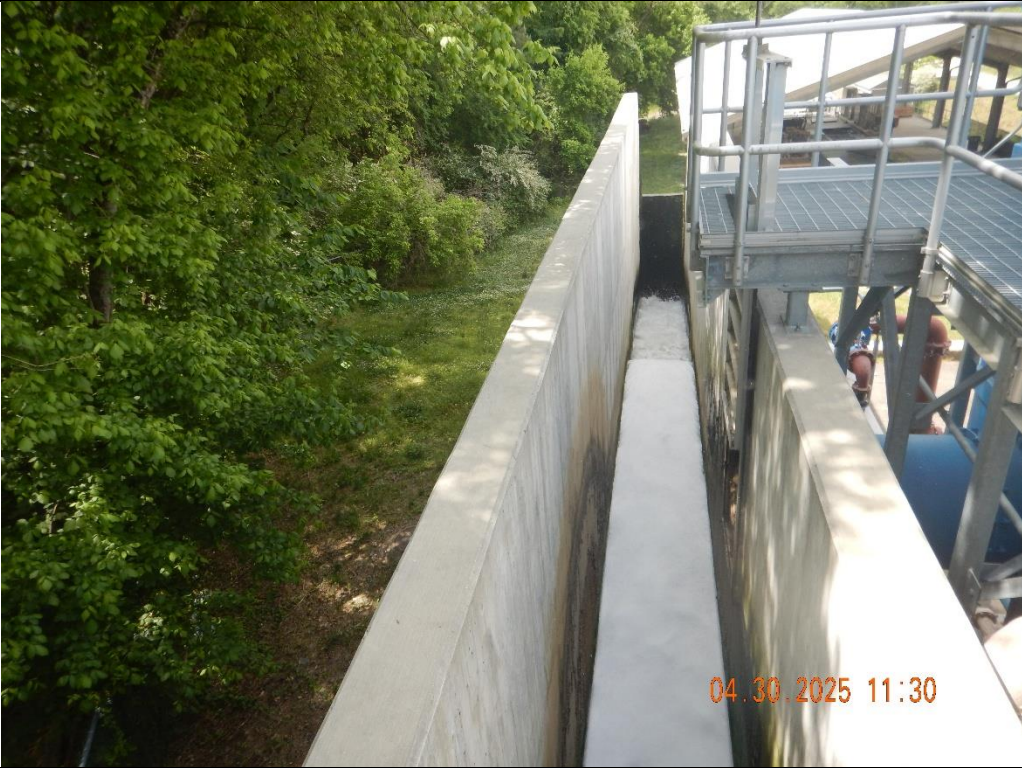
| Office of Water Quality Photographic Evidence Sheet | | | | |
|---|--|---|---|--|
| Witness: None | | | Photo #: 11 | |

| Office of Water Quality Photographic Evidence Sheet | | | | |
|---|--|---|---|--|
| Description: Cascade aeration discharge from drum filters | | | | |

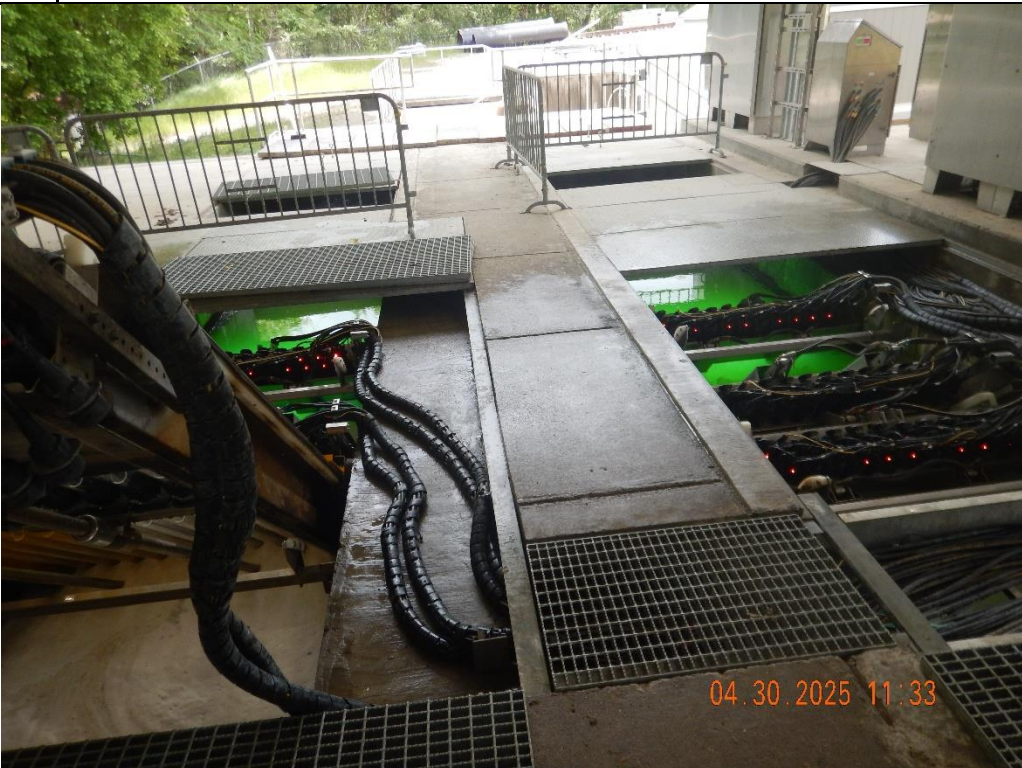
| Office of Water Quality Photographic Evidence Sheet | | | | |
|---|--|---|---|--|
| Witness: None | | | Photo #: 12 | |

| Office of Water Quality Photographic Evidence Sheet | | | | |
|---|--|---|---|--|
| Description: UV disinfection | | | | |

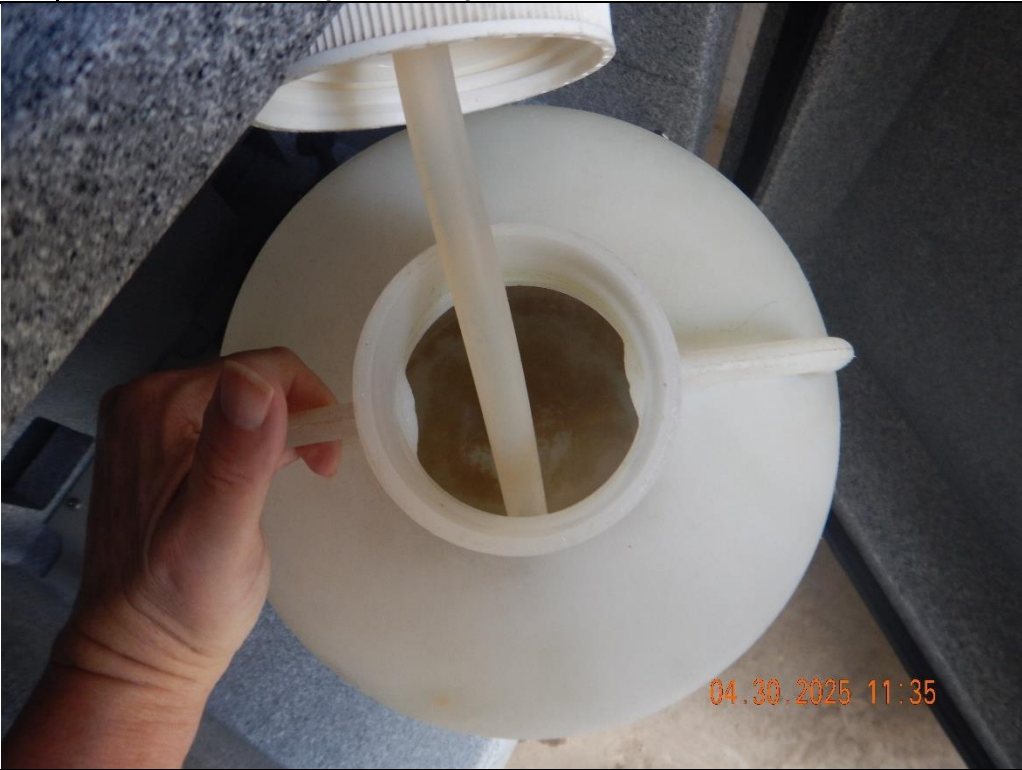
| Office of Water Quality Photographic Evidence Sheet | | | | |
|---|--|---|---|--|
| Witness: <b>None</b> | | Photo #: <b>13</b> | | |

| Office of Water Quality Photographic Evidence Sheet | | | | |
|---|--|---|---|--|
| Description: <b>Final effluent in composite sample bottle</b> | | | | |

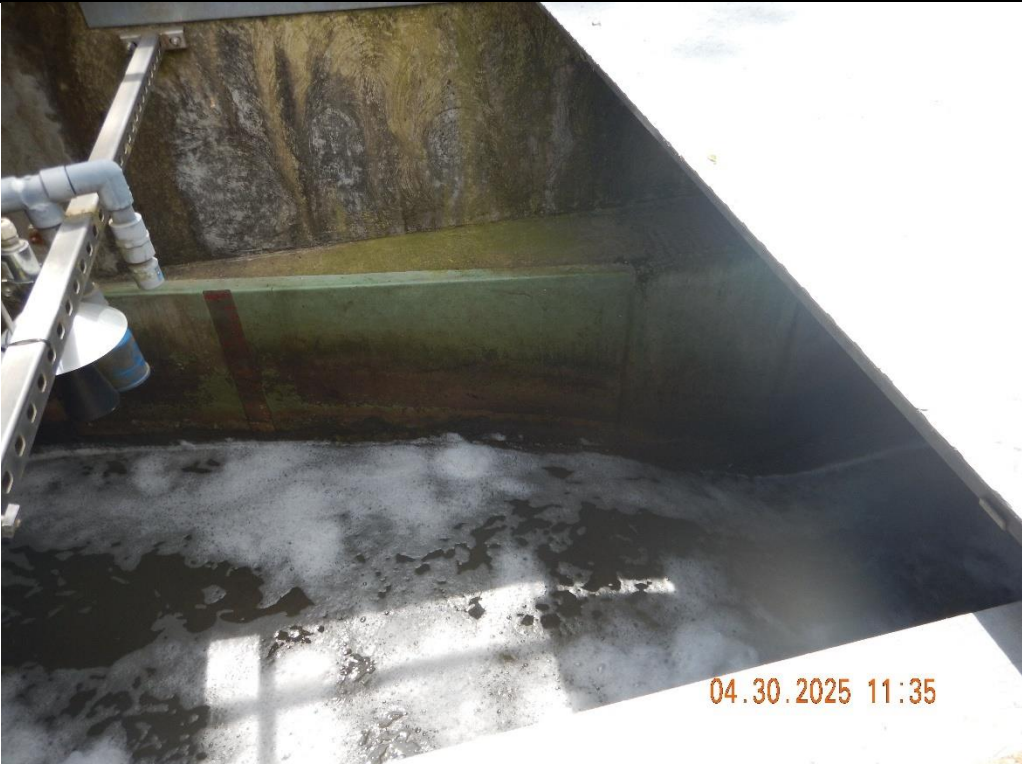
| Office of Water Quality Photographic Evidence Sheet | | | | |
|---|--|---|---|--|
| Witness: <b>None</b> | | Photo #: <b>14</b> | | |

| Office of Water Quality Photographic Evidence Sheet | | | | |
|---|--|---|---|--|
| Description: <b>View of flow monitor and effluent entering flume</b> | | | | |

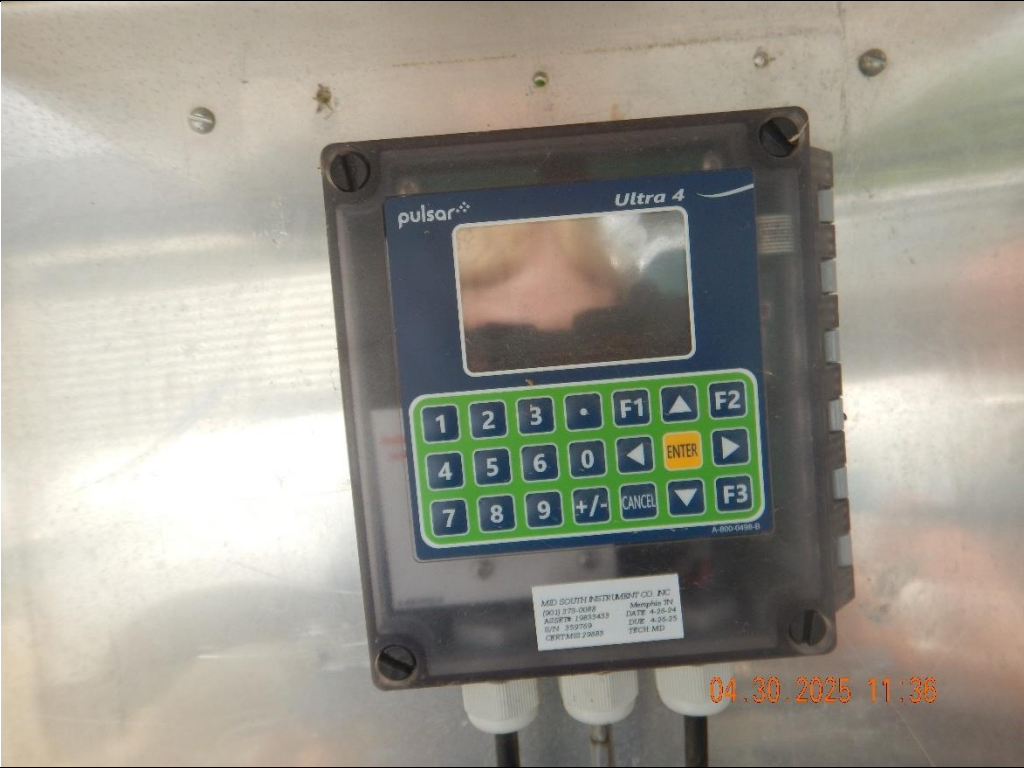
| Office of Water Quality Photographic Evidence Sheet | | | | | |
|---|---|---|---|---|---|
| Witness: | <b>None</b> | | | Photo #: | <b>15</b> |

| Office of Water Quality Photographic Evidence Sheet | | | | | |
|---|---|---|---|---|---|
| Description: | <b>Flow meter calibrated 4/26/2024</b> | | | | |

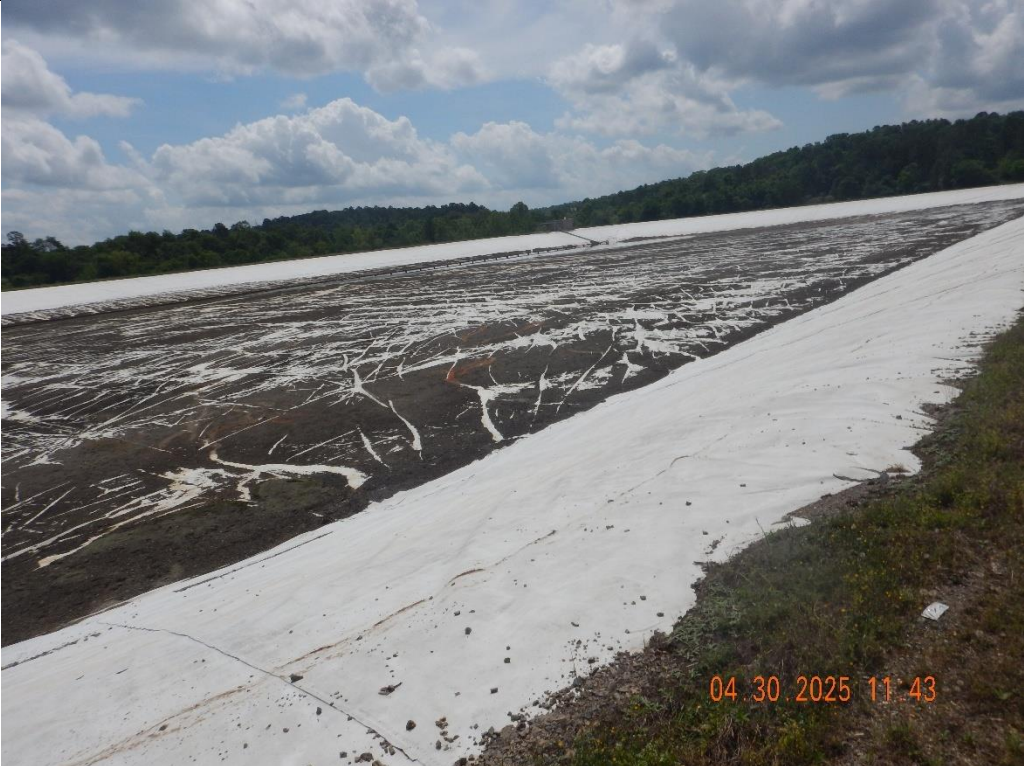
| Office of Water Quality Photographic Evidence Sheet | | | | | |
|---|---|---|---|---|---|
| Witness: | <b>None</b> | | | Photo #: | <b>16</b> |

| Office of Water Quality Photographic Evidence Sheet | | | | | |
|---|---|---|---|---|---|
| Description: | <b>Equalization basin</b> | | | | |
