RE: City of Van Buren South WWTP Inspection (Crawford Co.) – PDS# 133652  
AFIN: 17-00062 Permit No.: AR0021482

| <b>ENVIRONMENTAL QUALITY</b> | <b>OFFICE OF WATER QUALITY<br/>INSPECTION REPORT</b> | | | | |

A compliance inspection was conducted on 06/24/2025 for the City of Van Buren South WWTP. The participants listed above were present during this inspection. The inspection consisted of facility assessment and record review.

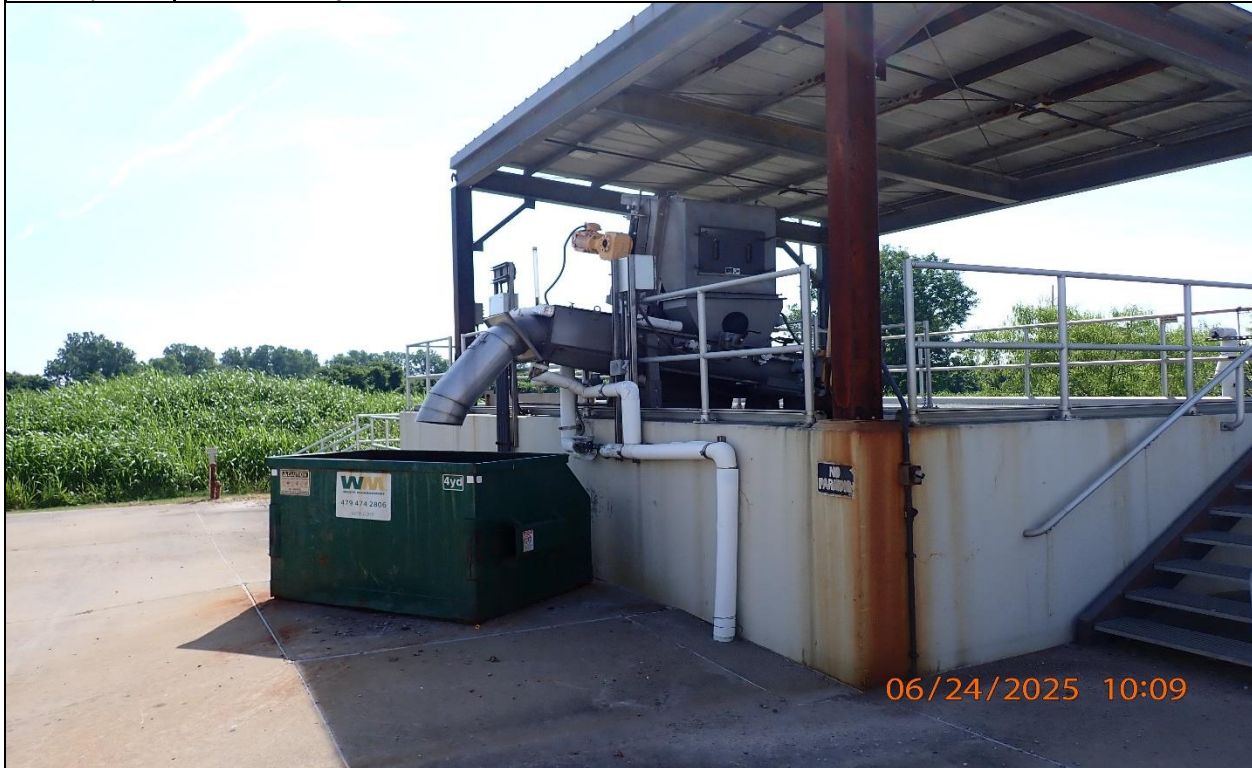
| | | Photo #: | <b>1</b> |

| Description: | <b>Head of the plant. Influent and bar screens.</b> | | |

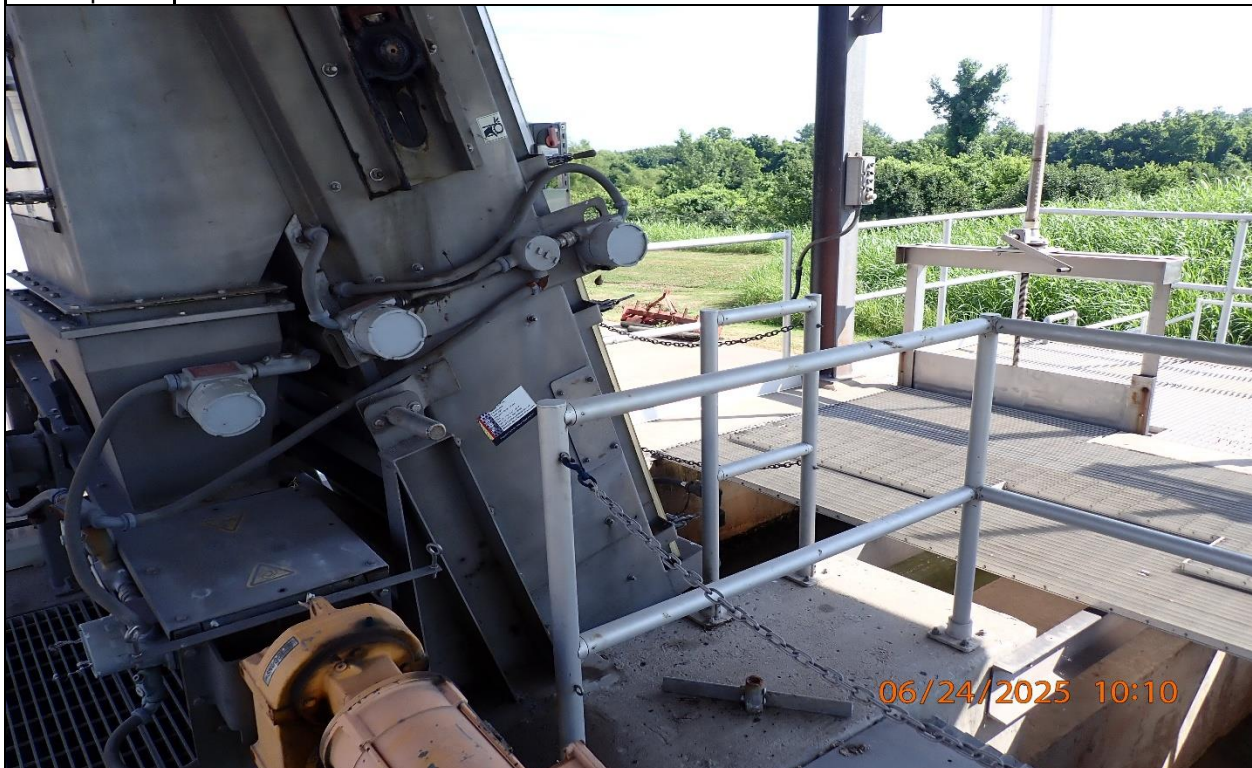
| | | Photo #: | <b>2</b> |

| Description: | <b>Automatic bar screen.</b> | | |

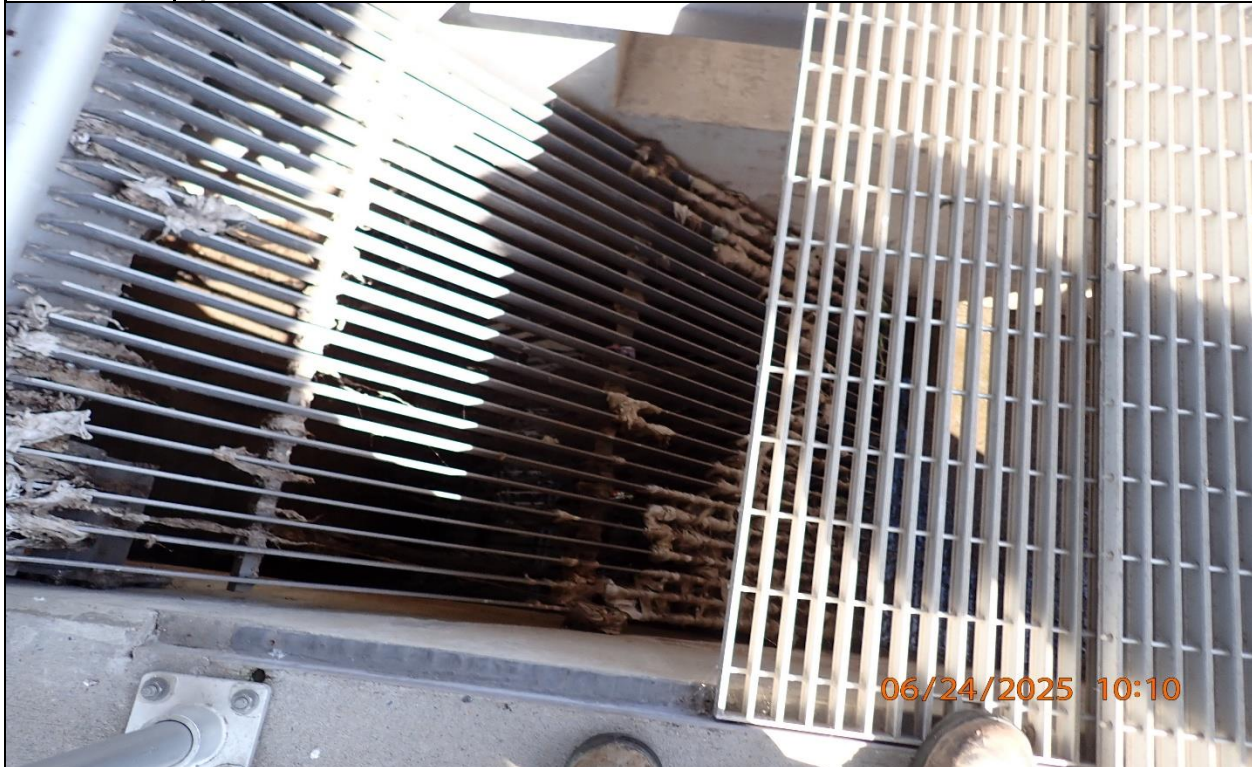
| Office of Water Quality Photographic Evidence Sheet | | | |
|---|---|---|---|
| | | Photo #: | <b>3</b> |

| Office of Water Quality Photographic Evidence Sheet | | | |
|---|---|---|---|
| Description: | <b>In case of failure of the automatic bar screen there is a manual side to stay in operation.</b> | | |

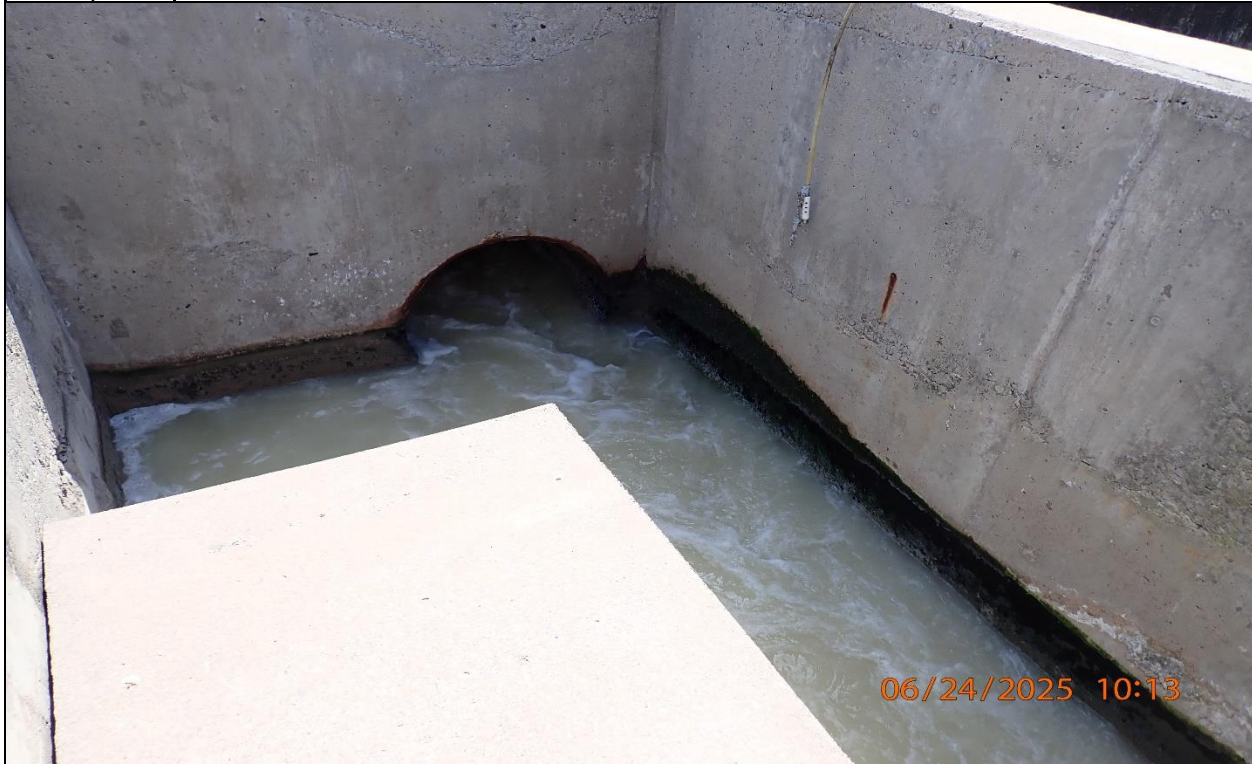
| | | Photo #: | <b>4</b> |

| Description: | <b>Wastewater after the bar screens.</b> | | |

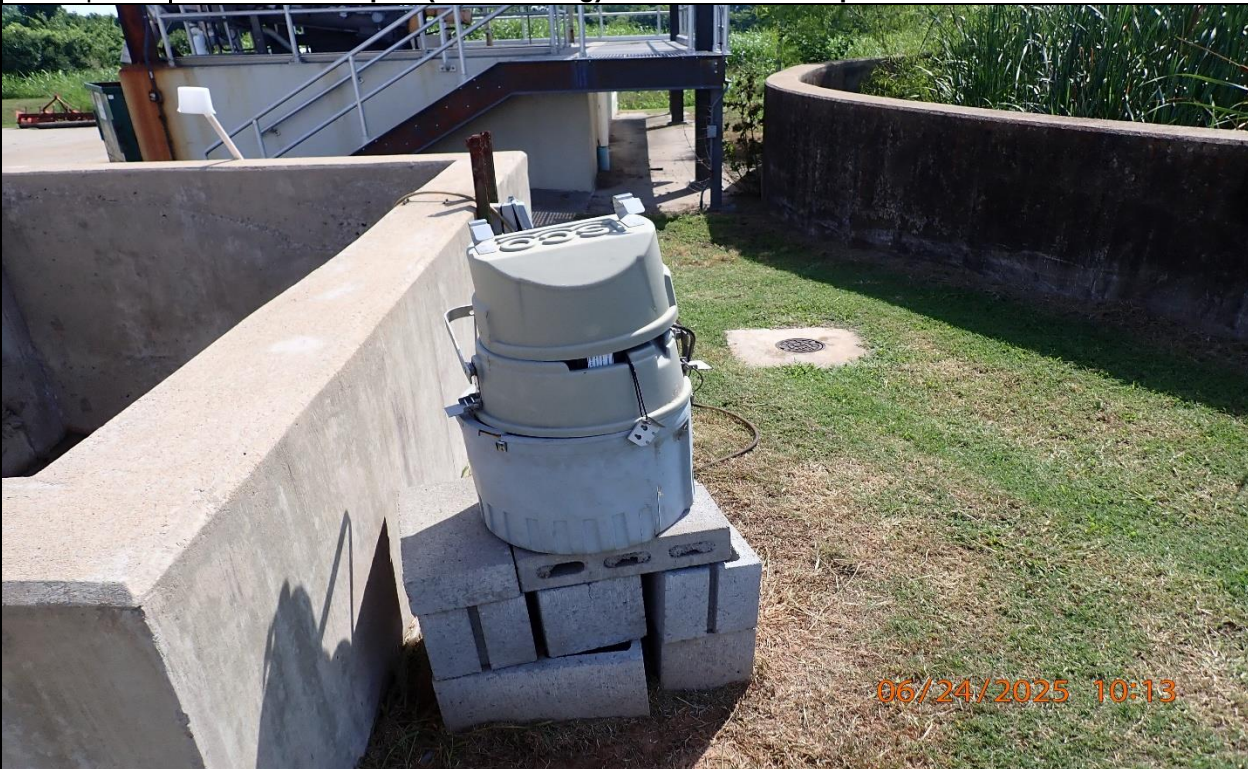
| Office of Water Quality Photographic Evidence Sheet | | | | | |
|---|---|---|---|---|---|
| Witness: | <b>Amy Huneycutt</b> | | | Photo #: | <b>5</b> |

| Office of Water Quality Photographic Evidence Sheet | | | | | |
|---|---|---|---|---|---|
| Description: | <b>Automatic sampler (Data Testing) at the head of the plant.</b> | | | | |

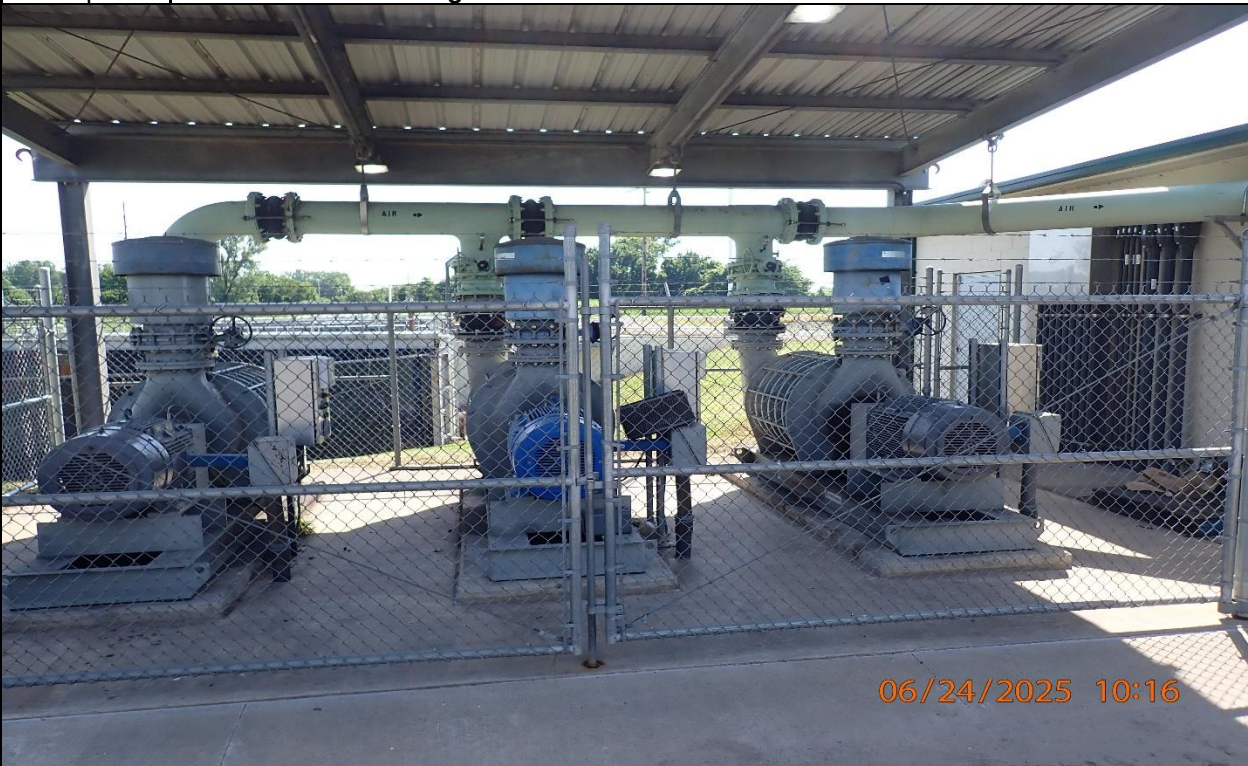
| Witness: | <b>Amy Huneycutt</b> | | | Photo #: | <b>6</b> |

| Description: | <b>Blowers. All 3 working with no maintenance issues.</b> | | | | |

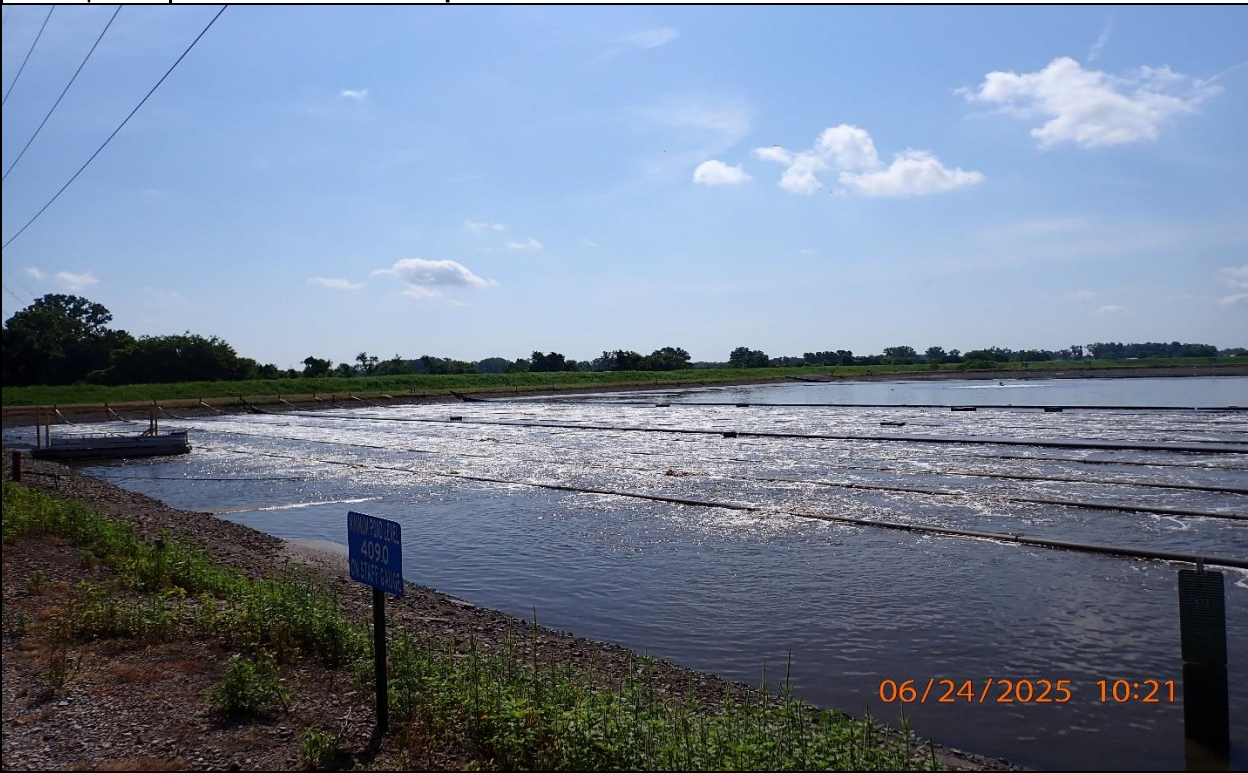
| Office of Water Quality Photographic Evidence Sheet | | | | | |
|---|---|---|---|---|---|
| Witness: | <b>Amy Huneycutt</b> | | | Photo #: | <b>9</b> |

| Office of Water Quality Photographic Evidence Sheet | | | | | |
|---|---|---|---|---|---|
| Description: | <b>Aeration and baffled pond.</b> | | | | |

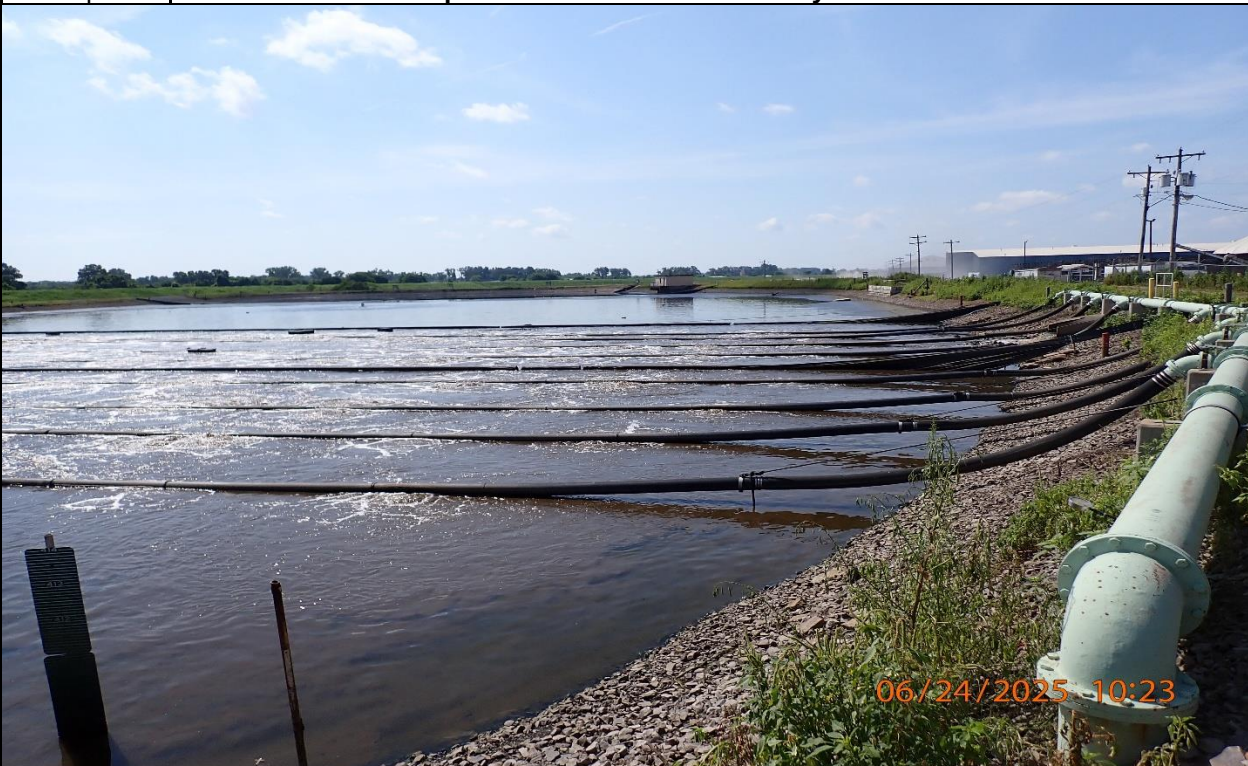
| Office of Water Quality Photographic Evidence Sheet | | | | | |
|---|---|---|---|---|---|
| Witness: | <b>Amy Huneycutt</b> | | | Photo #: | <b>10</b> |

| Office of Water Quality Photographic Evidence Sheet | | | | | |
|---|---|---|---|---|---|
| Description: | <b>Aeration and baffled pond. Air is distributed evenly.</b> | | | | |

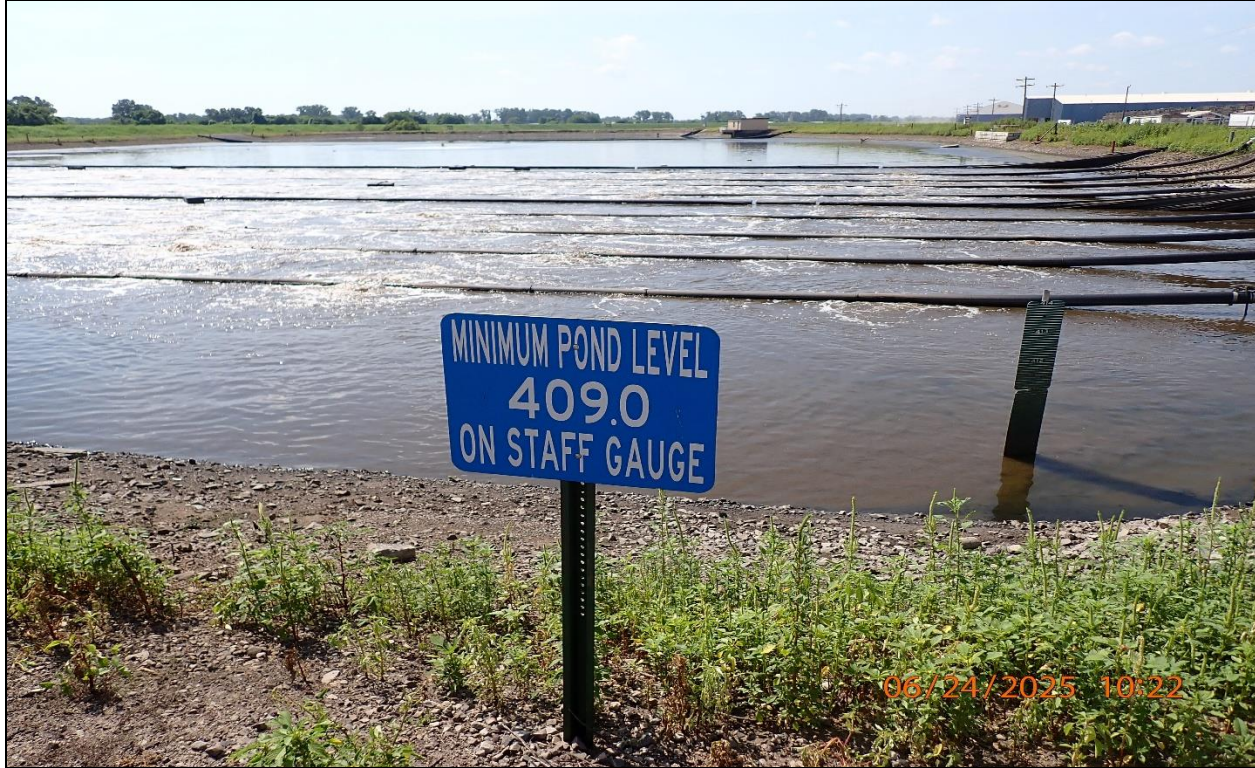
| Office of Water Quality Photographic Evidence Sheet | | | |
|---|---|---|---|
| | | Photo #: | <b>11</b> |

| Office of Water Quality Photographic Evidence Sheet | | | |
|---|---|---|---|
| Description: | <b>Sign shows pond level minimum. The pond bank is free of any erosion.</b> | | |

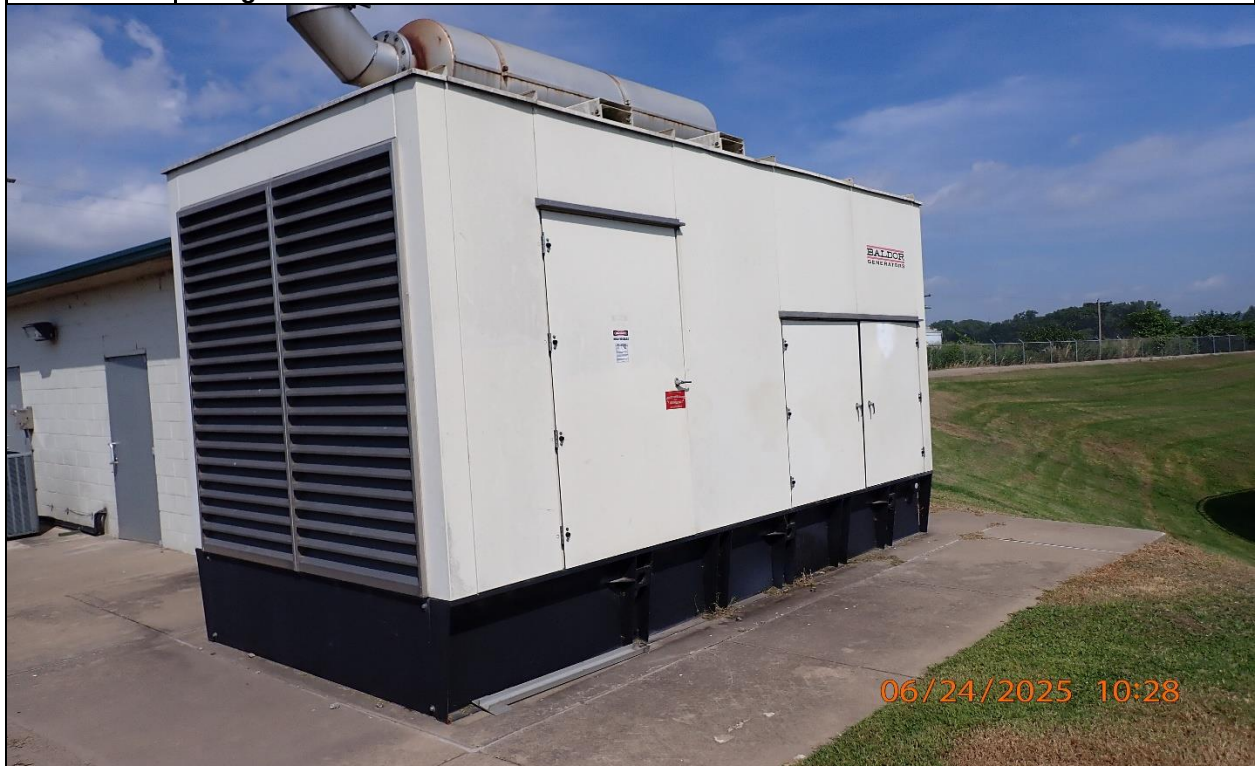
| | | Photo #: | <b>12</b> |

| Description: | <b>Automatic transfer generator. Will run the entire plant in the event of a power outage.</b> | | |

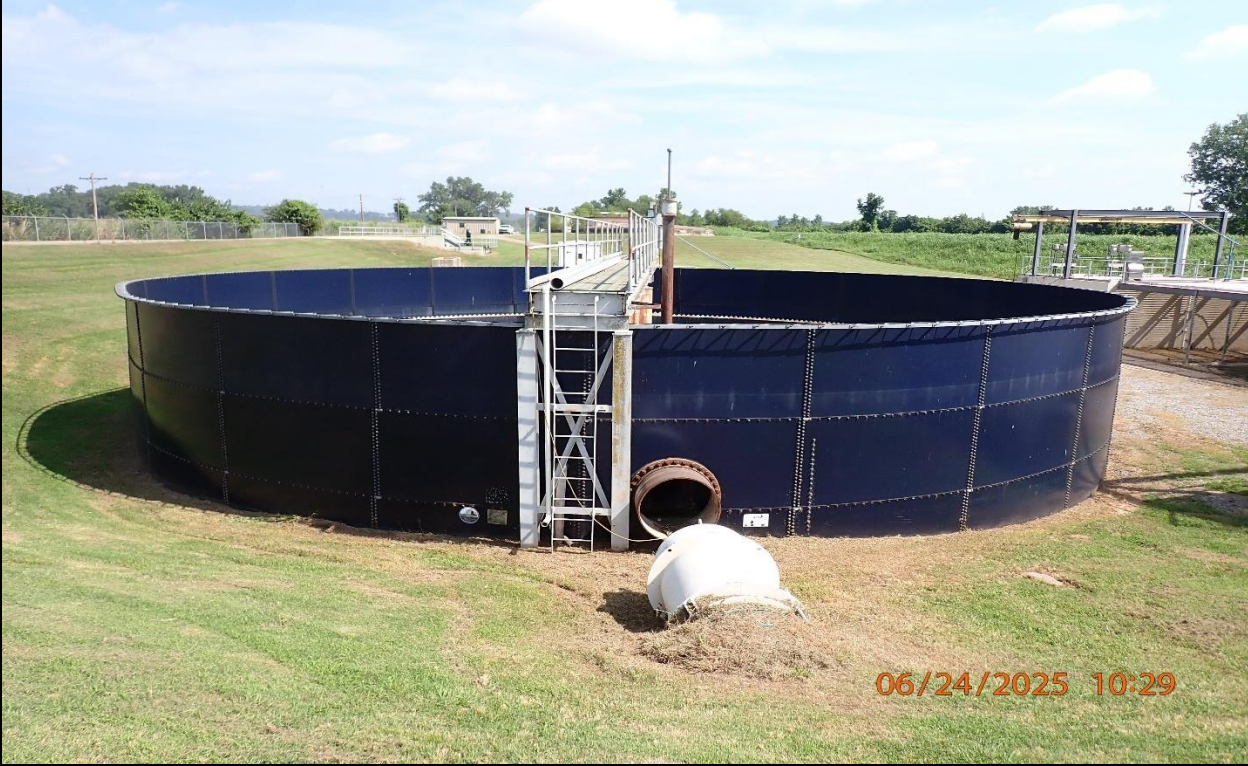
| Office of Water Quality Photographic Evidence Sheet | | | | | |
|---|---|---|---|---|---|
| Witness: | <b>Amy Huneycutt</b> | | | Photo #: | <b>13</b> |

| Office of Water Quality Photographic Evidence Sheet | | | | | |
|---|---|---|---|---|---|
| Description: | <b>Abandoned clarifier. This clarifier is not used for plant operations.</b> | | | | |

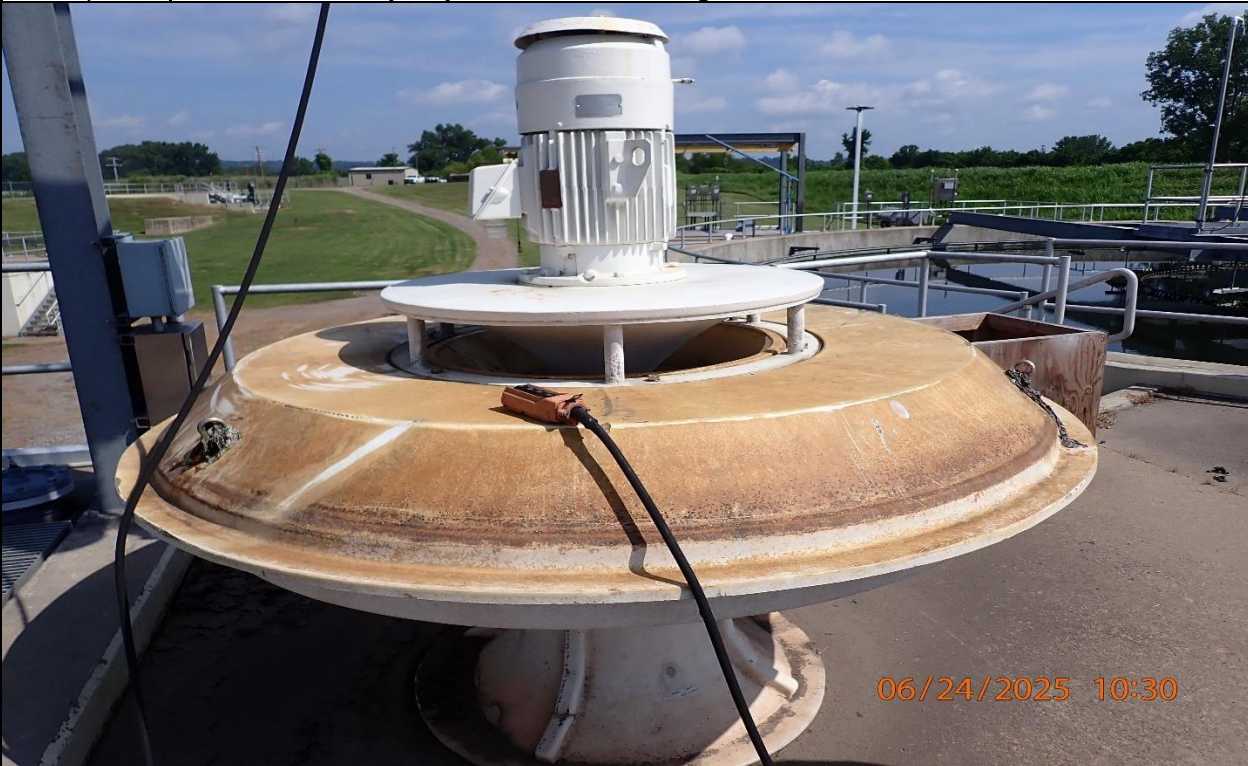
| Office of Water Quality Photographic Evidence Sheet | | | | | |
|---|---|---|---|---|---|
| Witness: | <b>Amy Huneycutt</b> | | | Photo #: | <b>14</b> |

| Office of Water Quality Photographic Evidence Sheet | | | | | |
|---|---|---|---|---|---|
| Description: | <b>Rebuilt aeration pump and motor awaiting installation.</b> | | | | |

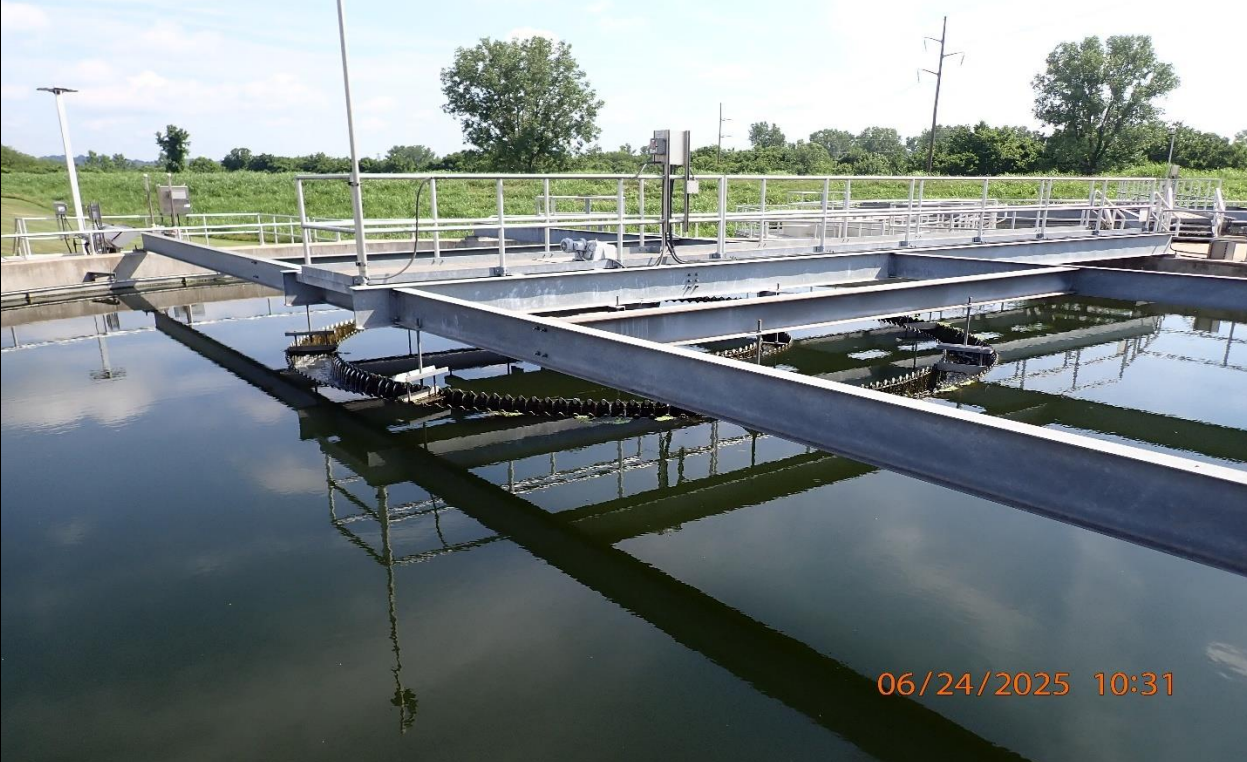
| Office of Water Quality Photographic Evidence Sheet | | | | | |
|---|---|---|---|---|---|
| Witness: | Amy Huneycutt | | | Photo #: | 15 |

| Office of Water Quality Photographic Evidence Sheet | | | | | |
|---|---|---|---|---|---|
| Description: | 1 <sup>st</sup> Clarifier. This model does not use a skimmer arm. | | | | |

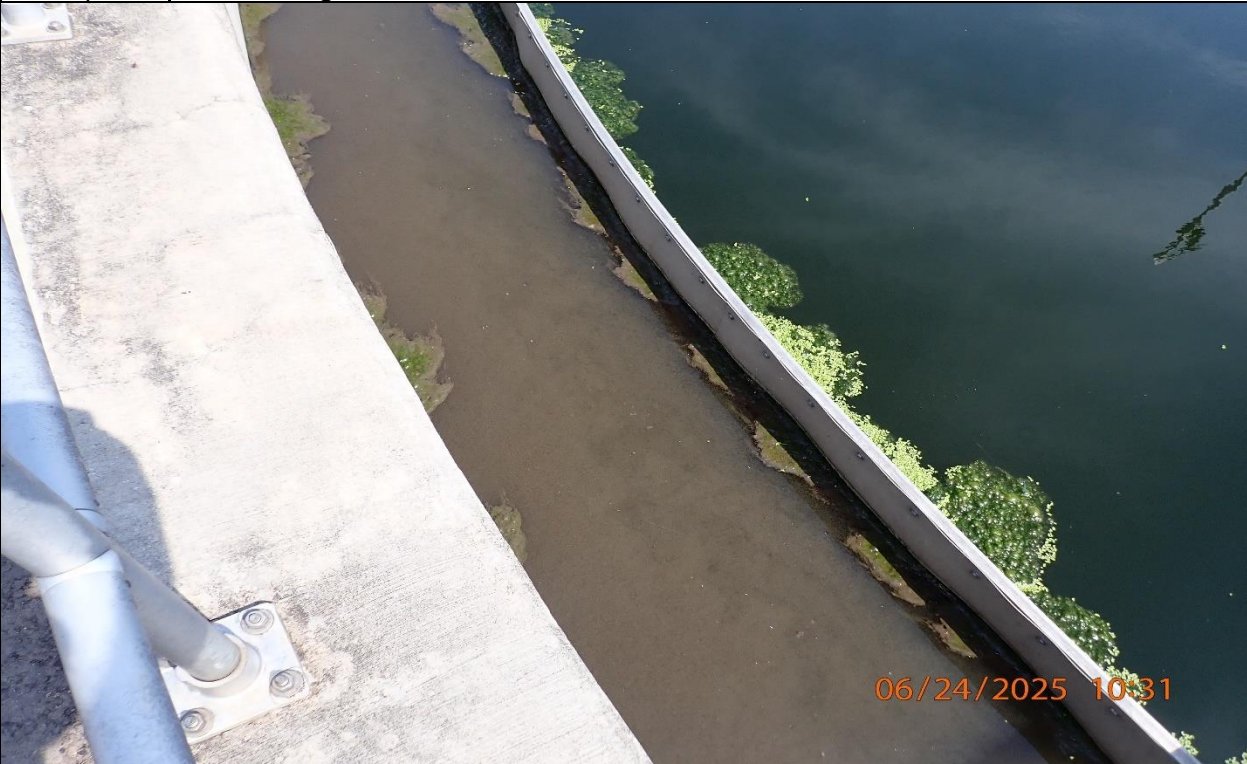
| Office of Water Quality Photographic Evidence Sheet | | | | | |
|---|---|---|---|---|---|
| Witness: | Amy Huneycutt | | | Photo #: | 16 |

| Office of Water Quality Photographic Evidence Sheet | | | | | |
|---|---|---|---|---|---|
| Description: | Outside ring of the 1 <sup>st</sup> clarifier. | | | | |

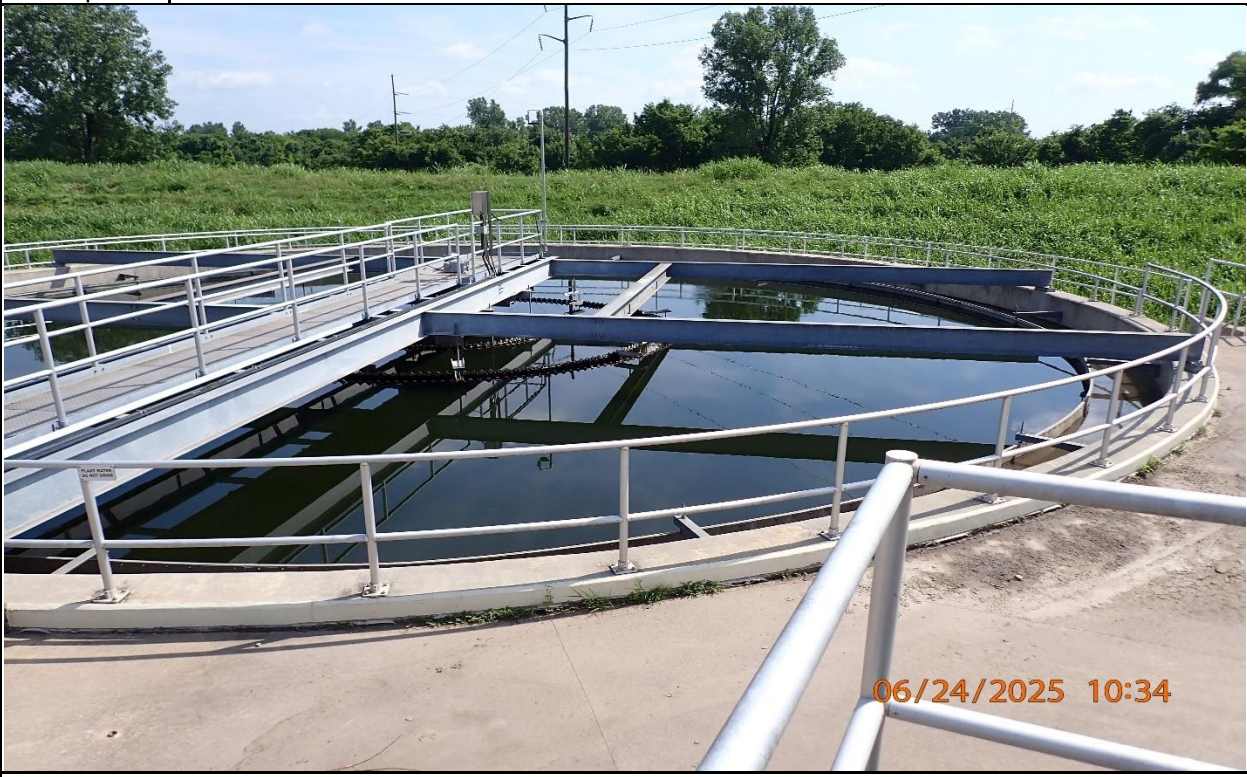
| Office of Water Quality Photographic Evidence Sheet | | | | | |
|---|---|---|---|---|---|
| Witness: | Amy Huneycutt | | | Photo #: | 17 |

| Office of Water Quality Photographic Evidence Sheet | | | | | |
|---|---|---|---|---|---|
| Description: | 2 <sup>nd</sup> Clarifier. This model clarifier does not use a skimmer arm. | | | | |

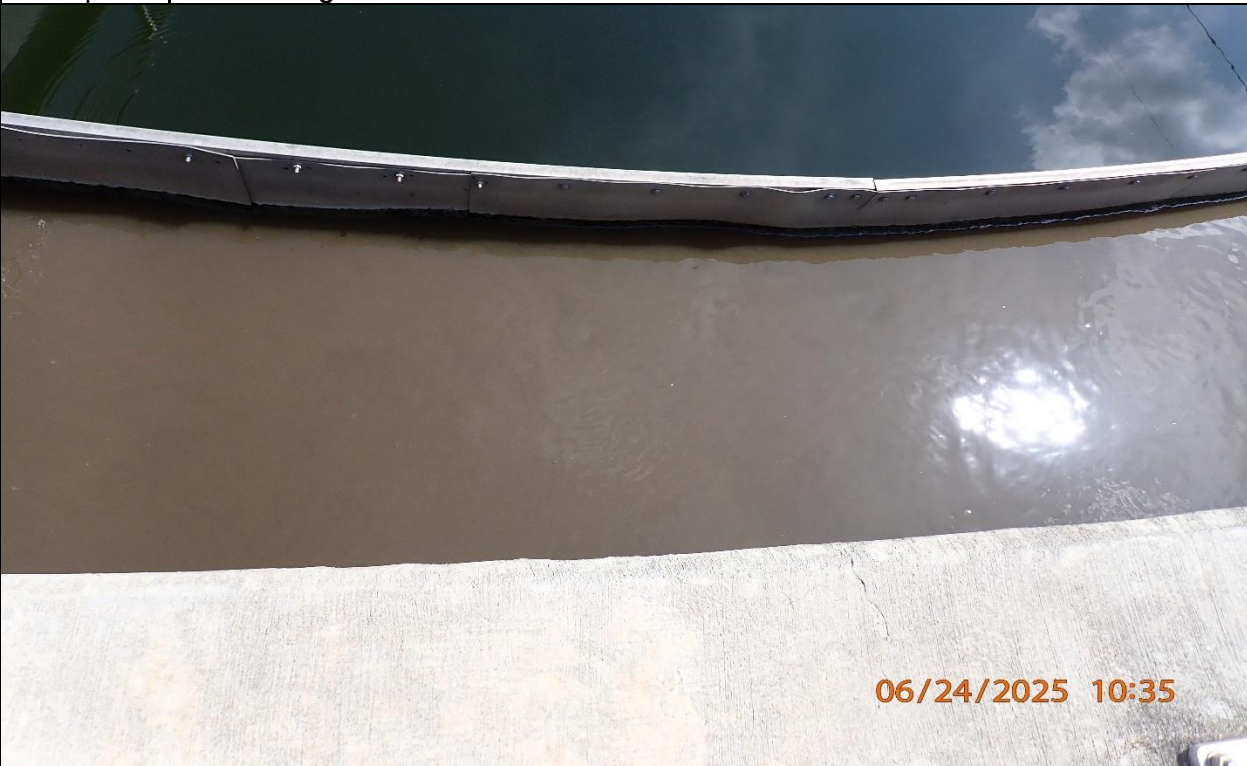
| Office of Water Quality Photographic Evidence Sheet | | | | | |
|---|---|---|---|---|---|
| Witness: | Amy Huneycutt | | | Photo #: | 18 |

| Office of Water Quality Photographic Evidence Sheet | | | | | |
|---|---|---|---|---|---|
| Description: | Outside ring of the 2 <sup>nd</sup> clarifier. | | | | |

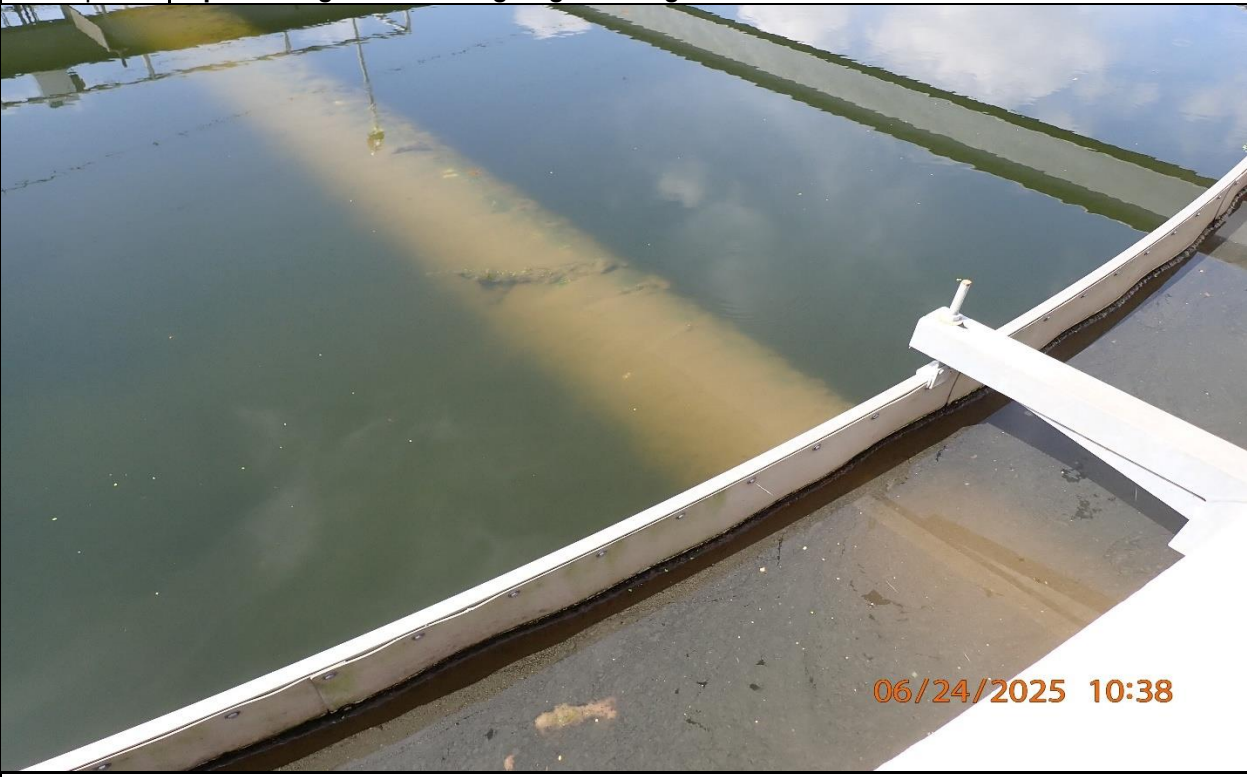
| Office of Water Quality Photographic Evidence Sheet | | | | | |
|---|---|---|---|---|---|
| Witness: | <b>Amy Huneycutt</b> | | | Photo #: | <b>19</b> |

| Office of Water Quality Photographic Evidence Sheet | | | | | |
|---|---|---|---|---|---|
| Description: | <b>Pipe leaving the clarifier going to UV light disinfection.</b> | | | | |

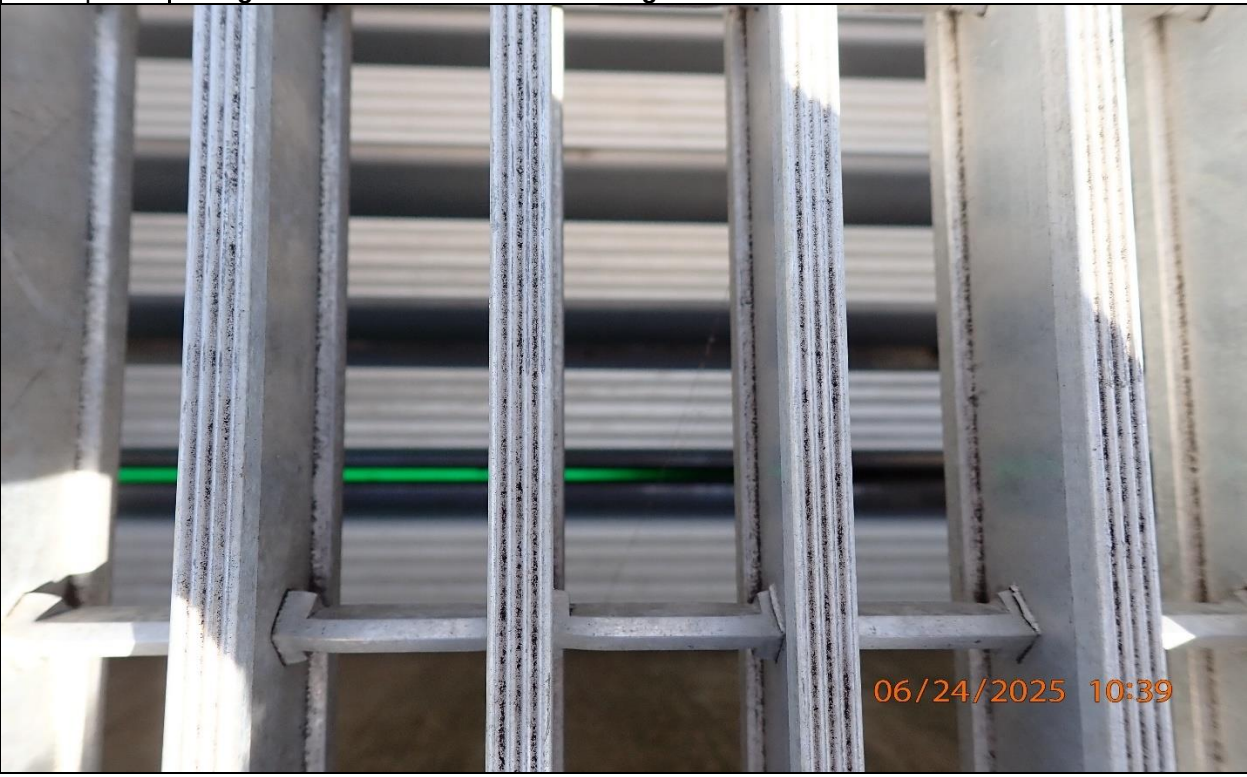
| Office of Water Quality Photographic Evidence Sheet | | | | | |
|---|---|---|---|---|---|
| Witness: | <b>Amy Huneycutt</b> | | | Photo #: | <b>20</b> |

| Office of Water Quality Photographic Evidence Sheet | | | | | |
|---|---|---|---|---|---|
| Description: | <b>UV light disinfection. Bulbs are changed on a 6-month interval.</b> | | | | |

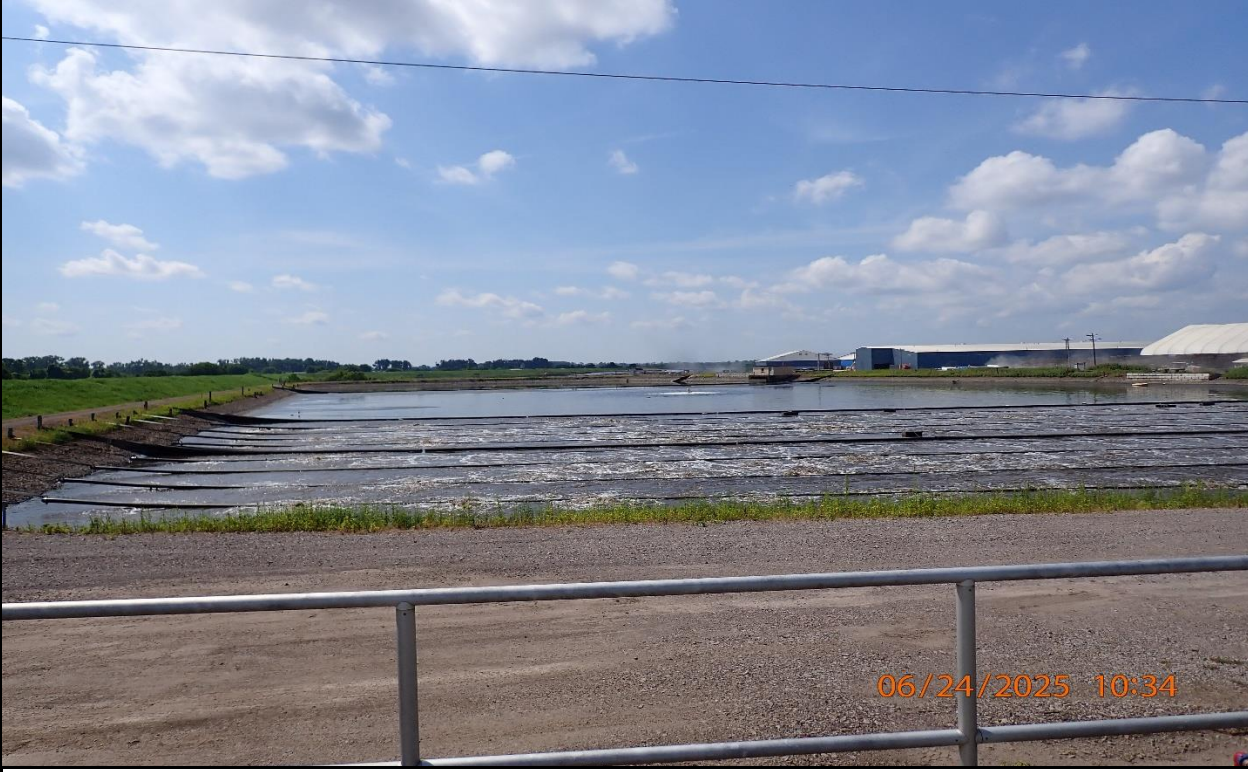
| Office of Water Quality Photographic Evidence Sheet | | | | | |
|---|---|---|---|---|---|
| Witness: | <b>Amy Huneycutt</b> | | | Photo #: | <b>21</b> |

| Office of Water Quality Photographic Evidence Sheet | | | | | |
|---|---|---|---|---|---|
| Description: | <b>Overview of the pond at the Southeast end of the site.</b> | | | | |

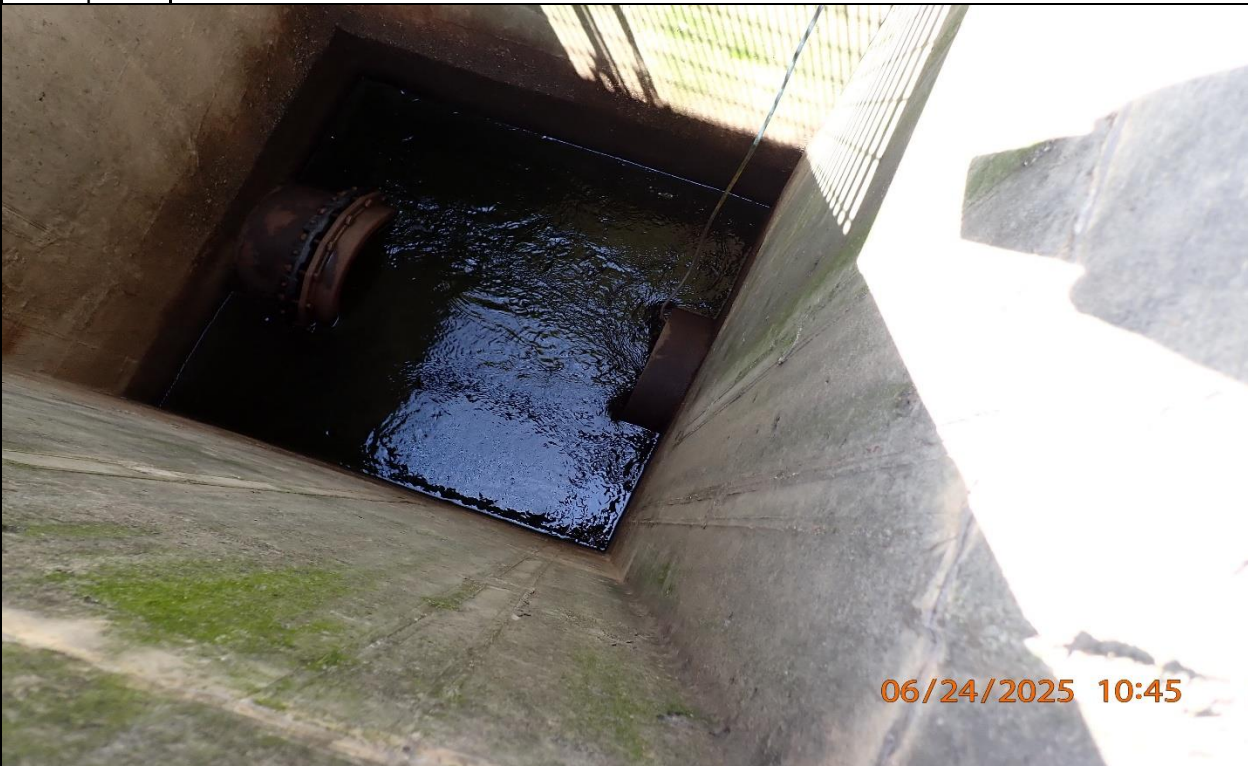
| Office of Water Quality Photographic Evidence Sheet | | | | | |
|---|---|---|---|---|---|
| Witness: | <b>Amy Huneycutt</b> | | | Photo #: | <b>22</b> |

| Office of Water Quality Photographic Evidence Sheet | | | | | |
|---|---|---|---|---|---|
| Description: | <b>Outfall 001.</b> | | | | |

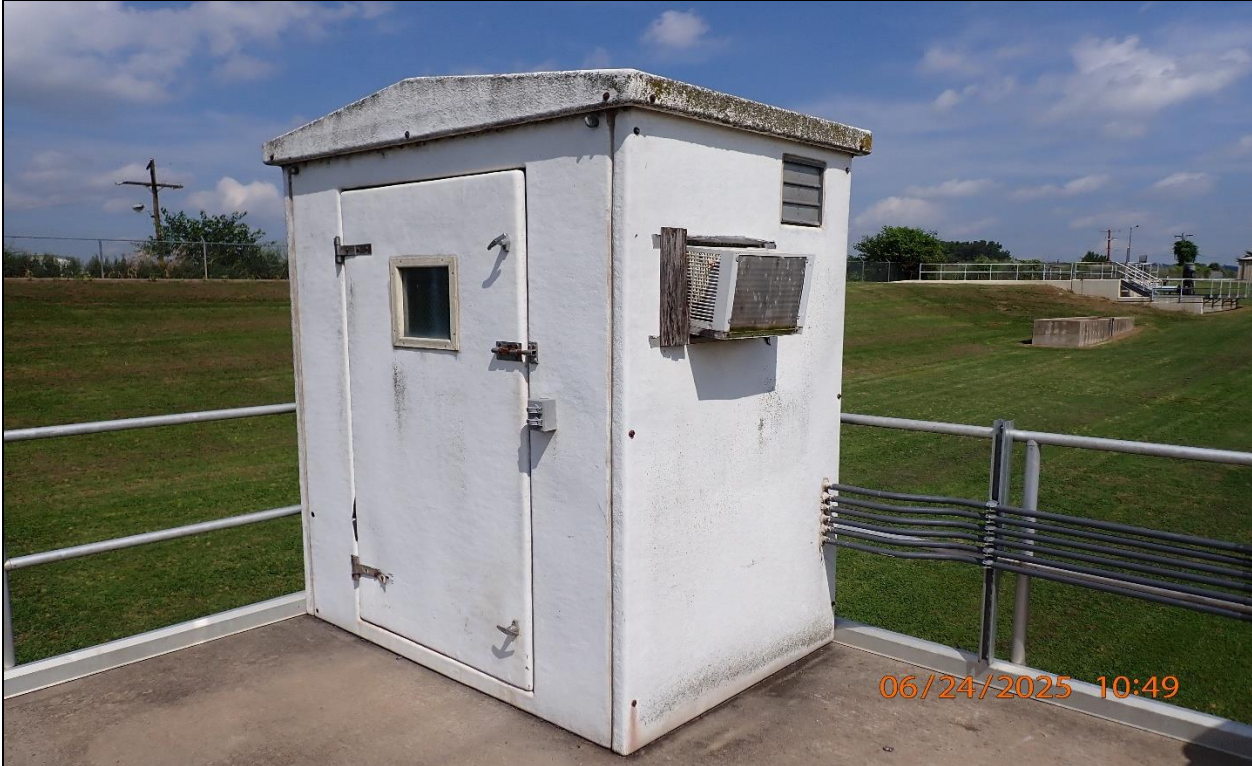
| | | Photo #: | 23 |

| Description: | Outfall 001 building. Mag meter and sampling location. | | |

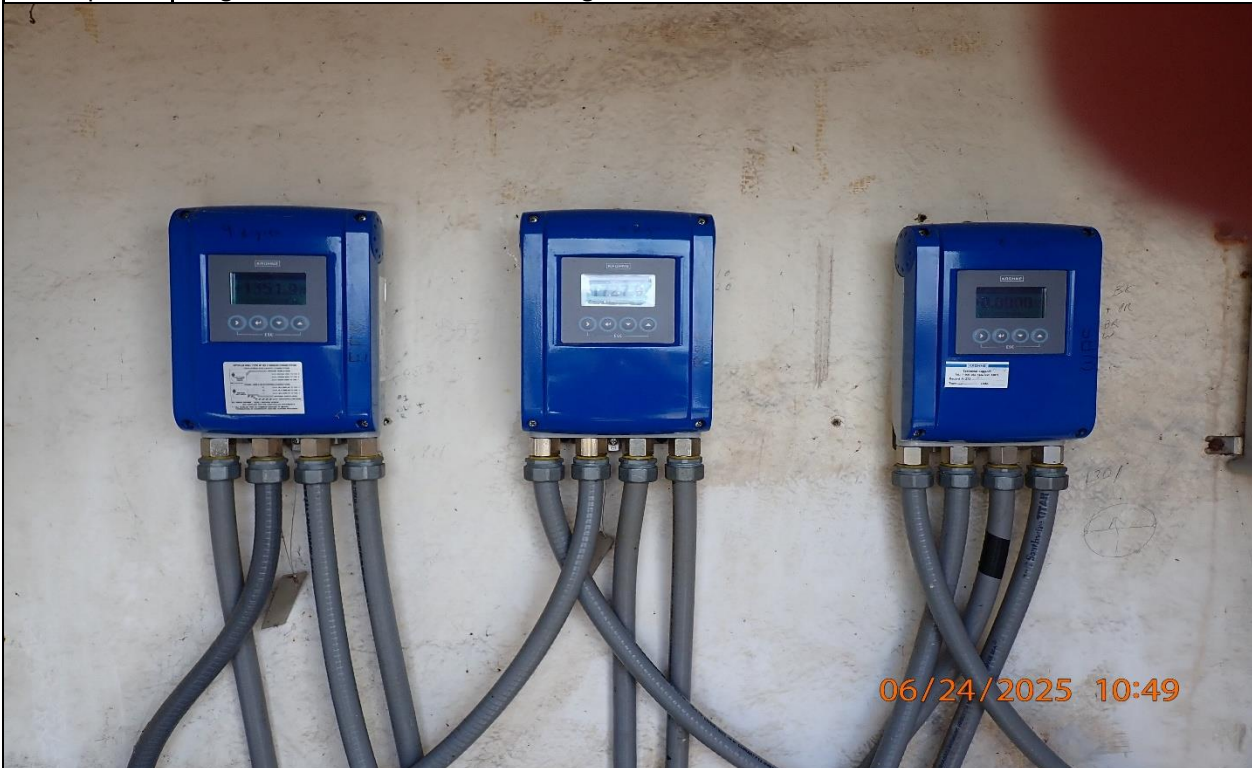
| | | Photo #: | 24 |

| Description: | Mag meter at outfall 001 building. | | |
