RE: AAR Components Inspection- PDS#133956 (Garland County)  
AFIN: 26-00145 Permit No.: AR0033880

| <div style="display: inline-block; vertical-align: middle; margin-left: 10px;"> <b>ENVIRONMENTAL<br/>QUALITY</b> </div> | | <b>OFFICE OF WATER QUALITY<br/>INSPECTION REPORT</b> | | | | |

**Pretreatment Compliance Inspection - Industrial User Site Visit**

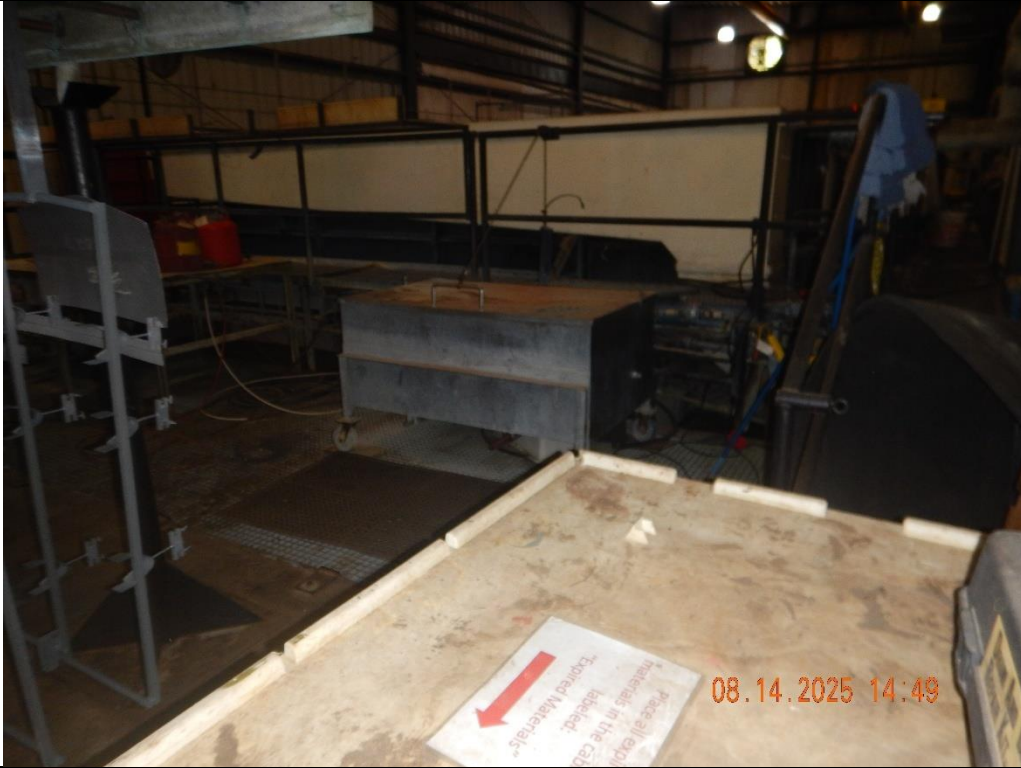
| | | Photo #: | <b>1</b> |

| Description: | <b>Wastewater to two pits</b> | | |

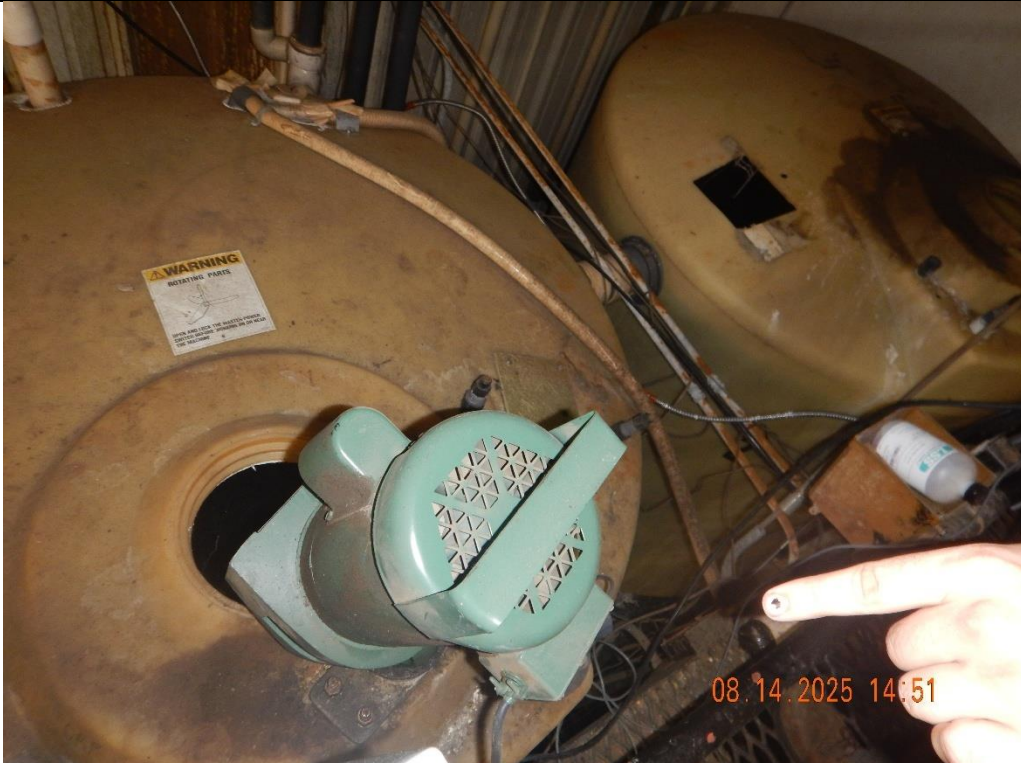
| | | Photo #: | <b>2</b> |

4. What is the basis for the permit limits: 40 CFR 437
5. Is the IU familiar with their permit limits and requirements? Yes
6. Describe the pretreatment equipment and procedures: Acidic breakdown and PH adjustment

| Description: | <b>PH adjustment</b> | | |

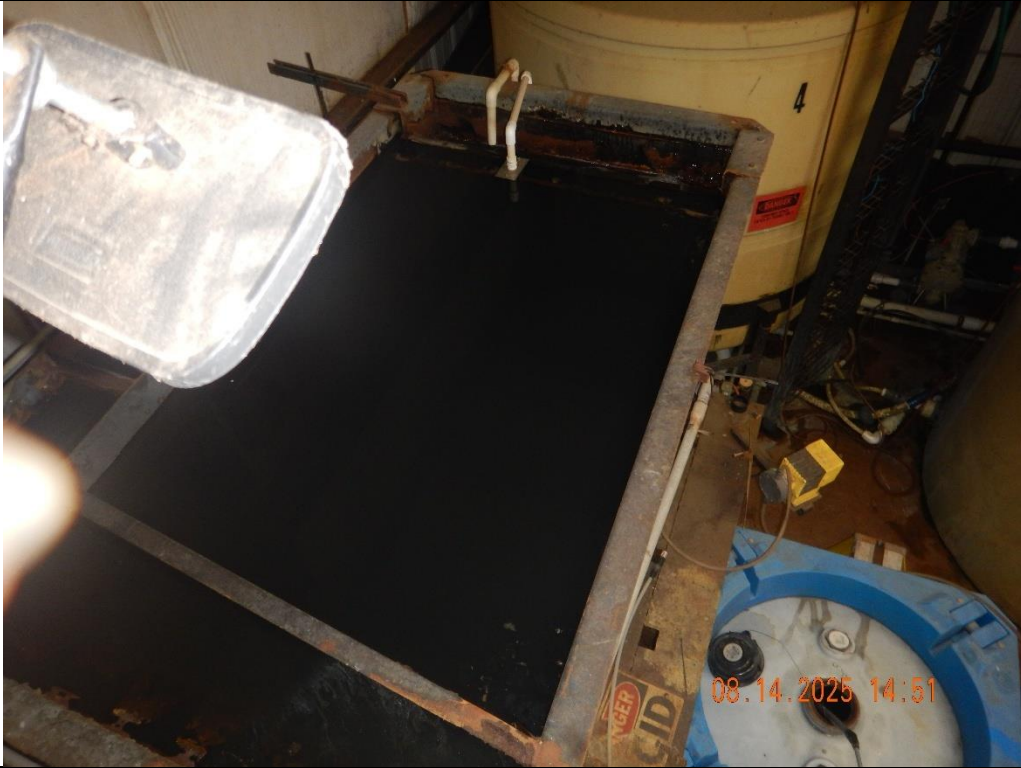
| | | Photo #: | <b>3</b> |

| Description: | <b>Clarifier; with sludge pressed and disposed by waste services</b> | | |

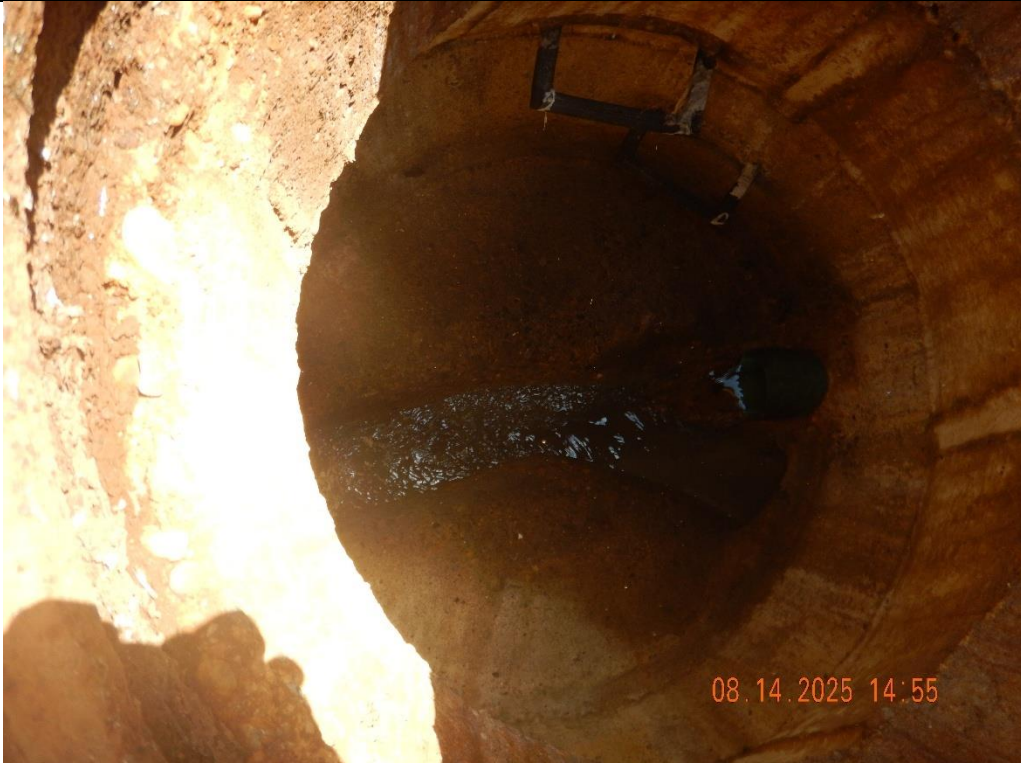
| | | Photo #: | <b>4</b> |

9. Describe the sampling location and monitoring equipment: Manhole at concrete pipe
10. Is the sampling location suitable for the collection of a representative sample? Yes

| Description: | <b>Sampling location and discharge to POTW</b> | | |

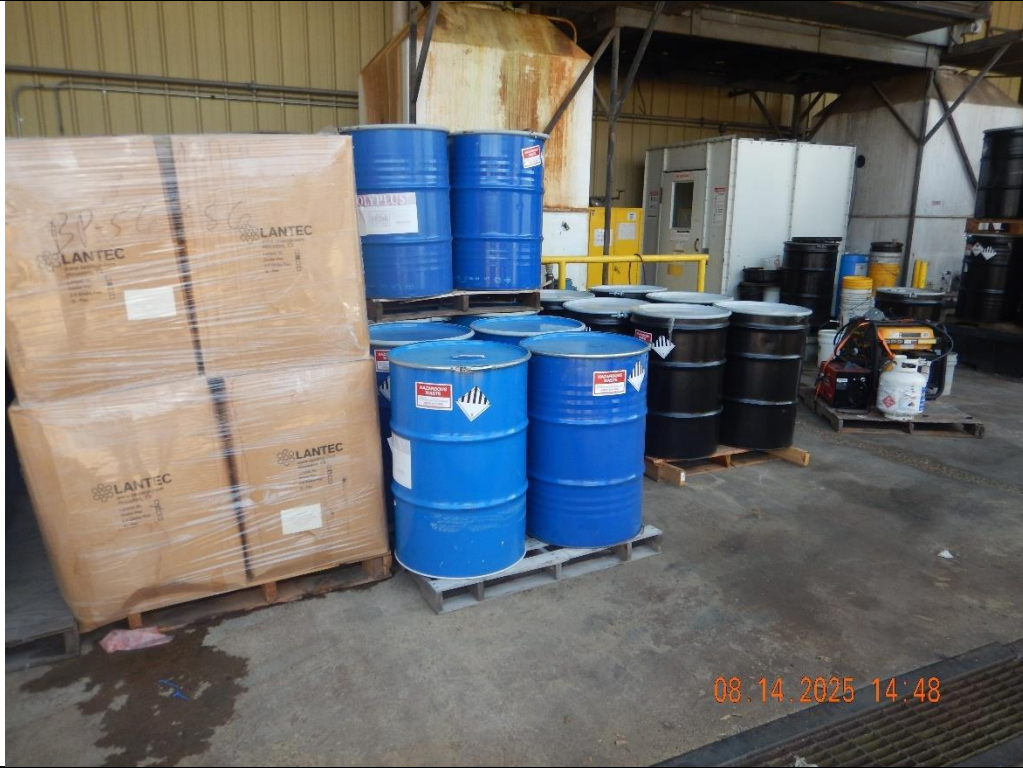
| | | Photo #: | <b>5</b> |

14. Does the facility have a chemical storage facility (if yes, describe)? Yes, Covered storage area with 55 gallon drums
15. Is solid waste properly disposed of? Yes, picked up by Waste Services once per week.

| Description: | <b>Hazardous waste storage area with drain back to treatment</b> | | |
