**RE: Inspection conducted on September 25, 2025**  
**AFIN 66-00226**  
**Permit Number 0267-S1-R1**

**Division of Environmental Quality - Office of Land Resources**  
**Class 1 Landfill Inspection Form**

| <b>Site Name</b> | City of Fort Smith Class 1 Landfill | <b>County</b> | Sebastian | <b>AFIN</b> | 66-00226 |

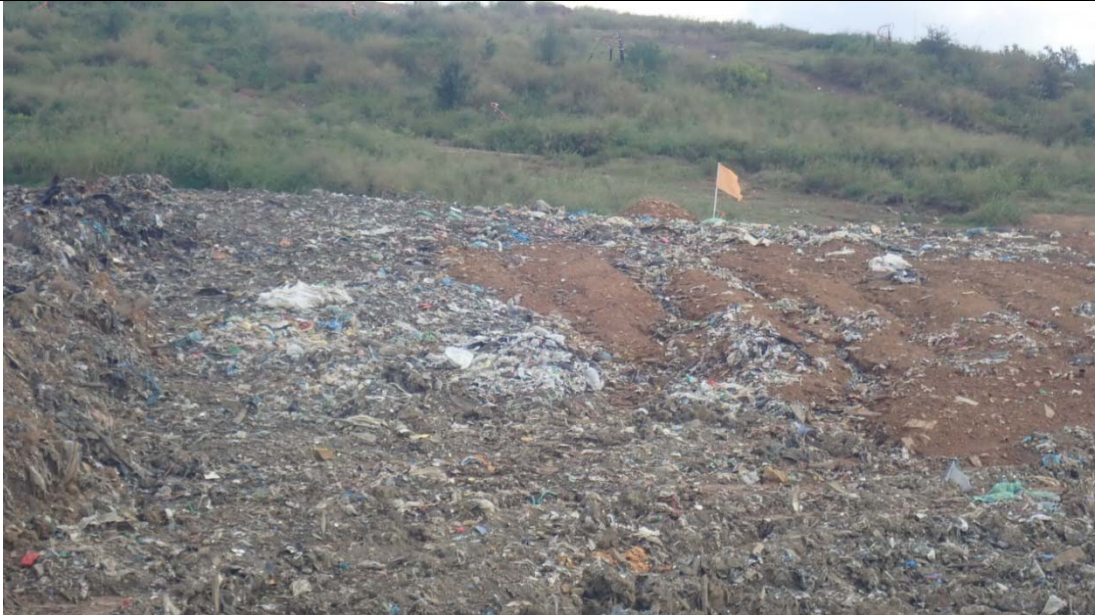
| <b>Photo #</b> | 1 | <b>of</b> | 4 | | <b>Date</b> | 9/25/2025 | <b>Time</b> | 1316 |

| | <b>Citation</b> | <b>Description</b> | <b>Comments</b> |
|---|---|---|---|
| X | 8 CAR § 60-413(a) | Satisfactory Daily/Alternate/Intermediate Cover | Exposed solid waste was observed on the lower western slope. (Refer to Photos #1-#4.) |

| <b>Description</b> | Exposed solid waste was observed on the lower western slope, facing east. | | | | | | | |

You should immediately initiate actions to correct the alleged violations cited. A written response of the corrective actions taken, or to be taken, must be submitted within thirty (30) calendar days from the date on this letter to the attention of Jason Gilkey. The response may include, but is not limited to, photographs, copies of disposal receipts, records, or analytical results, as applicable. If you have any questions regarding the alleged violations, please do not hesitate to contact me at (501) 993-7188 or [jason.gilkey@arkansas.gov](mailto:jason.gilkey@arkansas.gov).

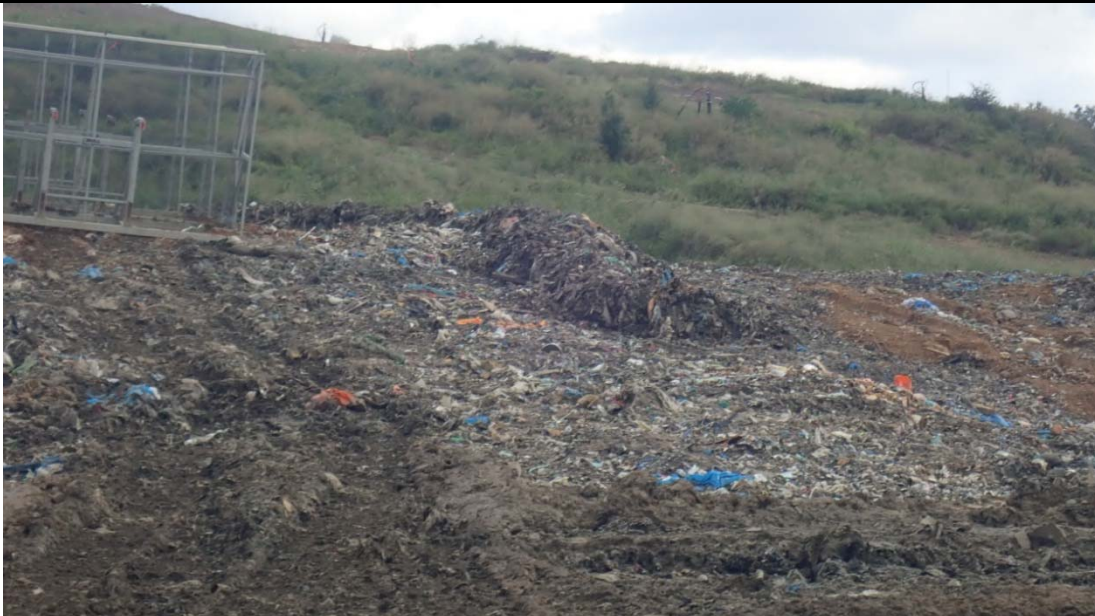
| <b>Photo #</b> | 1 | <b>of</b> | 4 | | <b>Date</b> | 9/25/2025 | <b>Time</b> | 1315 |

| <b>Description</b> | Exposed solid waste was observed on the lower western slope, facing east. | | | | | | | |

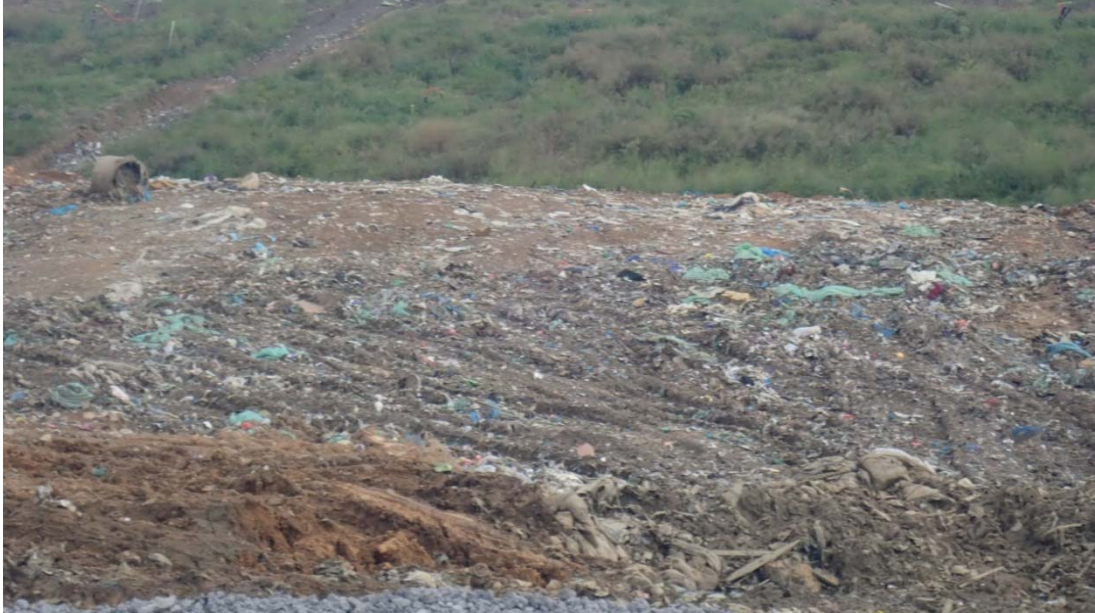
| <b>Photo #</b> | 1 | <b>of</b> | 4 | | <b>Date</b> | 9/25/2025 | <b>Time</b> | 1315 |

| <b>Description</b> | Exposed solid waste was observed on the lower western slope, facing northeast. | | | | | | | |

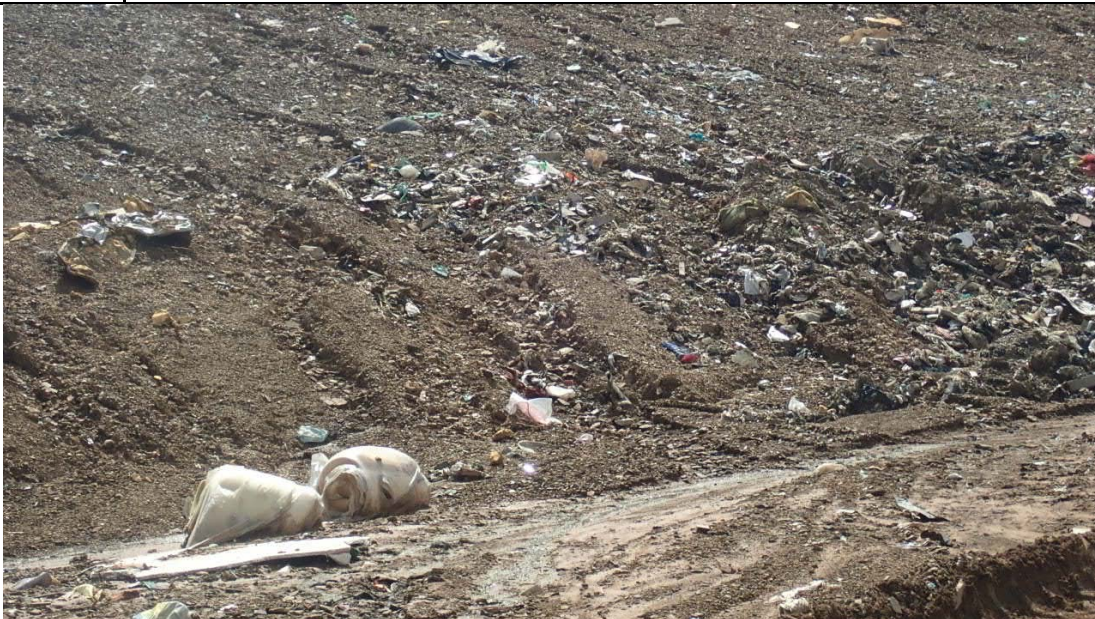
| <b>Photo #</b> | 1 | <b>of</b> | 4 | | <b>Date</b> | 9/25/2025 | <b>Time</b> | 1310 |

| <b>Description</b> | Exposed solid waste was observed on the lower western slope, facing southeast. | | | | | | | |
