RE: Compliance Inspection, Bassett Wastewater Treatment Plant  
AFIN: 47-00240 Permit No.: AR0046272

## WATER DIVISION INSPECTION REPORT

| FACILITY INFORMATION | INSPECTION INFORMATION |
|---|---|
| NAME: City of Bassett WWTP | DATE(S): 3/27/2014 |

INSPECTION TYPE: SSO/Collection System

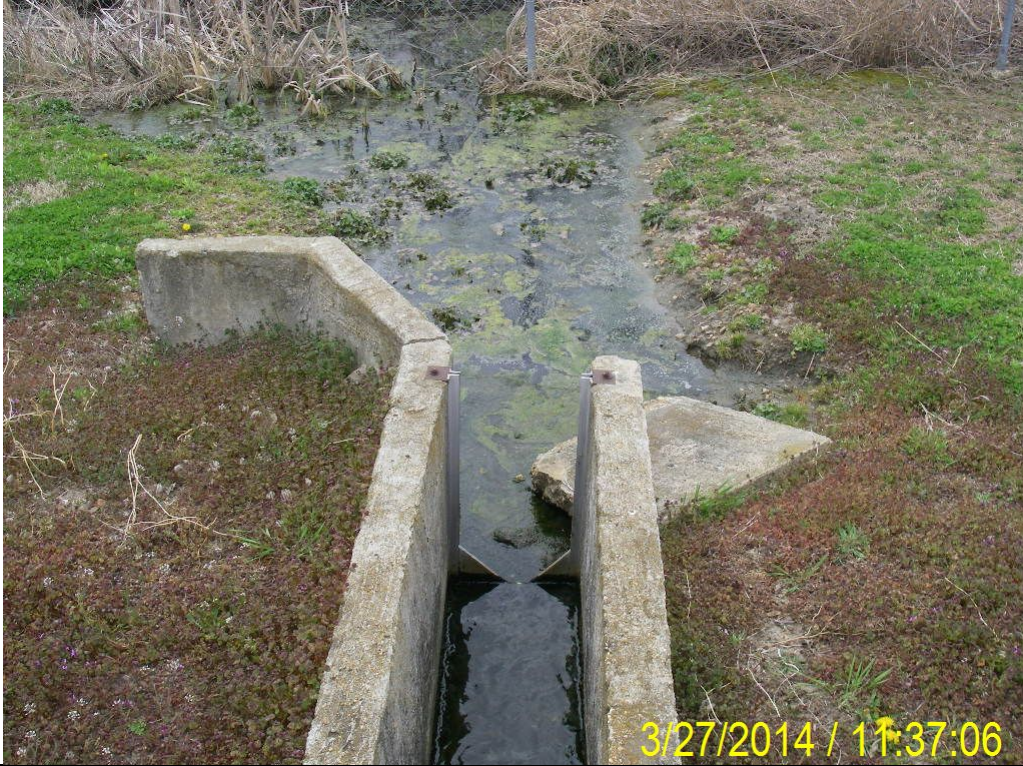
| | | Photo #: | <b>1</b> |

1. There was scum in the receiving stream and upstream of the outfall weir (Photos 1-3). This violates Part I, Section A of the Permit.
2. Improper operation and maintenance. This violates Part III, Section B, Item 1A of the Permit. The following items were noted:

| Description: | <b>View of the outfall and receiving stream. Note the scum.</b> | | |

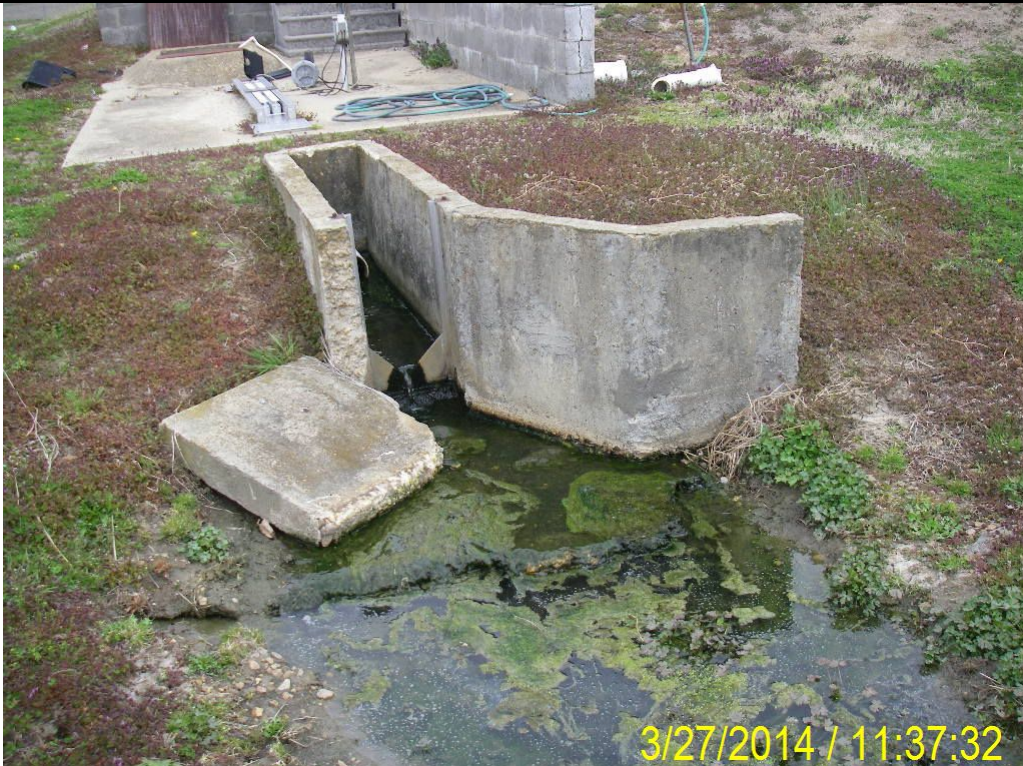
| | | Photo #: | <b>2</b> |

| Description: | <b>View of the outfall. Note the scum in the water upstream and downstream of the weir.</b> | | |

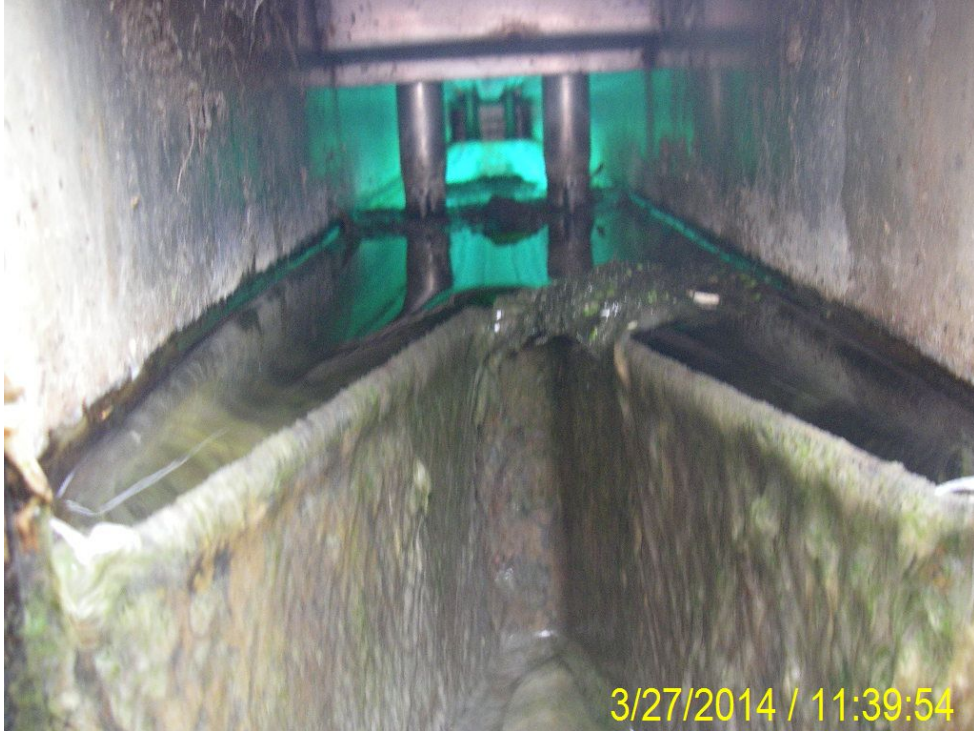
| Water Division Photographic Evidence Sheet | | | | | |
|---|---|---|---|---|---|
| Witness: | <b>None</b> | | | Photo #: | <b>3</b> |

| Water Division Photographic Evidence Sheet | | | | | |
|---|---|---|---|---|---|
| Description: | <b>View of the effluent from the UV disinfection unit. Note the solids on top of the water.</b> | | | | |

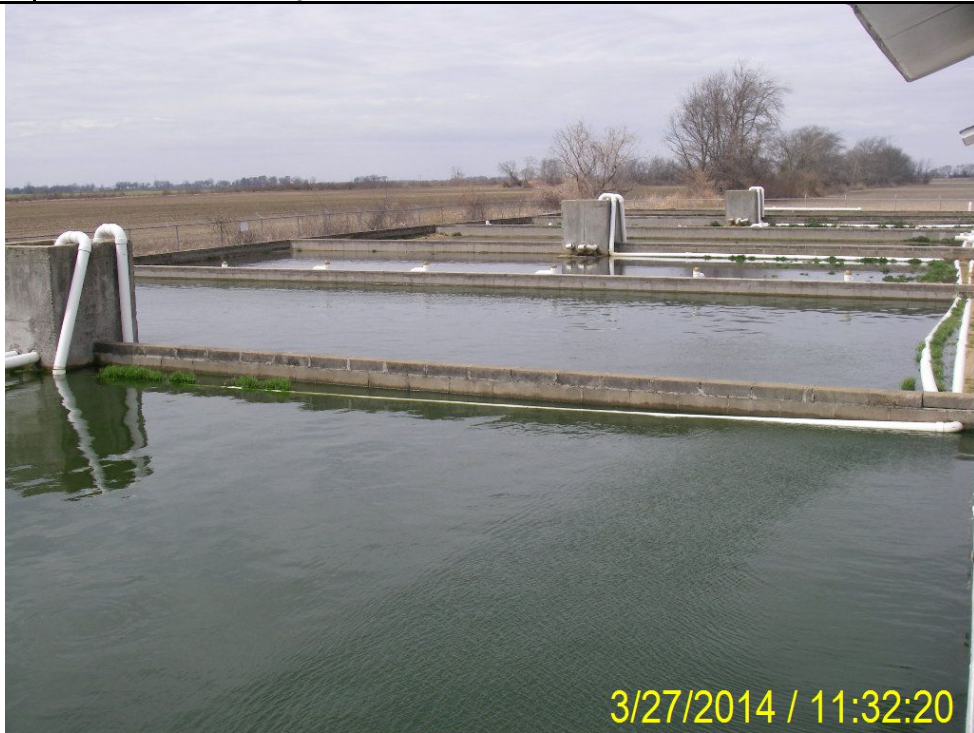
| Water Division Photographic Evidence Sheet | | | | | |
|---|---|---|---|---|---|
| Witness: | <b>None</b> | | | Photo #: | <b>4</b> |

- a) There was excessive ponding on the sand filter beds (Photo 4).
  - b) There were multiple leaks in the walls of the sand filter beds (Photos 5-7). These leaks were also unpermitted discharges in violation of the Arkansas Water and Air Pollution Control Act - A.C.A. § 8-4-217(b)(1)(E) which states, "It shall be unlawful for any person to discharge sewage, industrial waste, or other wastes into any of the waters of this state without having first obtained a written permit from the Department."

| Water Division Photographic Evidence Sheet | | | | | |
|---|---|---|---|---|---|
| Description: | <b>View of wastewater ponded on the sand filter beds.</b> | | | | |

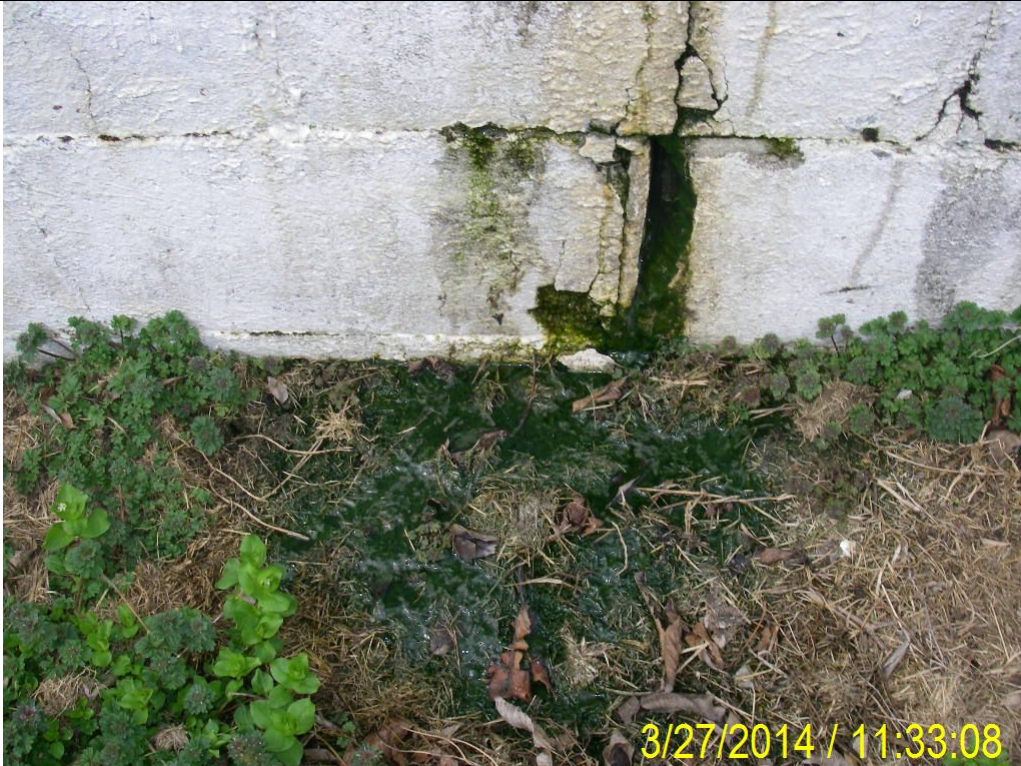
| | | Photo #: | <b>5</b> |

| Description: | <b>View of a leak in the wall of one of the sand filter beds.</b> | | |

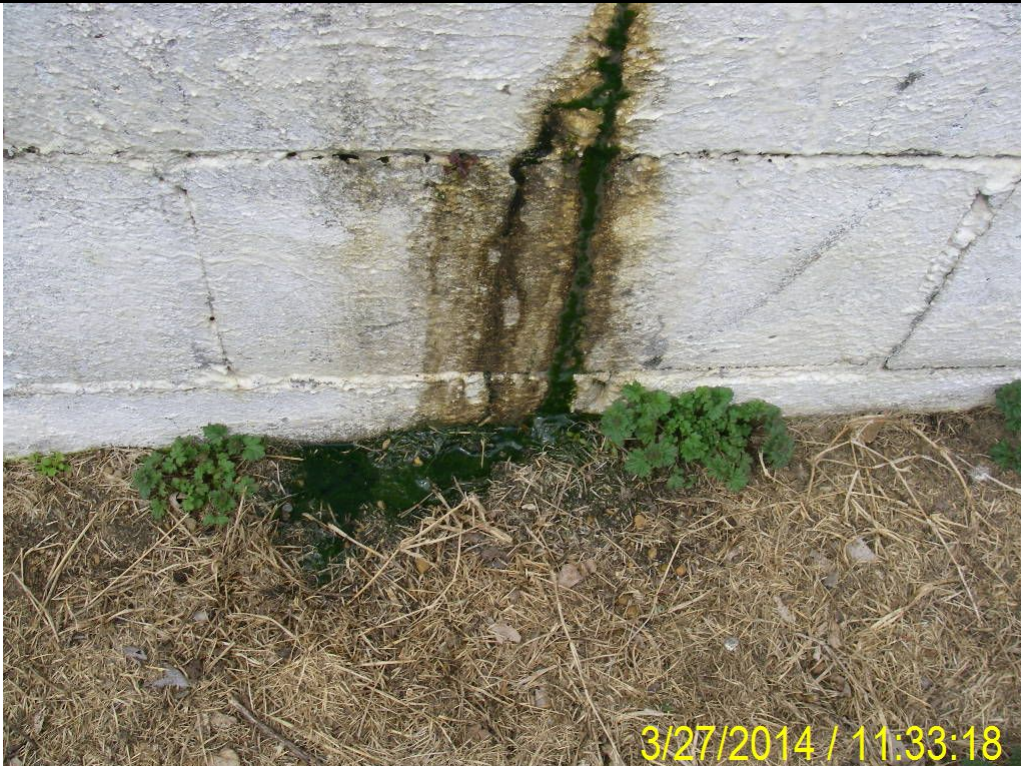
| | | Photo #: | <b>6</b> |

| Description: | <b>View of a leak in the wall of one of the sand filter beds.</b> | | |

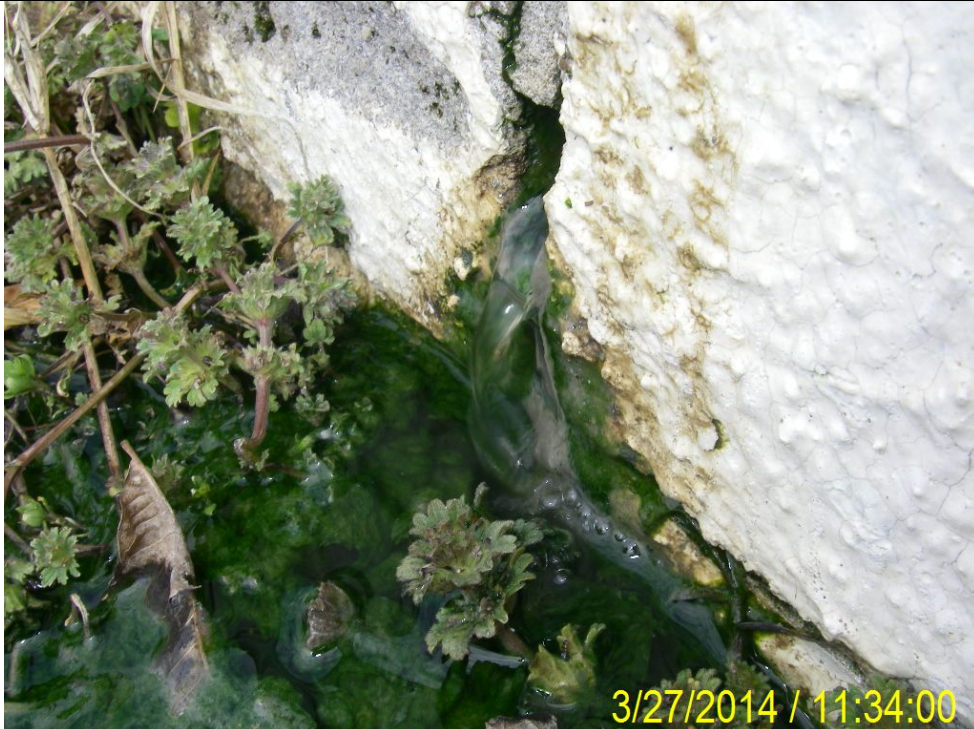
| | | Photo #: | <b>7</b> |

| Description: | <b>View of a leak in the wall of one of the sand filter beds.</b> | | |

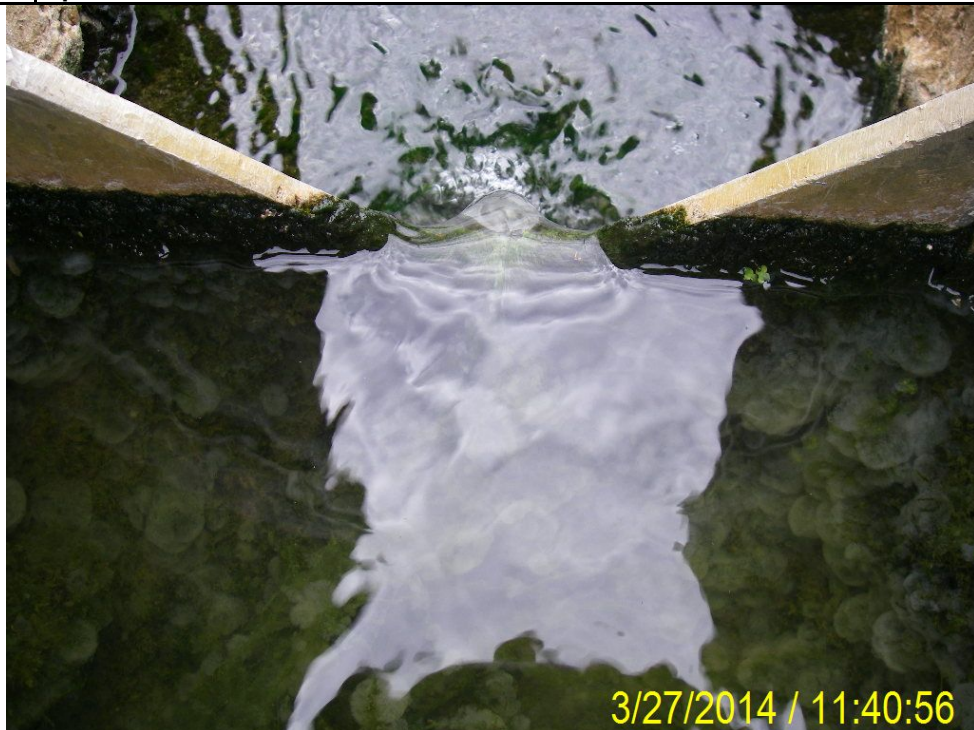
| | | Photo #: | <b>8</b> |

- c) There was excessive scum and algae in the channel upstream of the outfall weir (Photos 8-9).
3. The flow measurement device was not properly installed or maintained. There was an excessive amount of algae on the weir (Photo 8), and the facility did not have a staff gauge installed at least 3 times the expected head upstream of the weir (Photo 9). This violates Part III, Section C, Item 2 of the Permit.

| Description: | <b>View of algae growth on the outfall weir. Also note the growth in the channel upstream of the weir.</b> | | |

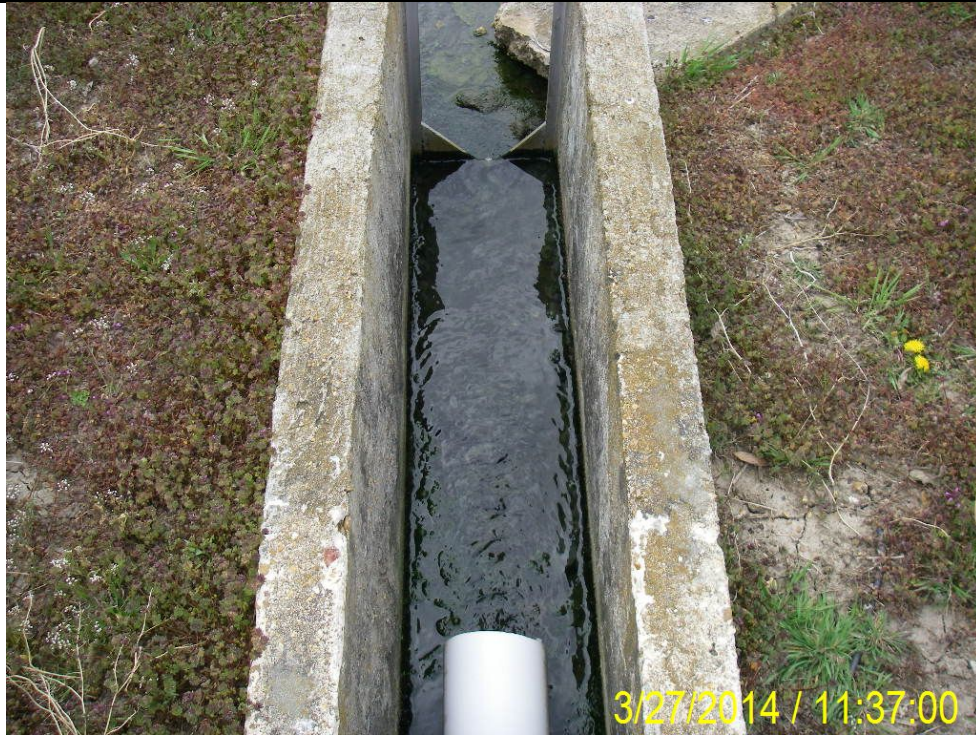
| | | <b>9</b> | |

| Description: | <b>View of the effluent channel and outfall weir. Note the lack of a staff gauge in the channel, and the scum/algae near the white pipe.</b> | | |

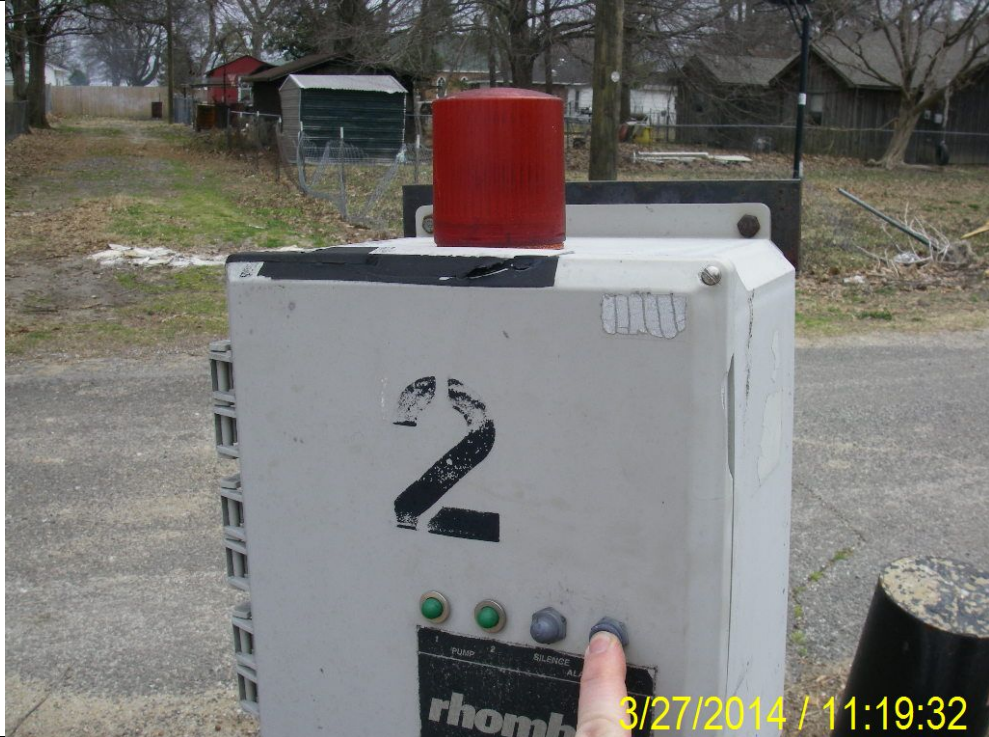
- The alarm system was not adequately maintained at pump station #2 (Photo 1).
- The wet well cover was not locked at pump station #2 (Photo 2).
- The lock hinge had corroded and the wet well was not adequately locked at pump station #3 (Photo 3).
- The alarm system was not adequately maintained at pump station #5 (Photo 4).

| Photo #: | <b>1</b> | Description: | <b>The alarm was not adequately maintained at pump station #2. The alarm light and buzzer did not work when the test button was pushed.</b> |

That is the light on #2 pumping station, the part is on order and will be installed as soon as it comes in and I will take picture and send to you.

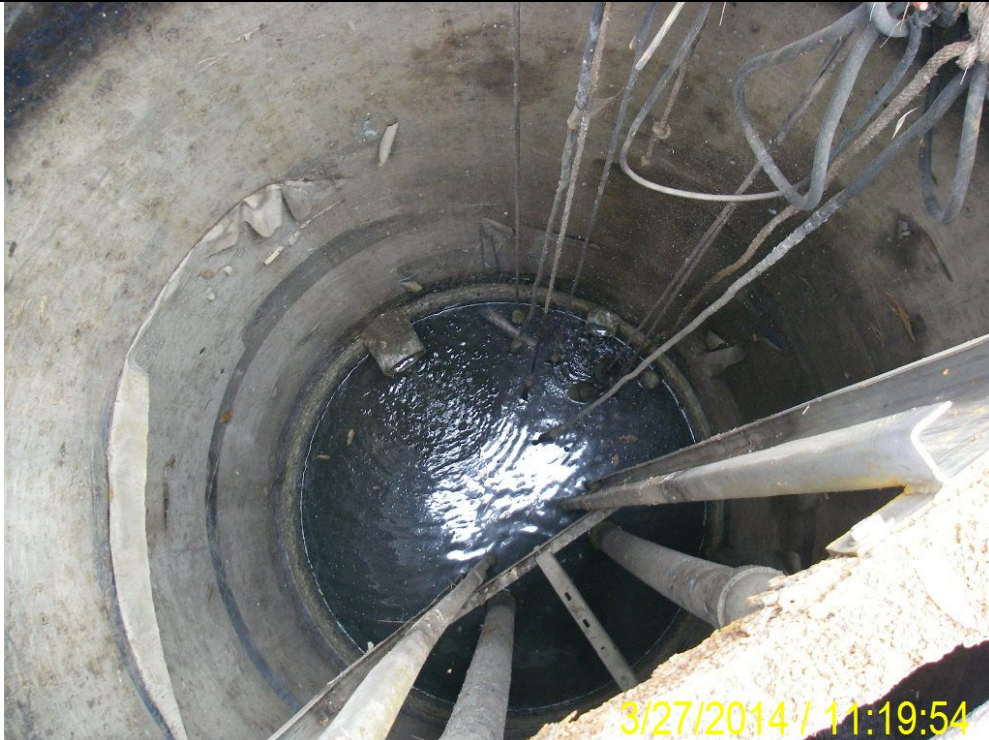
| Photo #: | <b>2</b> | Description: | <b>View inside the wet well at pump station #2. The wet well cover was not locked.</b> |

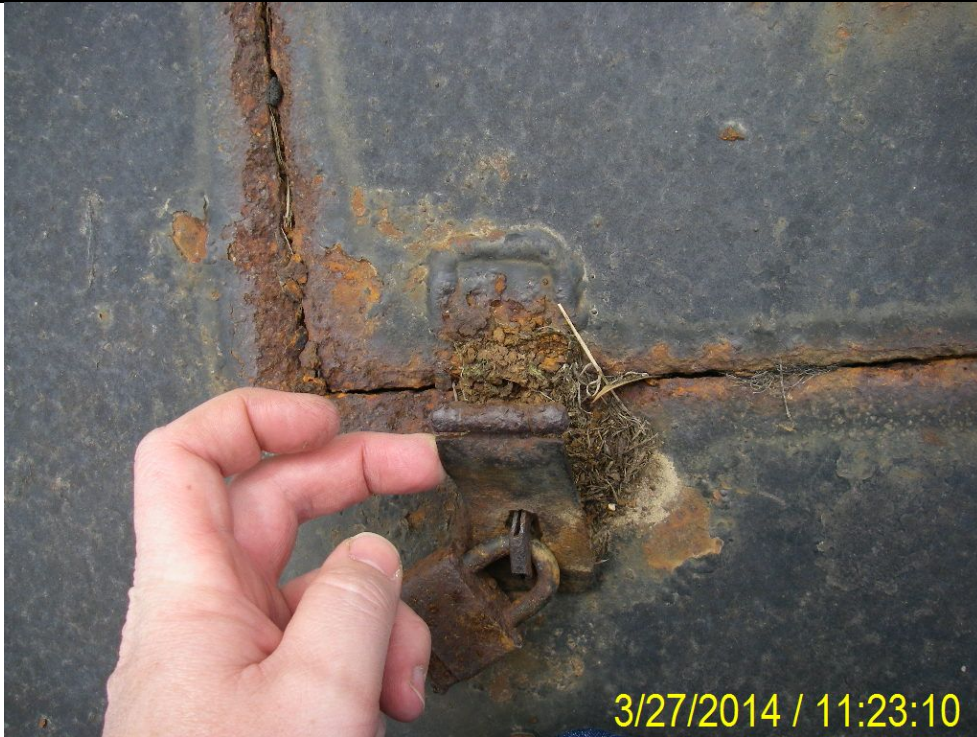
| Description: | <b>View of the lock and hinge at pump station #3. Note the hinge has corroded and was no longer attached to the wet well cover.</b> | | |

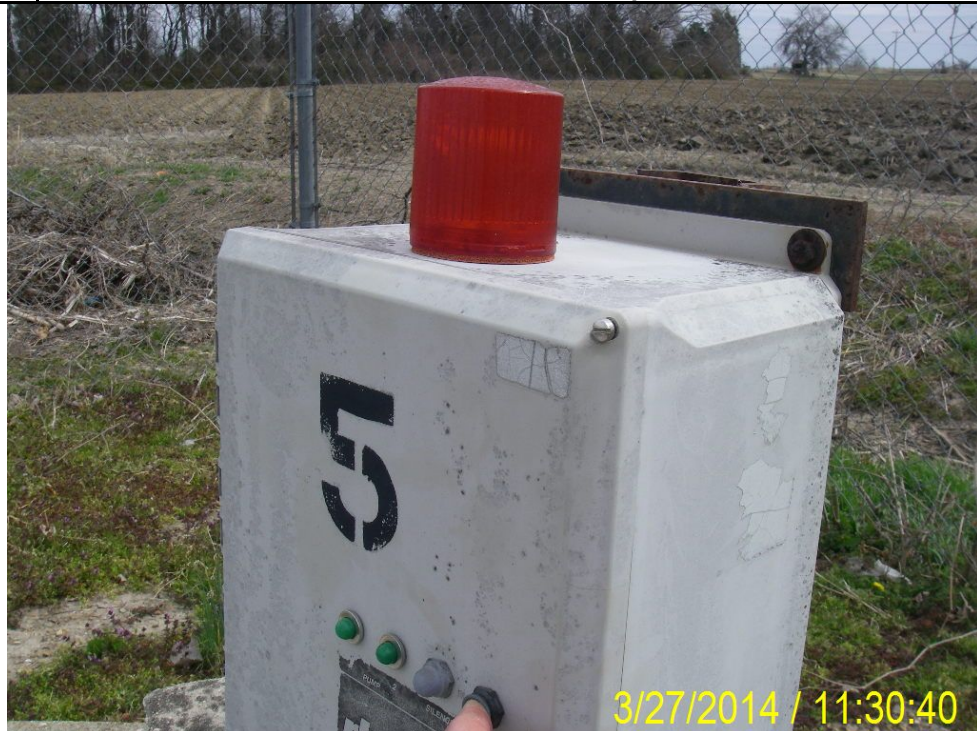
| Description: | <b>The alarm was not adequately maintained at pump station #5. The alarm light and buzzer did not work when the test button was pushed.</b> | | |

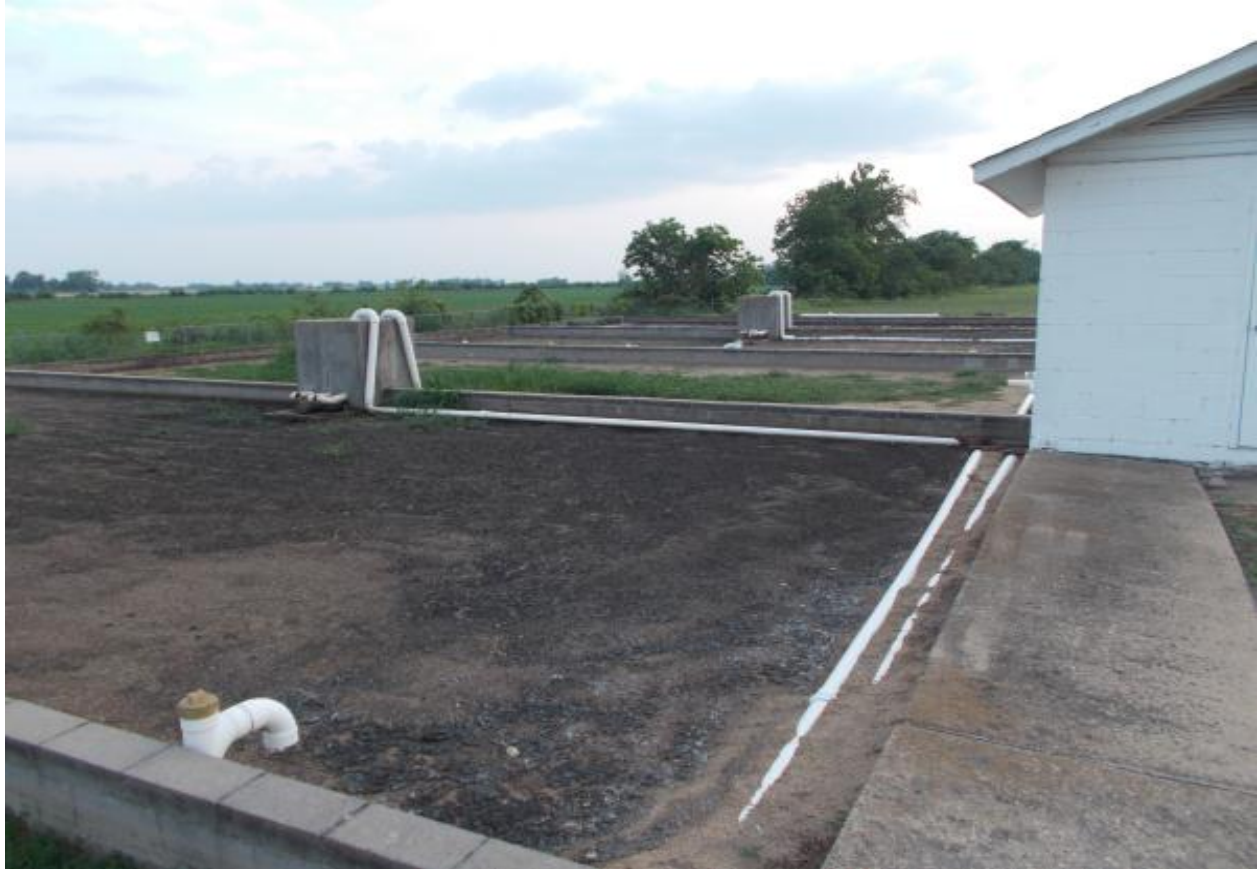
Condition of sand beds.
