Re: City of Camden Class IV Landfill 2025 Annual Engineering Inspection Report
ADEQ Permit #0255-S4 (AFIN 52-00069)

ANNUAL ENGINEERING INSPECTION REPORT (AEIR) FORM Reporting Year: 2025

Facility Name: **City of Camden Class IV Landfill** AFIN: **52-00069** Permit #: **0255-S4** Landfill Class: **4**

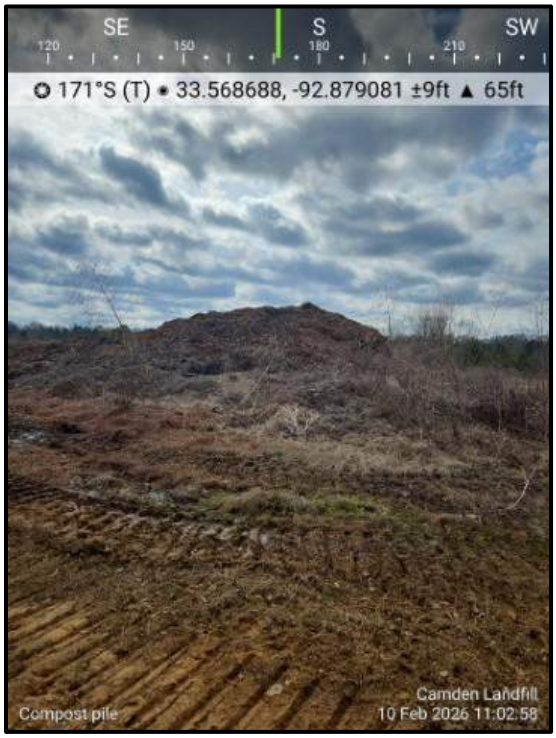
Figure 2: Looking south at the mulch pile

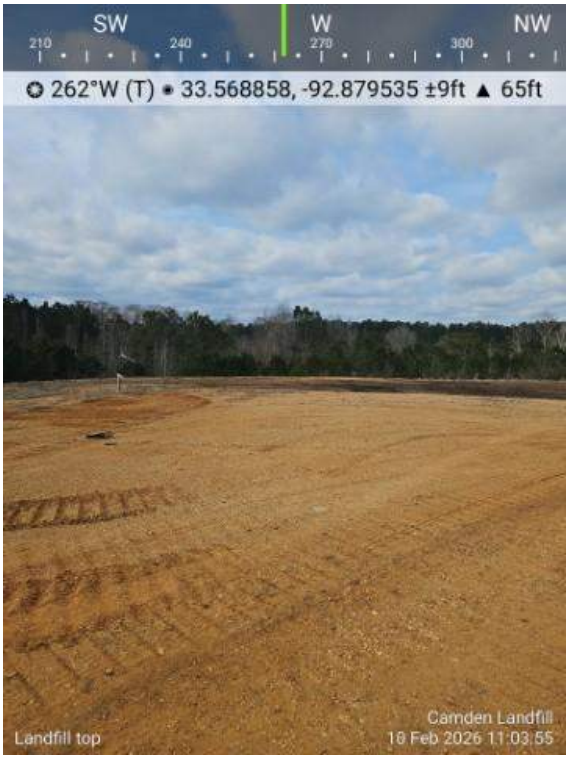
Figure 4: Looking west along the top of the landfill

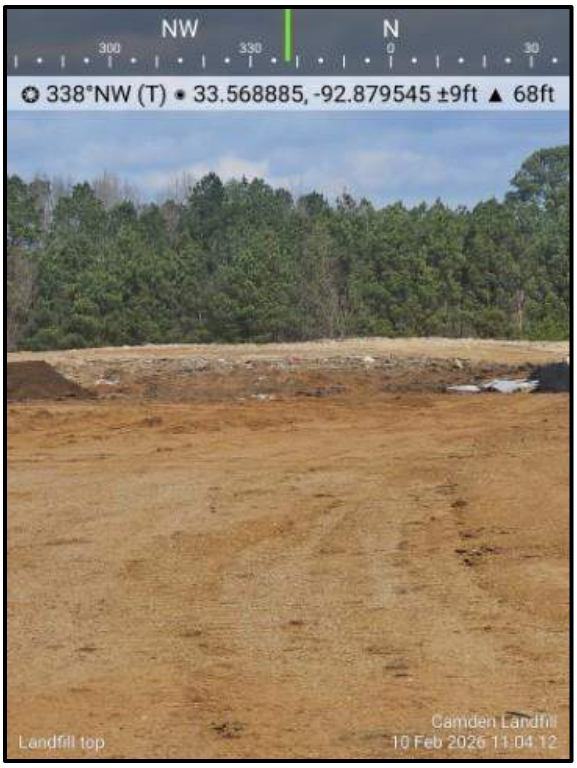
Figure 5: Looking northwest across the top of the landfill

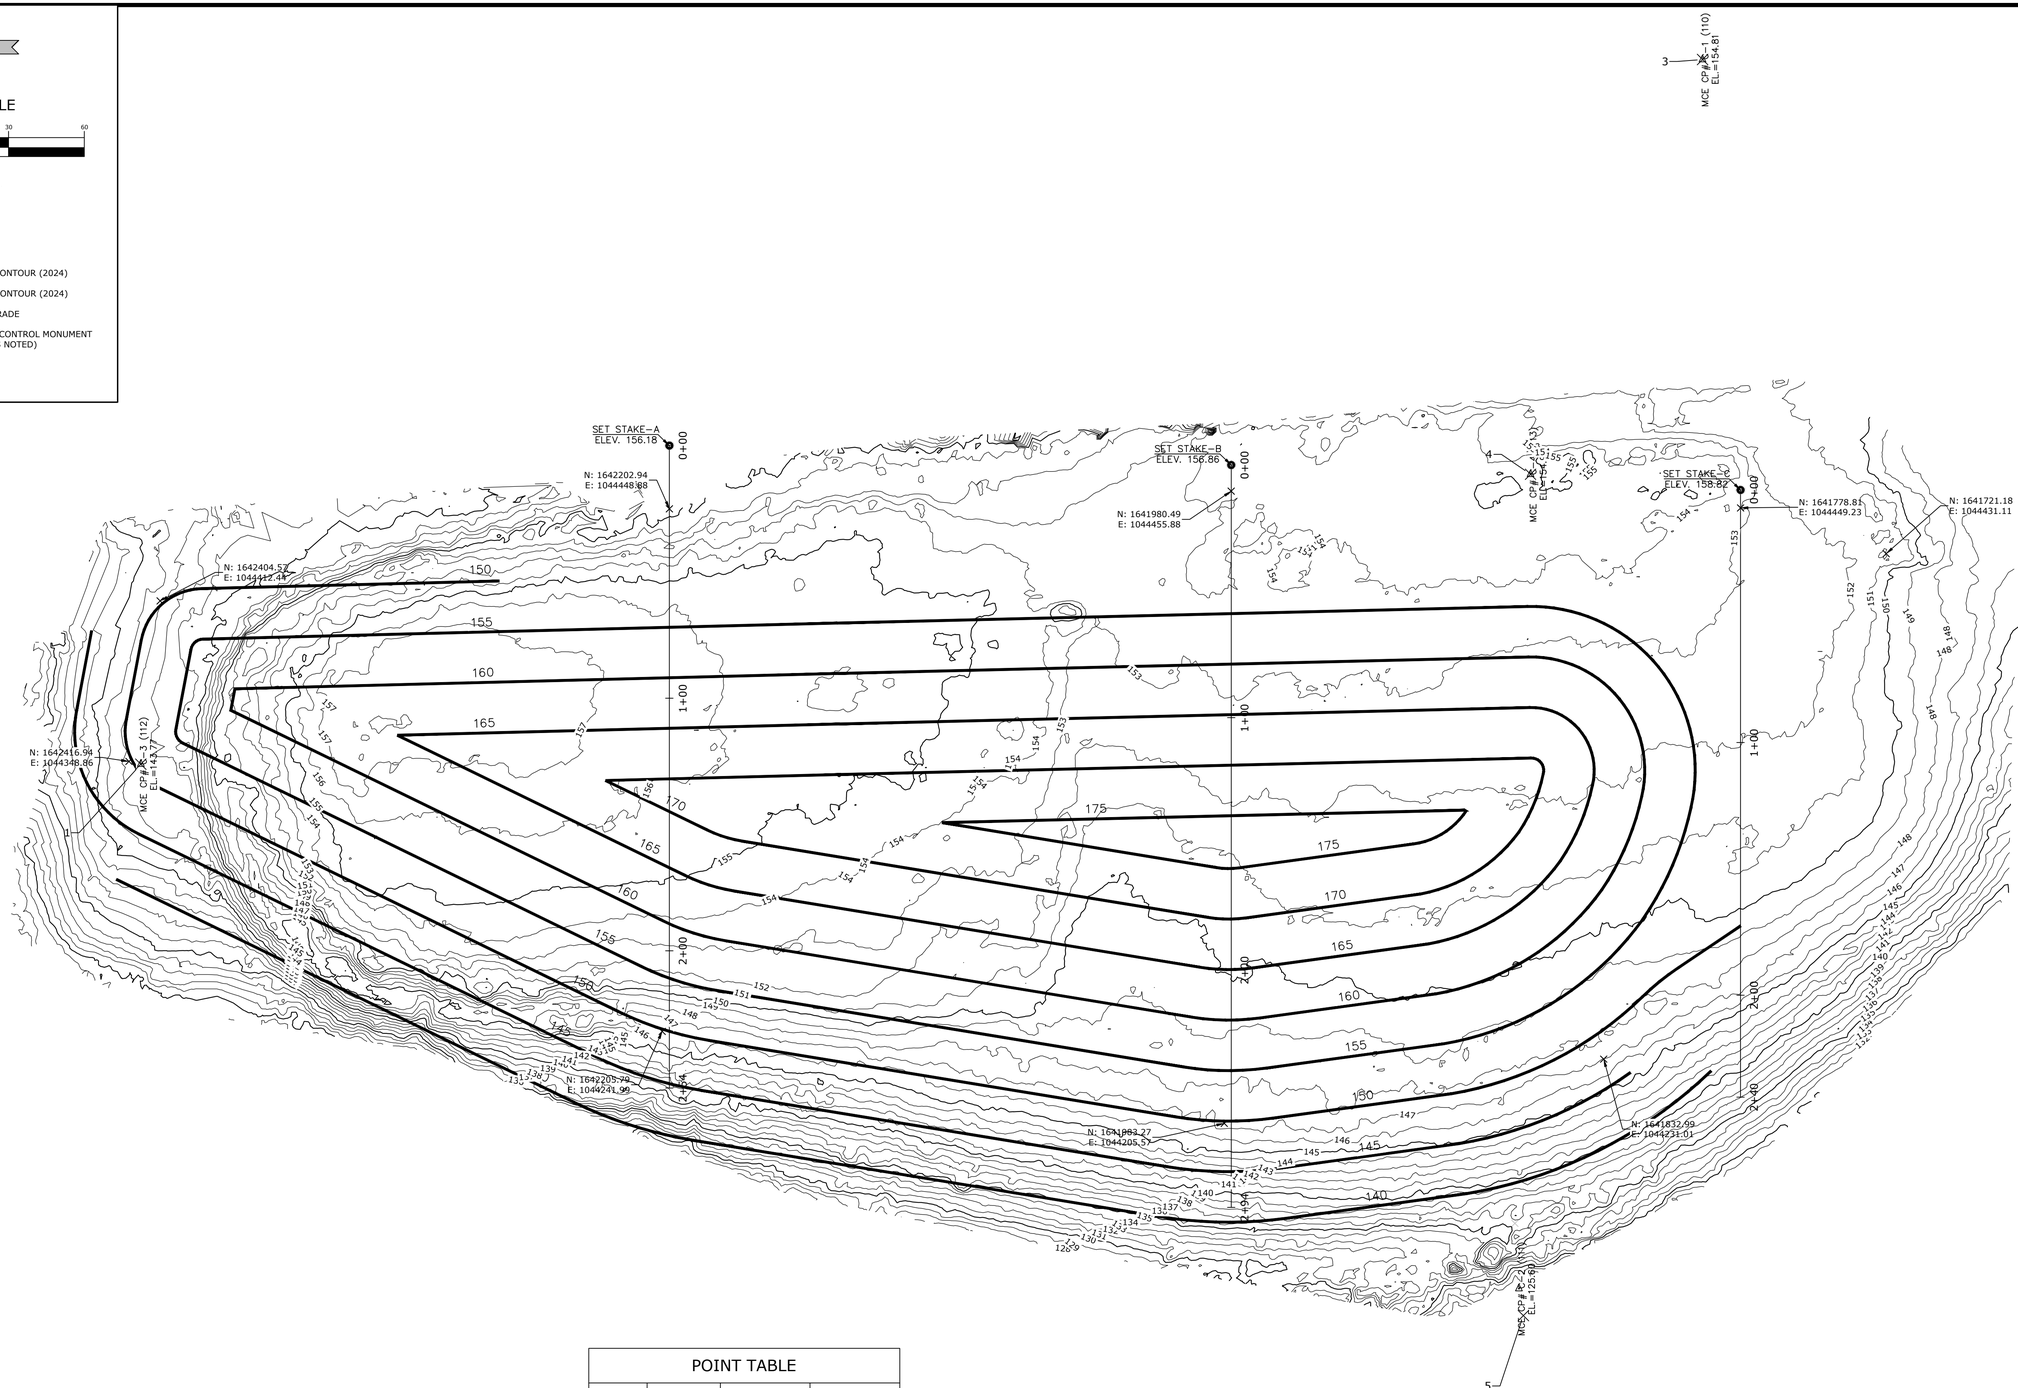
SURFACE COMPARISON 2024/ULTIMATE

Please note that we have recalculated the remaining area (volume) left compared to the Final permitted surface. The remaining volume is approximately 36,385 cu.yds. Based on this volume, approximately 5 years are remaining in space. This could certainly change based on activity.
