2024 Annual Engineering Inspection Report

Perry County Class 4 Landfill

Permit No. 0264-S

July 25, 2025 | Terracon Project 35257143

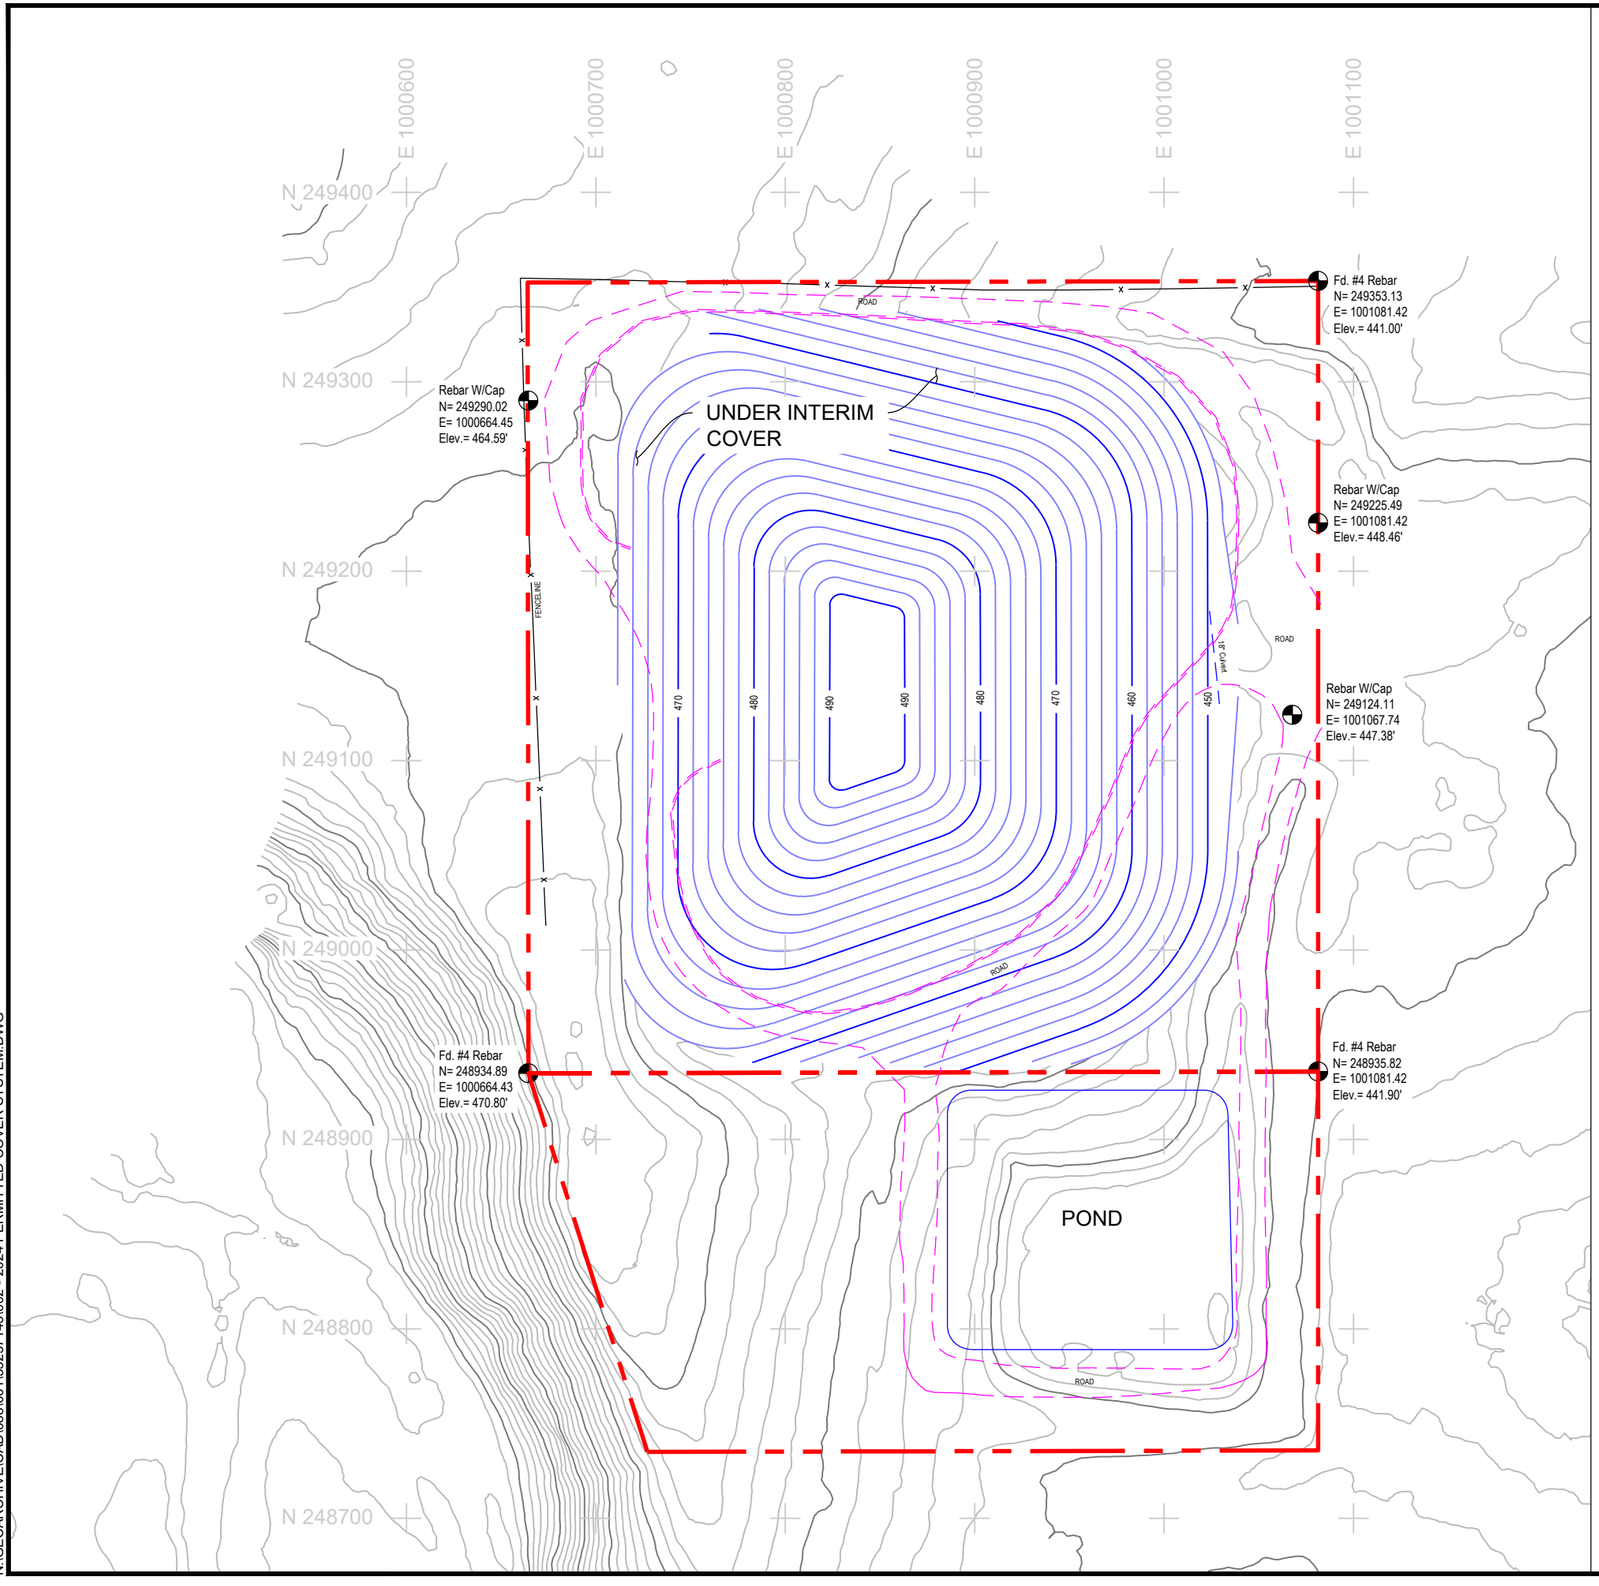
FIGURE 2

PERMITTED FINAL WASTE GRADES
2024 ANNUAL ENGINEERING INSPECTION REPORT
PERRY COUNTY
PERRY COUNTY CLASS 4 LANDFILL
CASA ARKANSAS
