2024 Annual Engineering Inspection Report

Cedar Glades Class 4 Landfill
Permit No. 0300-S4
AFIN: 26-00405

June 27, 2025

Terracon Project No. 35257045

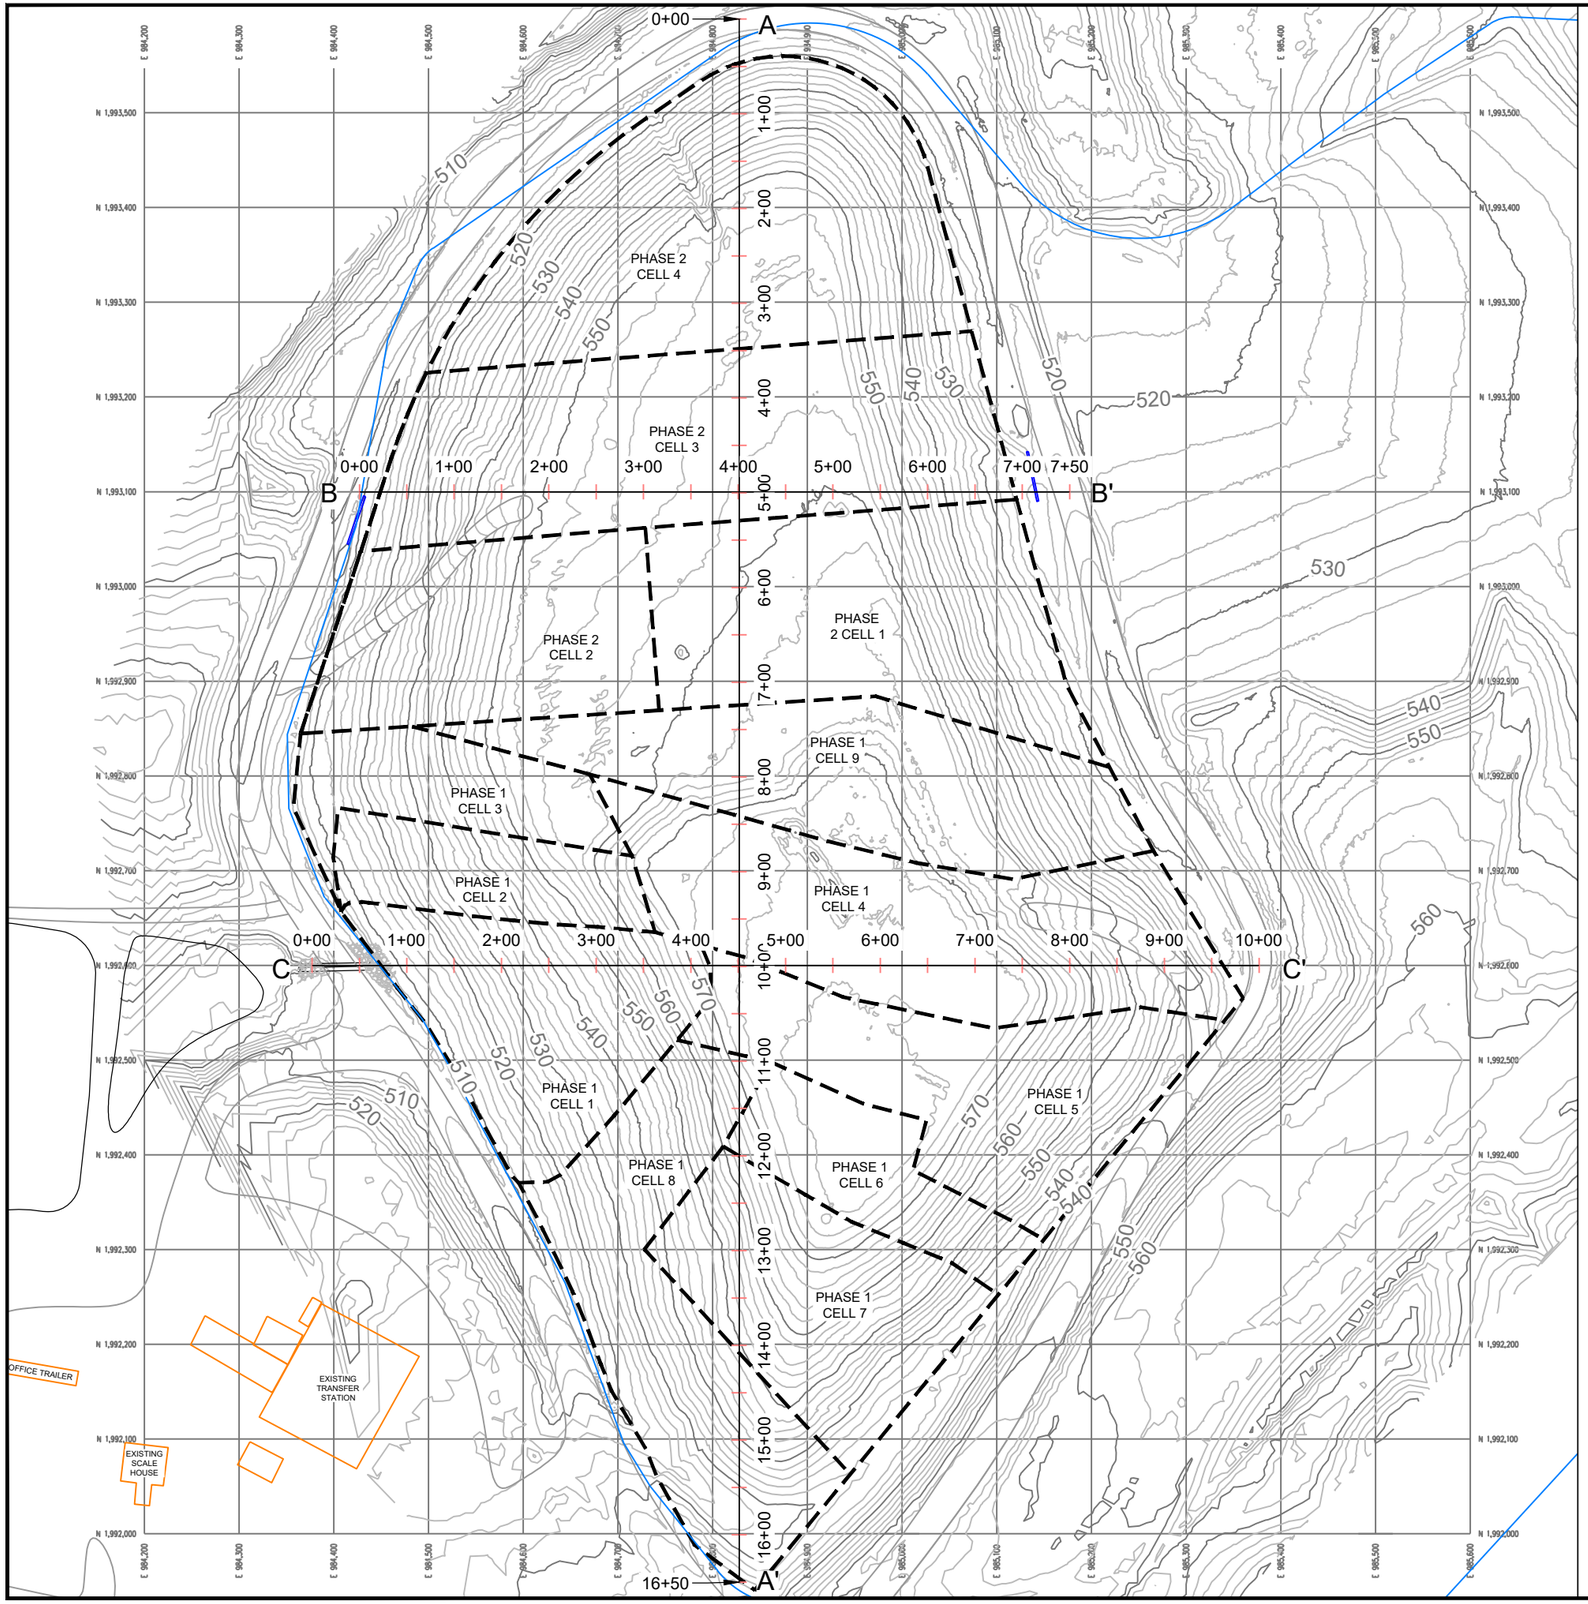
Looking south across top deck of landfill

Looking southeast at active fill area of landfill
