RE: Revised Overfill Management Plan
Garland County Cedar Glades Class 4 Landfill
Permit# 0300-S4; AFIN 26-00405
Terracon Project No. 35247209

ISOPACH CONTOURS WITH GRADE STAKING POINTS

CROSS SECTIONS SHOWING FINAL COVER GRADES

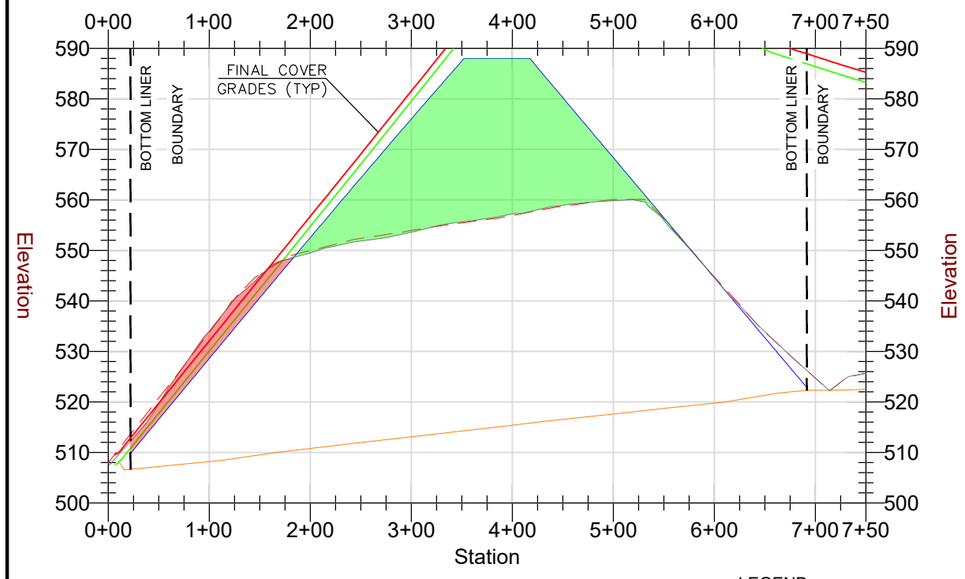
ALIGNMENT B-B'

Roadway materials and supporting soil have also been placed above the finished final waste grades slope along the western portions of Phase 2, Cell 2 and Phase 2, Cell 3. Fill from the roadway construction is visible on cross section B-B' on attached Figure 4. If portions of overfill in this area are not associated with the ingress/egress operational road and are not in place to support the access road, they will also be removed to within the final waste grades within 30 days of the DEQ approval of this OFMP.
