**DATE:** January 7, 2026

**TO:** Emily Brickman, P.G., *Senior Project Manager – Geologist, EnSafe*

**FROM:** Caleb Gourley, *Senior Staff Scientist, Harbor*

**RE:** Bi-weekly Site Inspection  
NABORS Landfill  
Mountain Home, AR  
*Harbor Project No: L8247885*

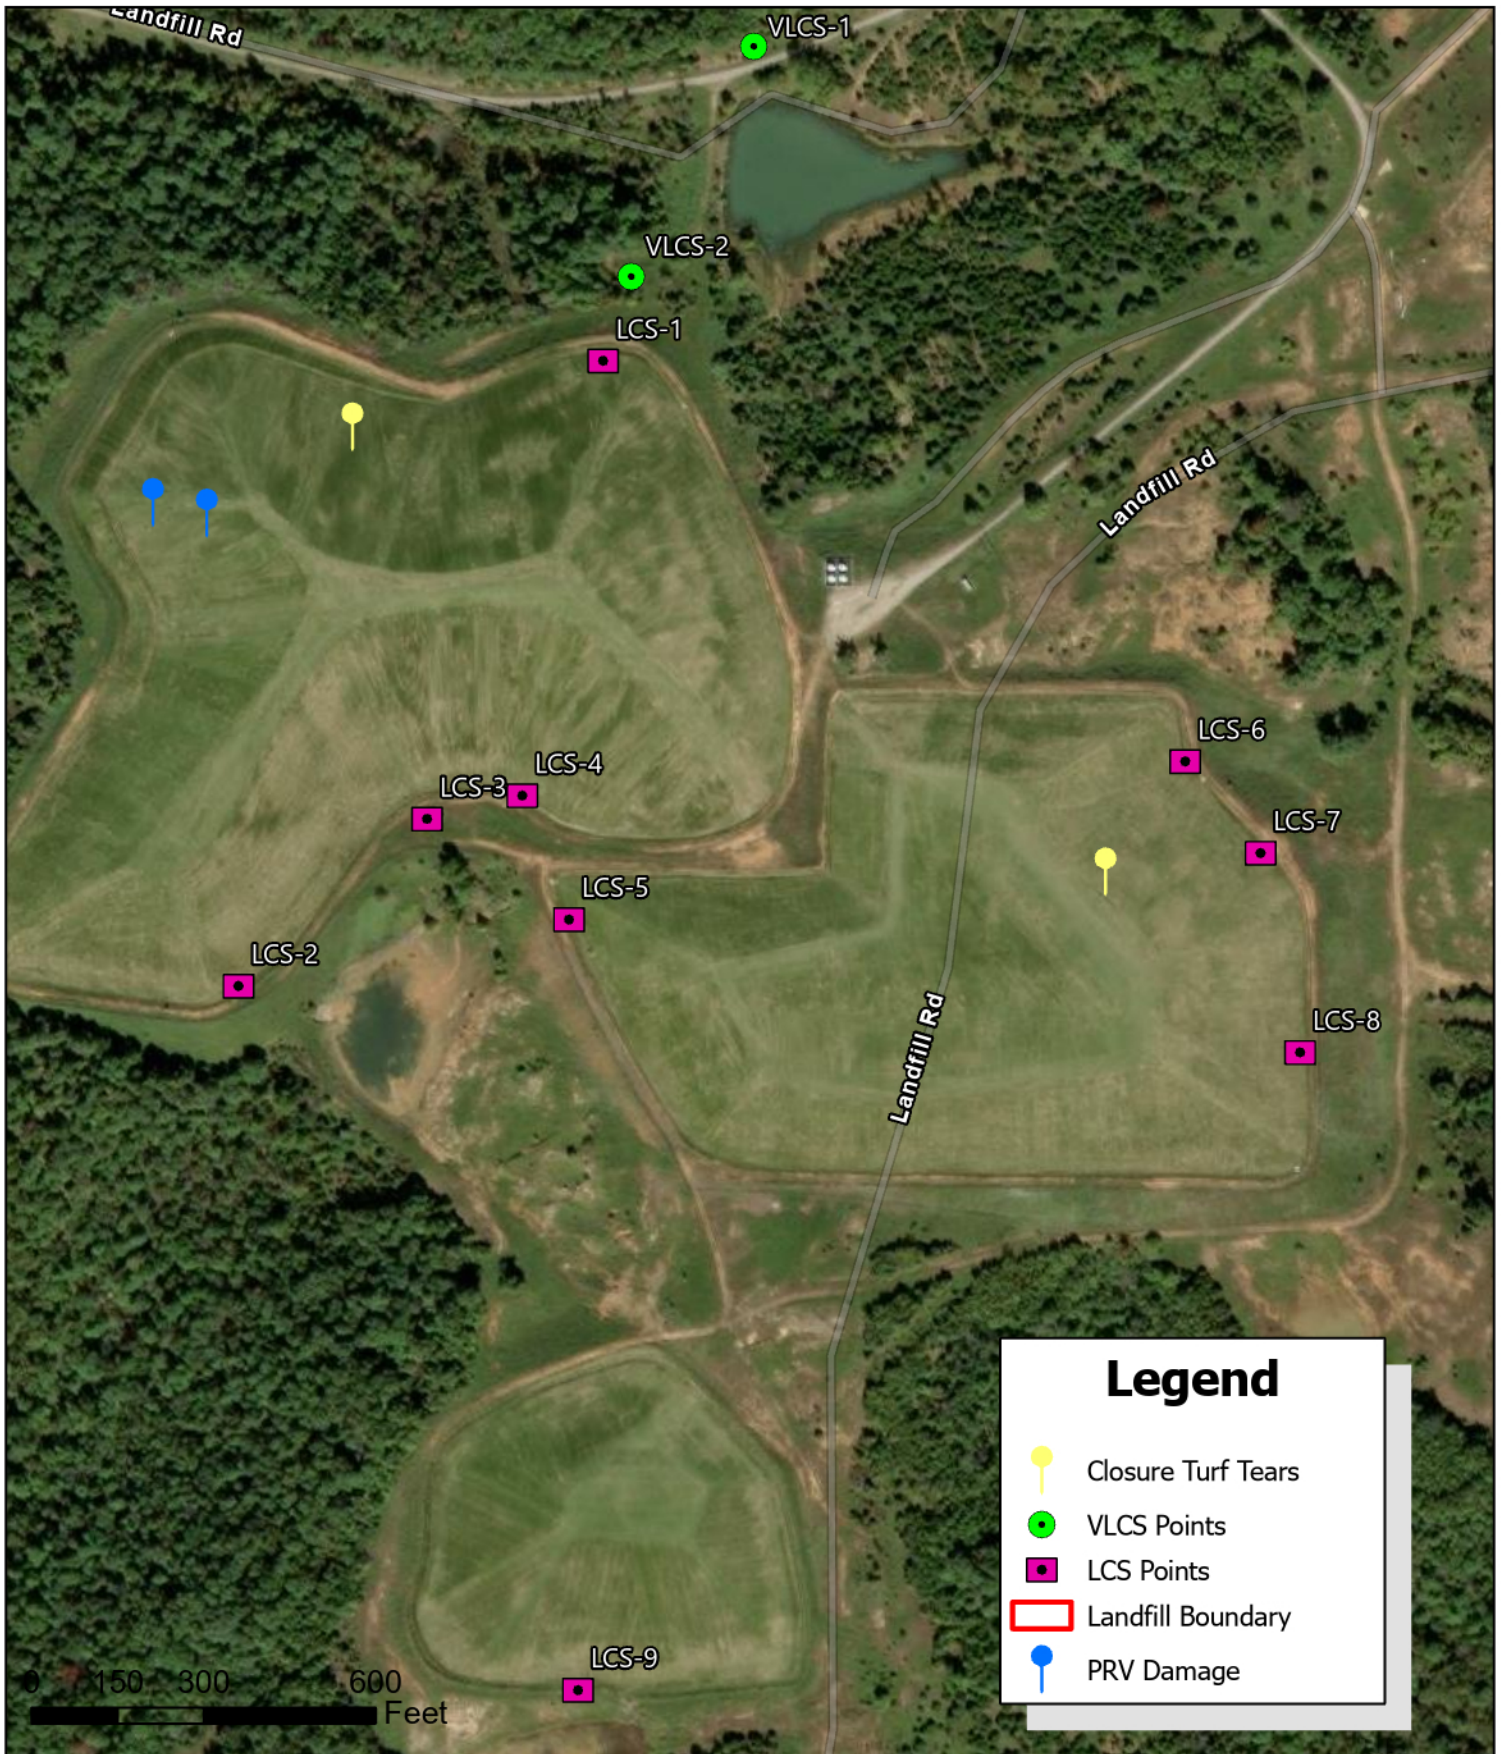
**Site Map**

- An erosional washout is present along the road between LCS-4 and LCS-5.
- Two damaged pressure relief vents (PRV) were observed on the west side of Area 1-2, between LCS-1 and LCS-2. The damage is located near coordinates 36.46144, -92.45128.

- Damaged closure turf was observed on the north side of Area 1-2 at coordinates 36.46181, -92.45045. The damage is approximately 30 feet long by 3 feet wide. The damage was first observed on July 2, 2025.

- Damaged closure turf was observed on the east side of Area 1-3, above LCS-7. The damage is approximately 100 feet long by 9 feet wide. The closure turf tear was first observed on June 17, 2025.
