**RE: Inspection conducted on June 16, 2022**  
**AFIN 66-00226**  
**Permit Number 0267-S1-R1**

**Office of Land Resources  
Regulated Waste Operations  
Class 1 Landfill Inspection Form**

| <b>Site Name</b> | City of Fort Smith Class 1 Landfill | <b>County</b> | Sebastian | <b>AFIN</b> | 66-00226 |

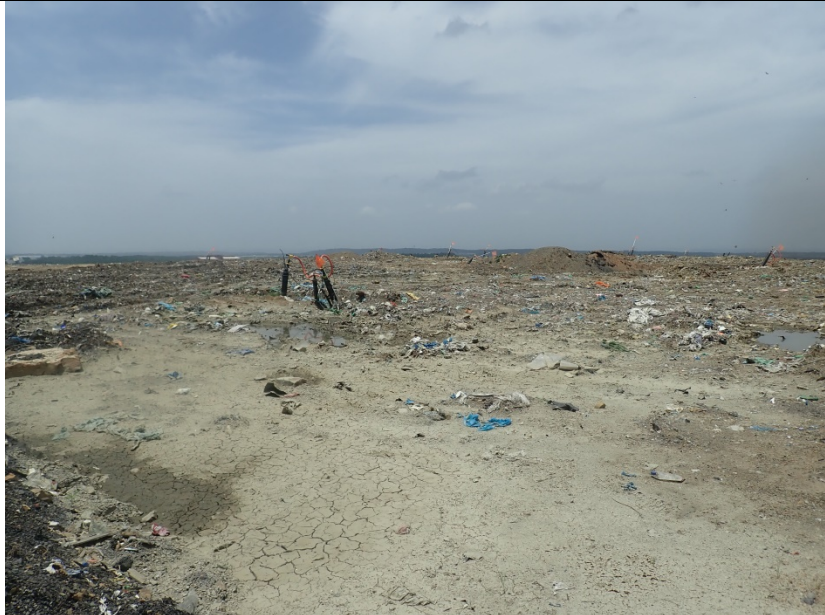
| <b>Photo #</b> | 1 | <b>Of</b> | 4 | | <b>Date</b> | 6/16/2022 | <b>Time</b> | 1240 |

| | <b>Regulation</b> | <b>Item Description</b> | <b>Comments</b> |
|---|---|---|---|
| X | 413(a)(b)(c) | Satisfactory Daily/Alternate/Intermediate Cover | Solid waste exposed on the southern top of the landfill observed. (Refer to Photos #1 - #4.) |

| <b>Description</b> | A view of exposed solid waste on the top southern portion of the landfill. | | | | | | | |

You should immediately initiate actions to correct the alleged violations cited. A written response of the corrective actions taken, or to be taken, must be submitted within thirty (30) calendar days from the date on this letter to the attention of Jason Gilkey. The response may include, but is not limited to, photographs, copies of disposal receipts, records, or analytical results, as applicable. If you have any questions regarding the alleged violations, please do not hesitate to contact me at (501) 993-7188 or [jason.gilkey@adeq.state.ar.us](mailto:jason.gilkey@adeq.state.ar.us).

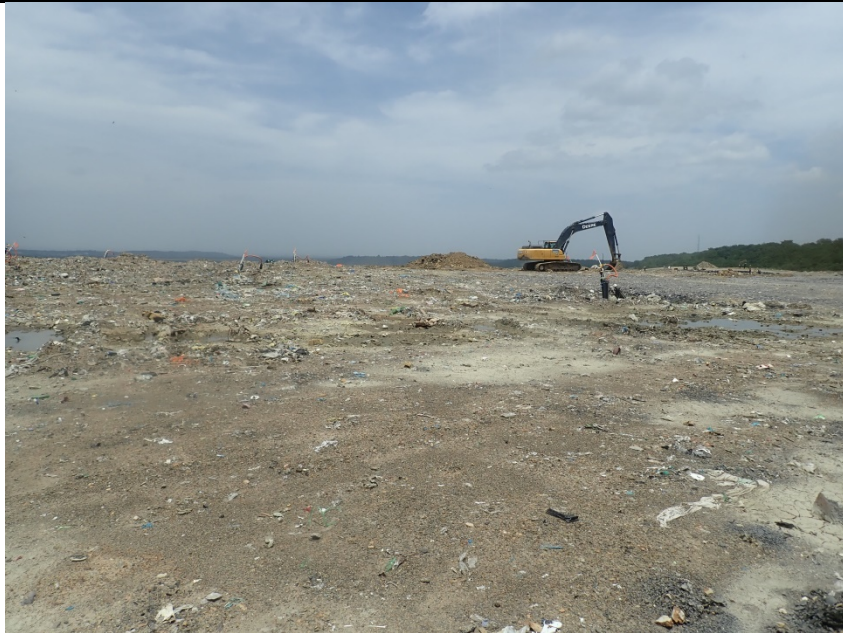
| <b>Photo #</b> | 2 | <b>Of</b> | 4 | | <b>Date</b> | 6/16/2022 | <b>Time</b> | 1240 |

| <b>Description</b> | Another view of exposed solid waste on the top southern portion of landfill. | | | | | | | |

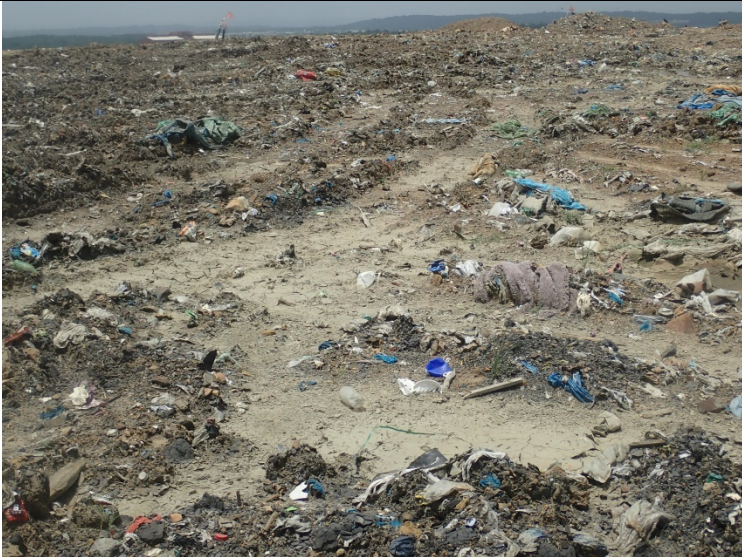
| <b>Photo #</b> | 3 | <b>Of</b> | 4 | | <b>Date</b> | 6/16/2022 | <b>Time</b> | 1240 |

| <b>Description</b> | Another view of exposed solid waste on the top southern portion of the landfill. | | | | | | | |

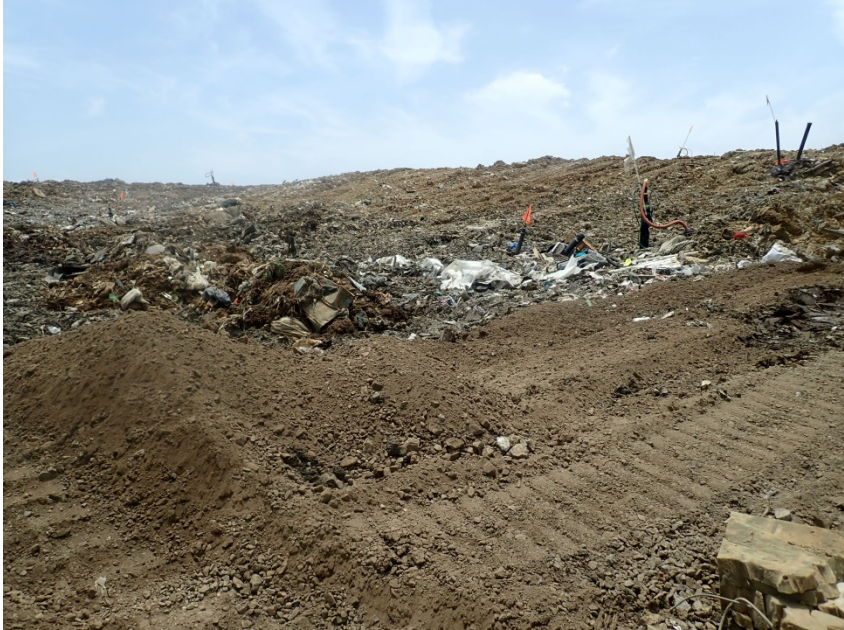
| <b>Photo #</b> | 4 | <b>Of</b> | 4 | | <b>Date</b> | 6/16/2022 | <b>Time</b> | 1237 |

| <b>Description</b> | Another view of exposed solid waste on the top northern portion of the landfill. | | | | | | | |
