RE: City of Siloam Springs Inspection – PDS# 131026 (Benton Co.)  
AFIN: 04-00106 Permit No.: AR0020273

| <b>ENVIRONMENTAL<br/>QUALITY</b> | <b>OFFICE OF WATER QUALITY<br/>INSPECTION REPORT</b> | | |

**SUMMARY OF FINDINGS**

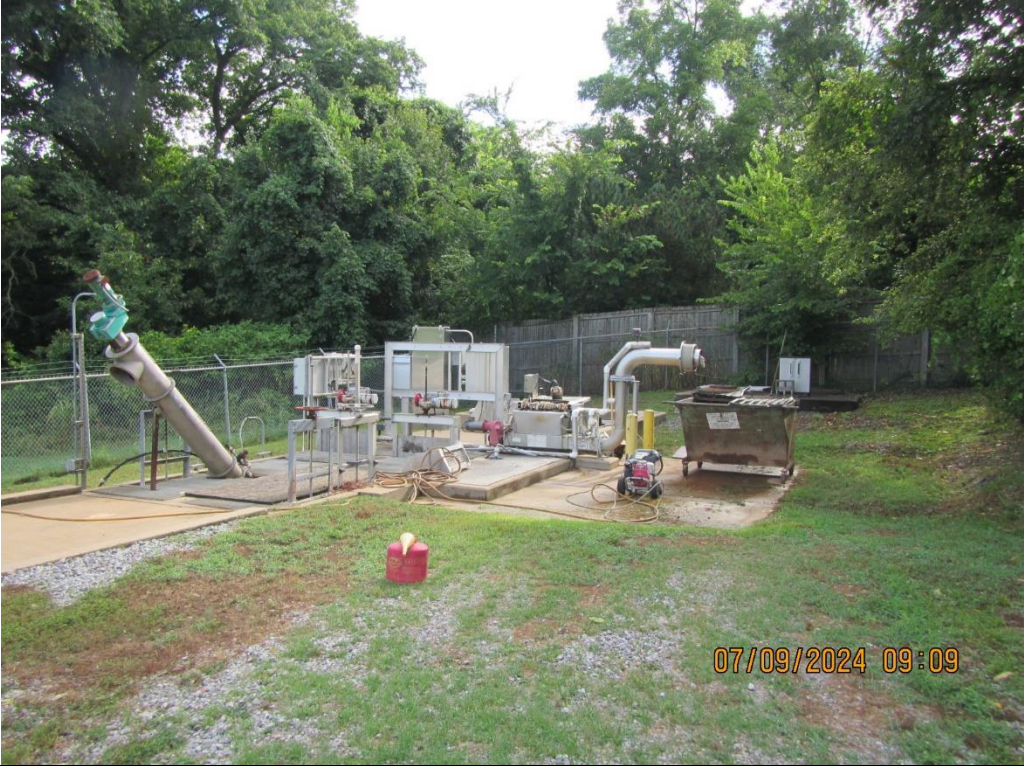
| Office of Water Quality Photographic Evidence Sheet | | | |
|---|---|---|---|
| | | Photo #: | <b>1</b> |

The facility is currently planning to redesign the headworks with an approximate start date of early 2025. The facility will be working with McClelland Consulting Engineers and Garney Construction. There is a moderate build-up of rags/solids at the influent bar screen before the grit removal area. Rags and other solids are loaded into a wheel barrow and placed in a dumpster. It appears that the excess build-up of rags and solids have potential to fall over the top of the concrete and be placed on the ground. It is requested that the bar screen materials be adequately cleaned up and removed. There are cracks in the concrete near the influent bar screen, which Mr. Brown mentioned they already have plans to remediate this with the headworks upgrade.

| Office of Water Quality Photographic Evidence Sheet | | | |
|---|---|---|---|
| Description: | <b>Facility headworks – planning for upgrade to start by the beginning of next year.</b> | | |

2. As mentioned during the inspection, the City of Siloam Springs is working with McClelland Consulting Engineers, Inc. (MCE), and Garney Construction to redesign the headworks to include a new influent pipe to replace the current open Parshall flume design. The target start date is set for 2025, and when final plans/drawing are approved an update will be provided to the Arkansas Department of Energy and Environment.

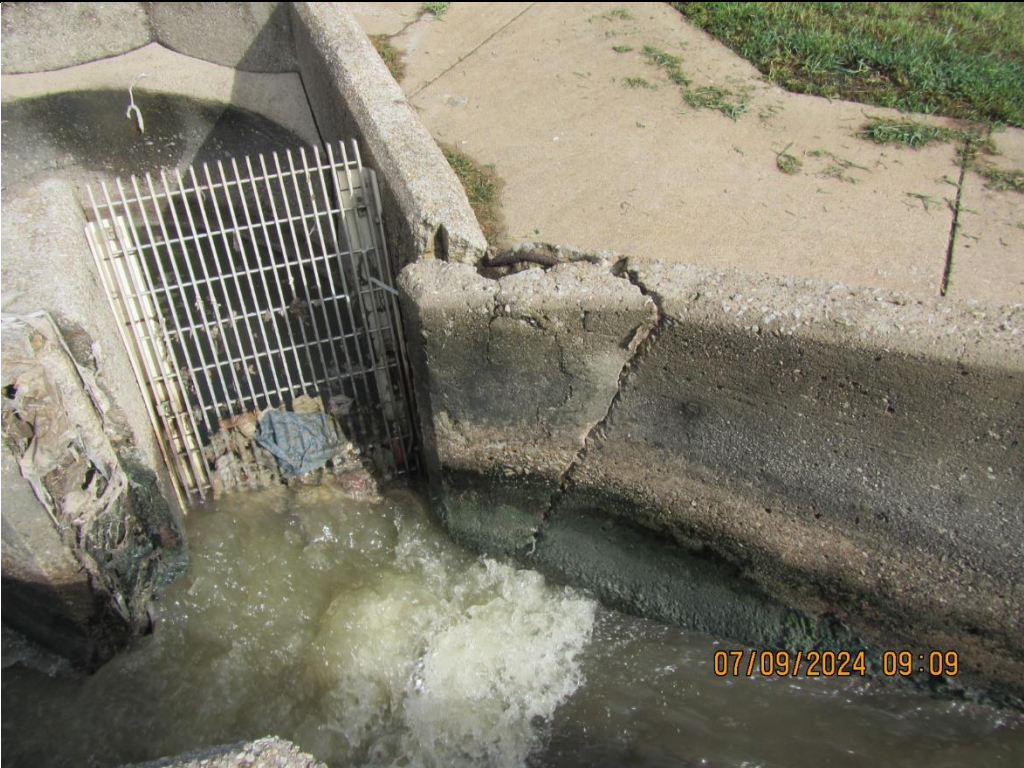
| Office of Water Quality Photographic Evidence Sheet | | | |
|---|---|---|---|
| | | Photo #: | <b>2</b> |

1. There is moderate build-up of influent rags/screenings at the influent bar screen. It is requested that this build-up be kept to a minimum to ensure proper operation and maintenance.
2. There are cracks in the concrete at the influent flume/bar screen. It is requested that an update be provided once plans are established to have this remediated in the headworks upgrade.

| Office of Water Quality Photographic Evidence Sheet | | | |
|---|---|---|---|
| Description: | <b>One section of cracked concrete at the influent bar screen area.</b> | | |

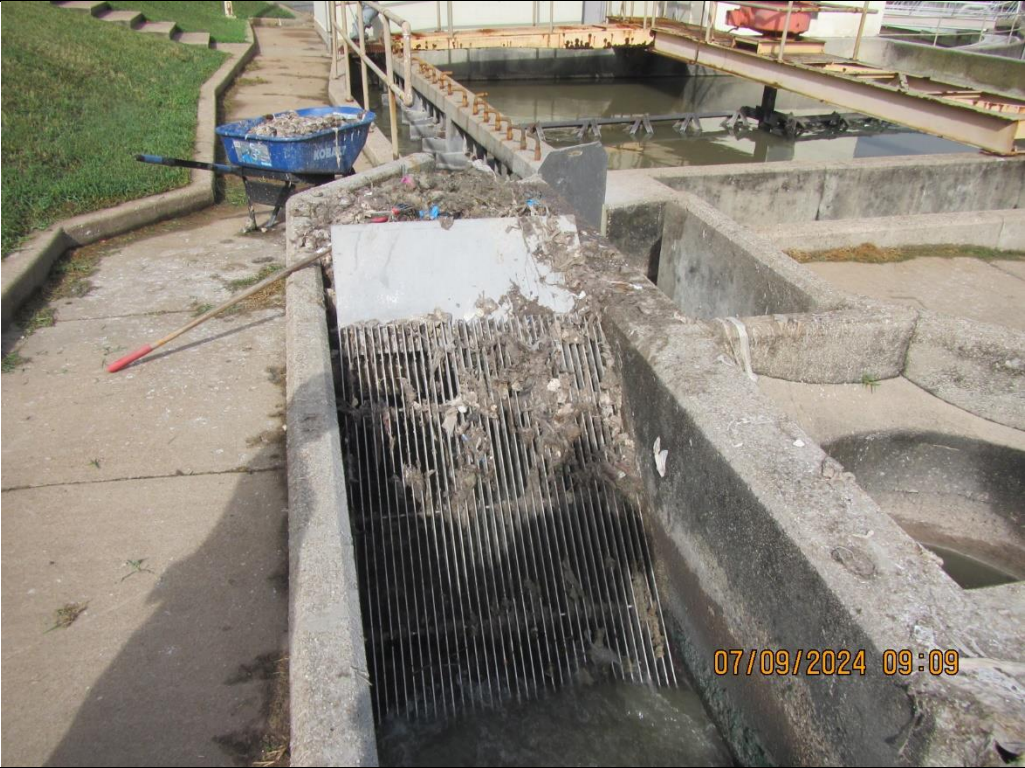
| Office of Water Quality Photographic Evidence Sheet | | | |
|---|---|---|---|
| | | Photo #: | <b>3</b> |

| Office of Water Quality Photographic Evidence Sheet | | | |
|---|---|---|---|
| Description: | <b>Influent bar screen with build-up of screenings/other material.</b> | | |

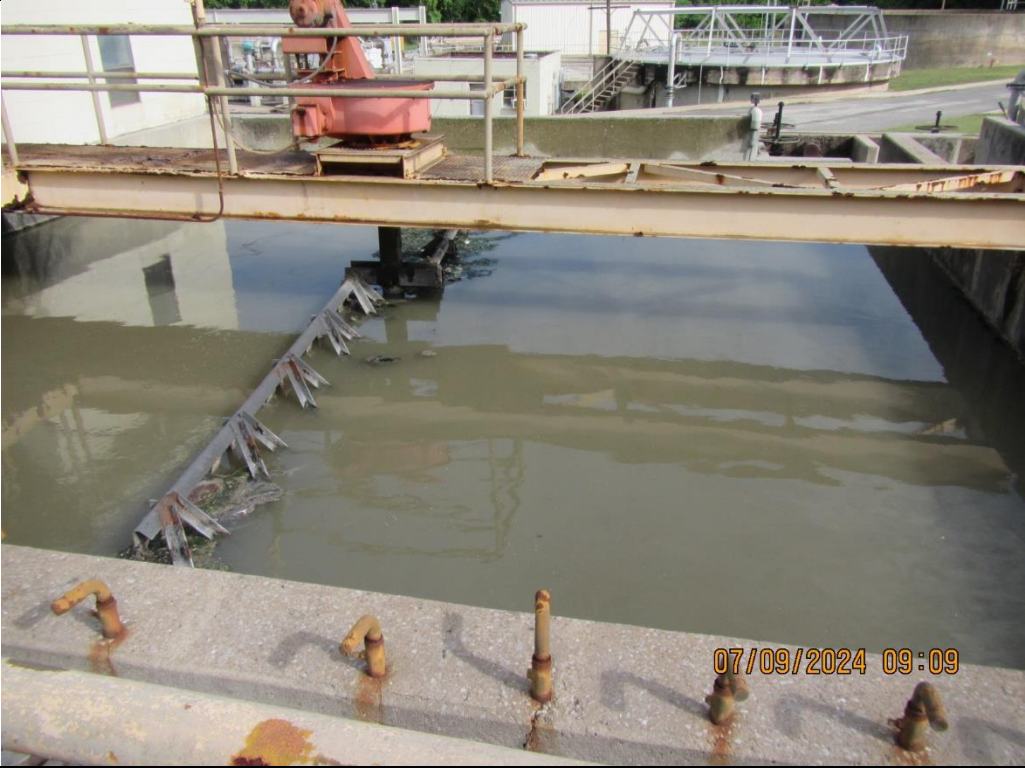
| Office of Water Quality Photographic Evidence Sheet | | | |
|---|---|---|---|
| | | Photo #: | <b>4</b> |

| Office of Water Quality Photographic Evidence Sheet | | | |
|---|---|---|---|
| Description: | <b>Grit chamber area not in operation.</b> | | |

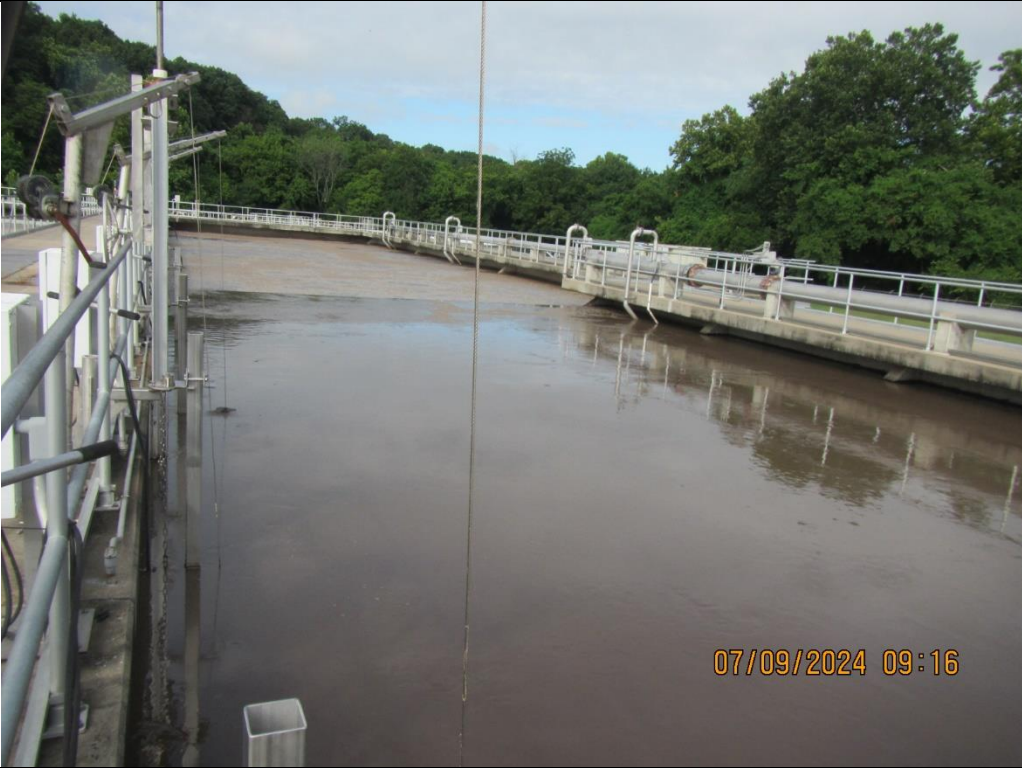
| Office of Water Quality Photographic Evidence Sheet | | | | | |
|---|---|---|---|---|---|
| Witness: | <b>Tony Brown, Austin Hawes</b> | | | Photo #: | <b>5</b> |

The facility utilizes centrifugal blowers to provide air to the Biological Nutrient Removal (BNR) treatment. There are two anaerobic zones, three anoxic zones, an aeration zone, and the ability to re-introduce wastewater into this treatment process to get ammonia and phosphorous numbers down. There are two additional sections of the BNR that are currently out of operation; however, only the one operating section is adequate for treatment. Following the BNR is a splitter box that includes Aluminum Chlorohydrate, and the wastewater can be sent to either of two final clarifiers. There is also a Return Activated Sludge and Waste Activated Sludge pipe at the splitter box where RAS can be returned to the system and WAS can be wasted. The final clarifiers utilize surface sprayers and has covers over the v-notch weirs to prohibit algae growth.

| Office of Water Quality Photographic Evidence Sheet | | | | | |
|---|---|---|---|---|---|
| Description: | <b>BNR treatment process – one of three cells, this is the only in operation currently.</b> | | | | |

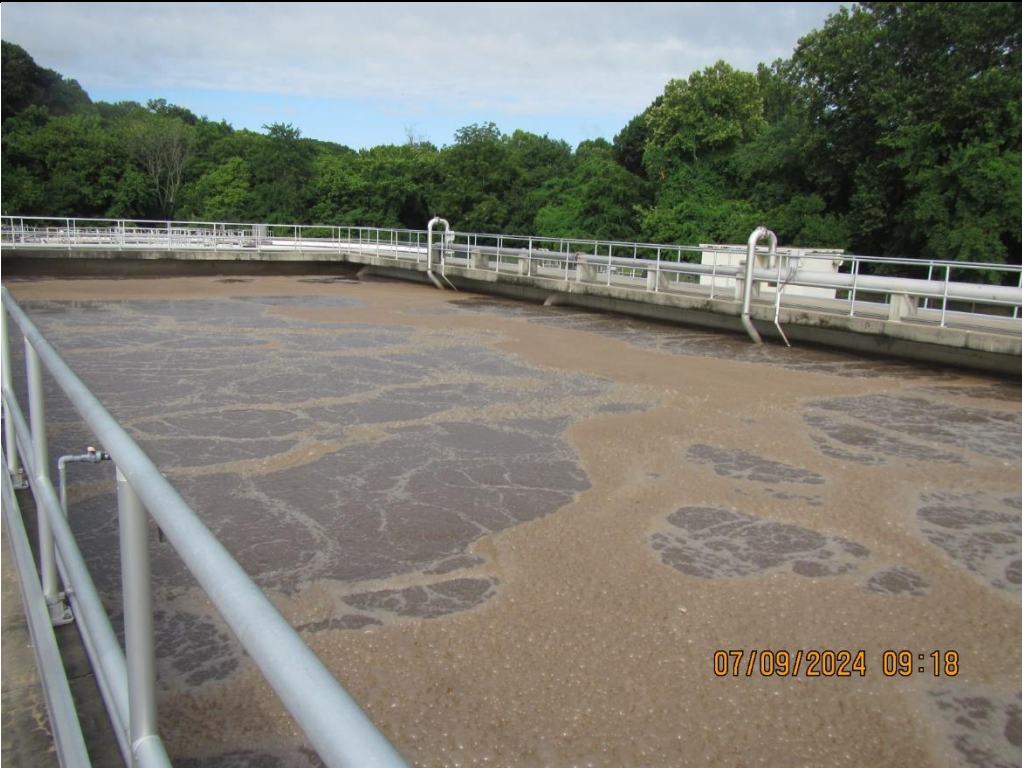
| Office of Water Quality Photographic Evidence Sheet | | | | | |
|---|---|---|---|---|---|
| Witness: | <b>Tony Brown, Austin Hawes</b> | | | Photo #: | <b>6</b> |

| Office of Water Quality Photographic Evidence Sheet | | | | | |
|---|---|---|---|---|---|
| Description: | <b>Additional view of the BNR – aeration zone.</b> | | | | |

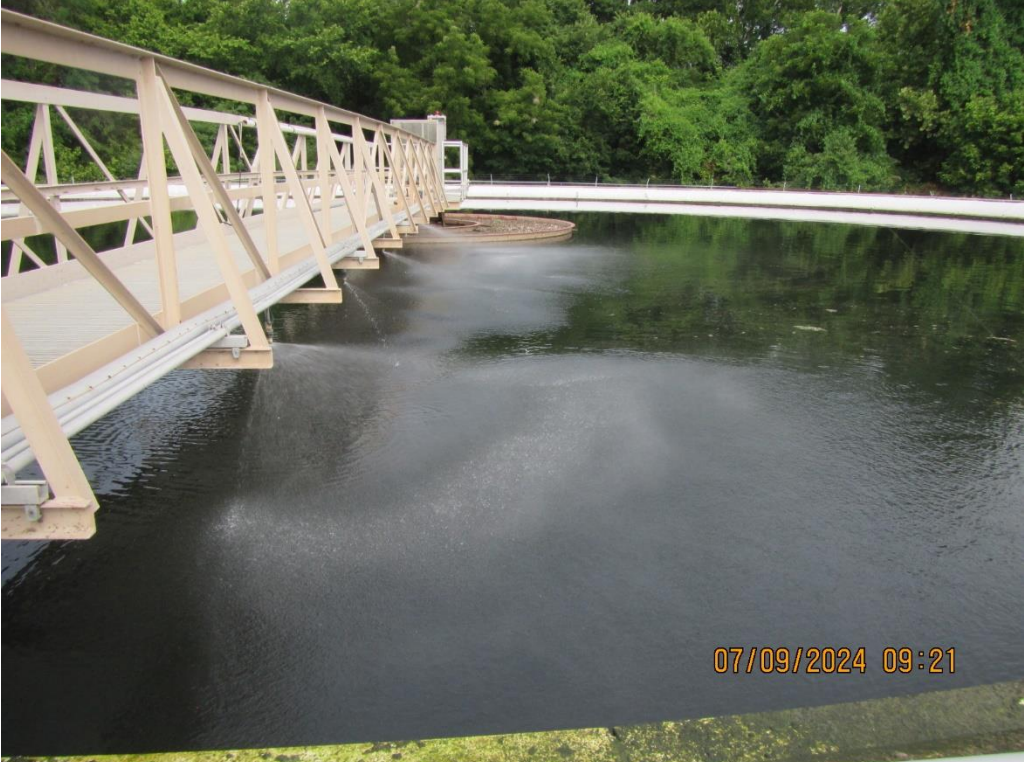
| Office of Water Quality Photographic Evidence Sheet | | | |
|---|---|---|---|
| Photo #: | <b>7</b> | | |

| Office of Water Quality Photographic Evidence Sheet | | | |
|---|---|---|---|
| Description: | <b>One of two final clarifiers with surface sprayers and covers over the v-notch weirs.</b> | | |

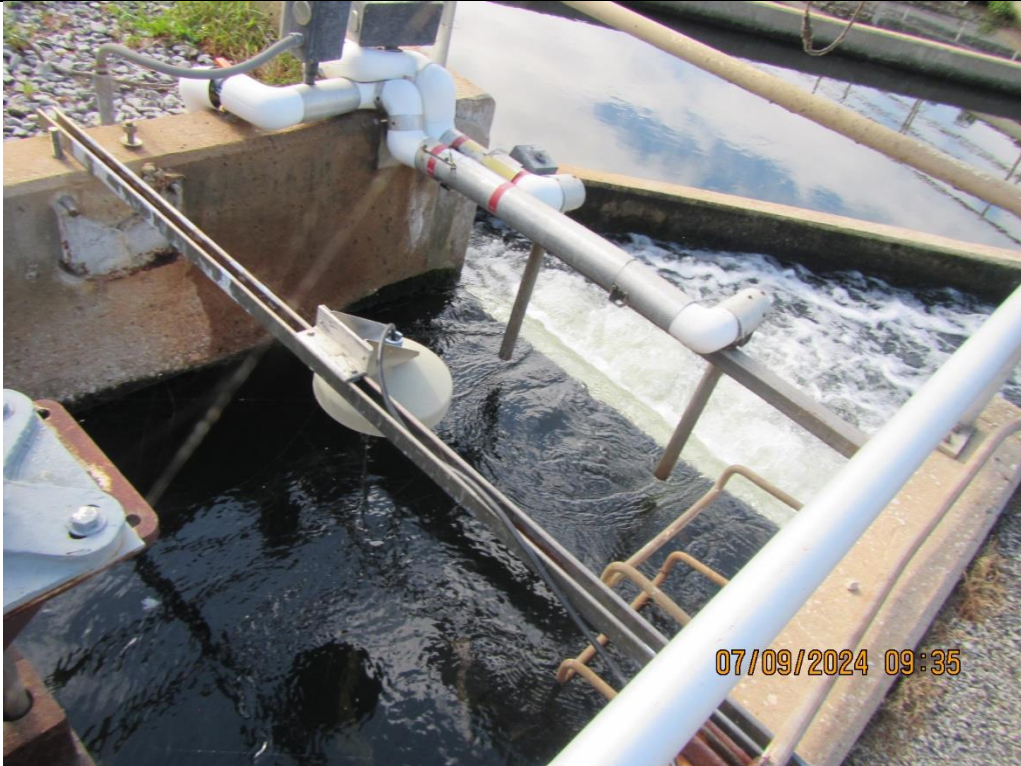
| Office of Water Quality Photographic Evidence Sheet | | | |
|---|---|---|---|
| | | Photo #: | <b>9</b> |

| Office of Water Quality Photographic Evidence Sheet | | | |
|---|---|---|---|
| Description: | <b>Location of flow meter and manual flow reading.</b> | | |

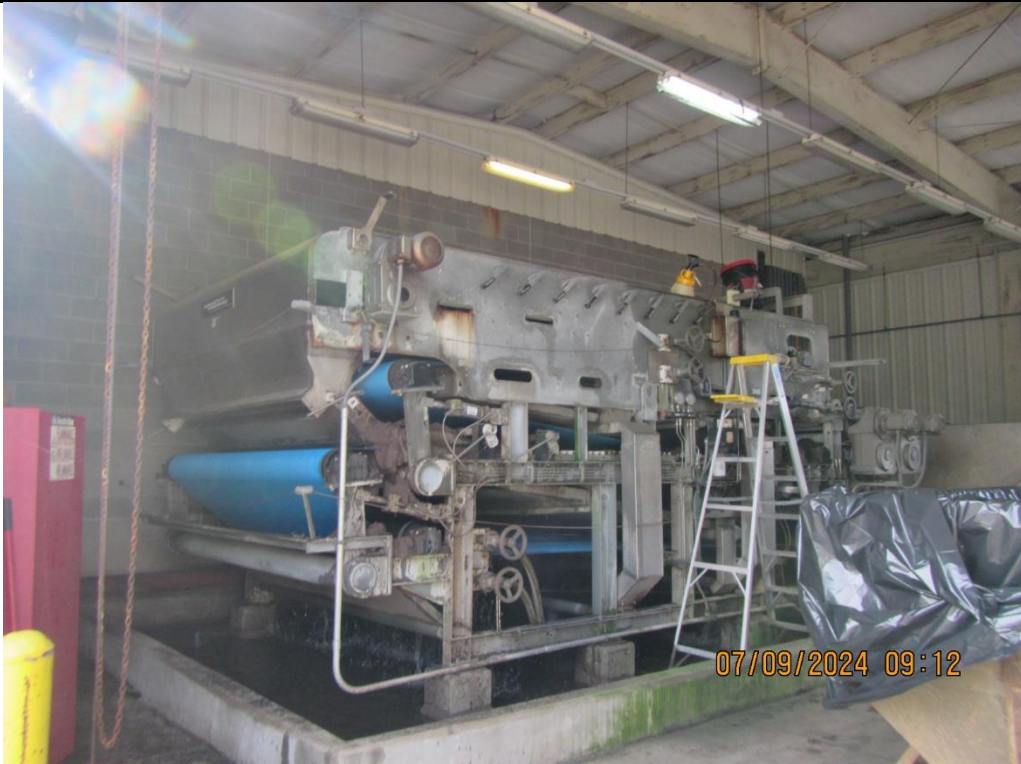
| Witness: | <b>Tony Brown, Austin Hawes</b> | | | Photo #: | <b>10</b> |

| Description: | <b>Solids handling belt feed press.</b> | | | | |

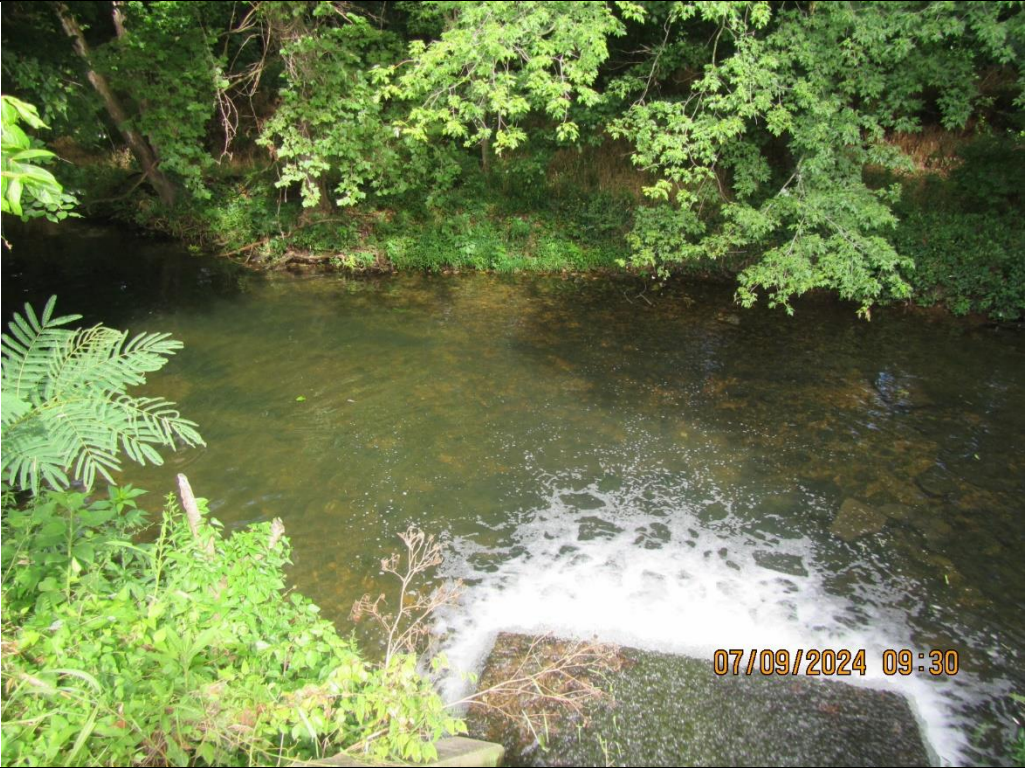
| Office of Water Quality Photographic Evidence Sheet | | | |
|---|---|---|---|
| | | Photo #: | <b>11</b> |

The facility utilizes chlorination and de-chlorination chambers following the final clarifiers before discharging through Outfall 001. There is minor vegetative growth in the chlorination/de-chlorination chamber; however, it does not appear that this impacts the final effluent. The outfall is clear of debris and has a clear, clean discharge.

| Office of Water Quality Photographic Evidence Sheet | | | |
|---|---|---|---|
| Description: | <b>Outfall 001.</b> | | |
