RE: City of Siloam Springs Inspection – PDS# 131027 (Benton Co.)  
AFIN: 04-00106 Permit No.: AR0020273

On July 9, 2024, I performed a SSO/Collection System Inspection of the above referenced facility in accordance with the provisions of the Federal Clean Water Act, the Arkansas Water and Air Pollution Control Act, and the regulations promulgated thereunder. A copy of the inspection report is enclosed for your records.

| <b>COLLECTION SYSTEM INSPECTION AND OVERALL RATING</b> | | <input checked="" type="checkbox"/> S <input type="checkbox"/> M <input type="checkbox"/> U <input type="checkbox"/> NA <input type="checkbox"/> NE |

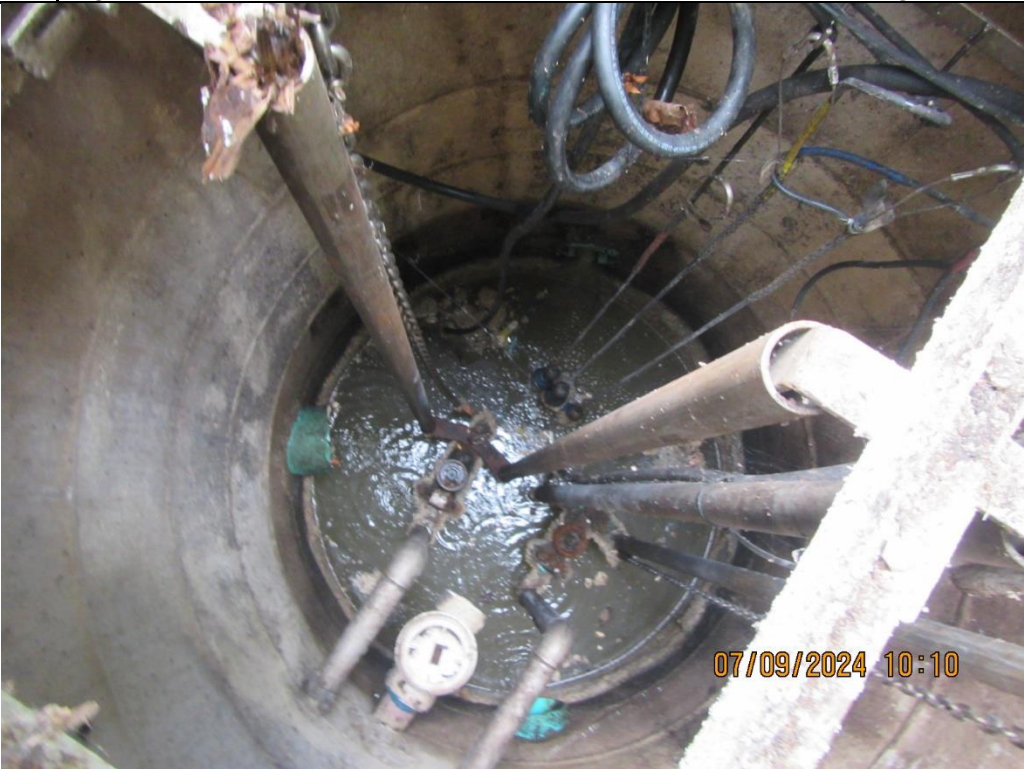
| Office of Water Quality Photographic Evidence Sheet | | | |
|---|---|---|---|
| | | Photo #: | 1 |

| <b>PUMP STATION VISIT (COMPLETE A SEPARATE CHECKLIST FOR EACH PUMP STATION VISITED)</b> | |
|---|---|
| MINIMAL ACCUMULATION OF GREASE AND SOLIDS IN WET WELLS: | <input checked="" type="checkbox"/> S <input type="checkbox"/> M <input type="checkbox"/> U <input type="checkbox"/> NA <input type="checkbox"/> NE |

| Office of Water Quality Photographic Evidence Sheet | | | |
|---|---|---|---|
| Description: | Eighteen Acres lift station with minor accumulation of solids and grease. | | |

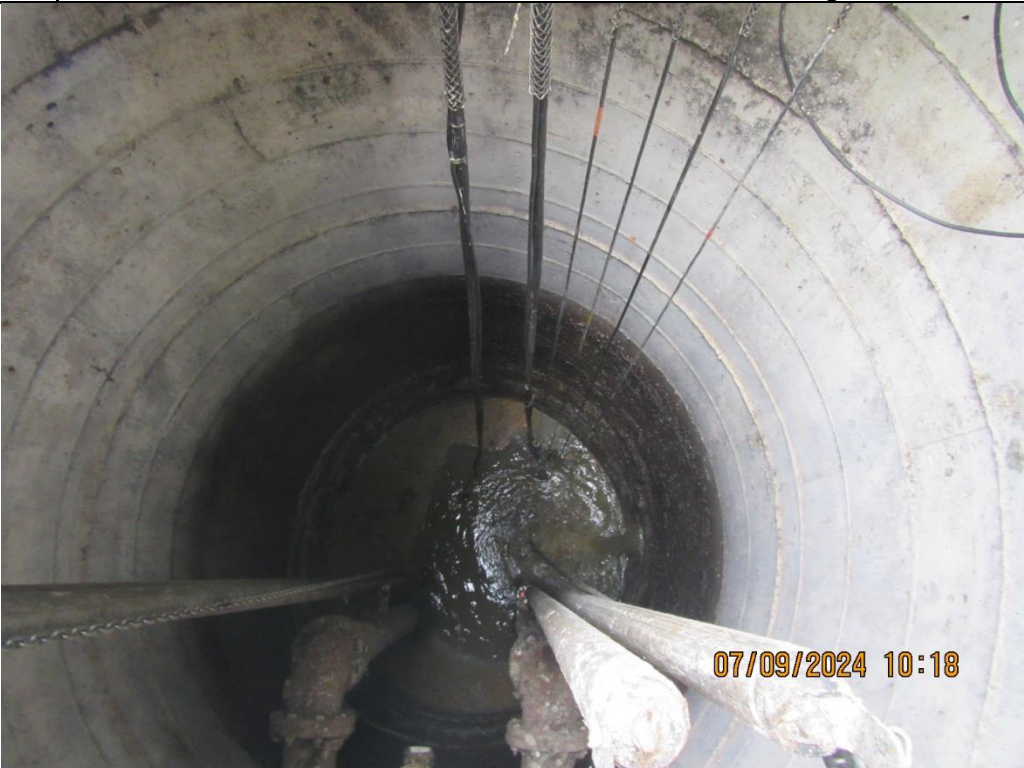
| Office of Water Quality Photographic Evidence Sheet | | | |
|---|---|---|---|
| | | Photo #: | 2 |

| <b>PUMP STATION VISIT (COMPLETE A SEPARATE CHECKLIST FOR EACH PUMP STATION VISITED)</b> | |
|---|---|
| MINIMAL ACCUMULATION OF GREASE AND SOLIDS IN WET WELLS: | <input checked="" type="checkbox"/> S <input type="checkbox"/> M <input type="checkbox"/> U <input type="checkbox"/> NA <input type="checkbox"/> NE |

| Office of Water Quality Photographic Evidence Sheet | | | |
|---|---|---|---|
| Description: | Villa View lift station with minor accumulation of solids and grease. | | |

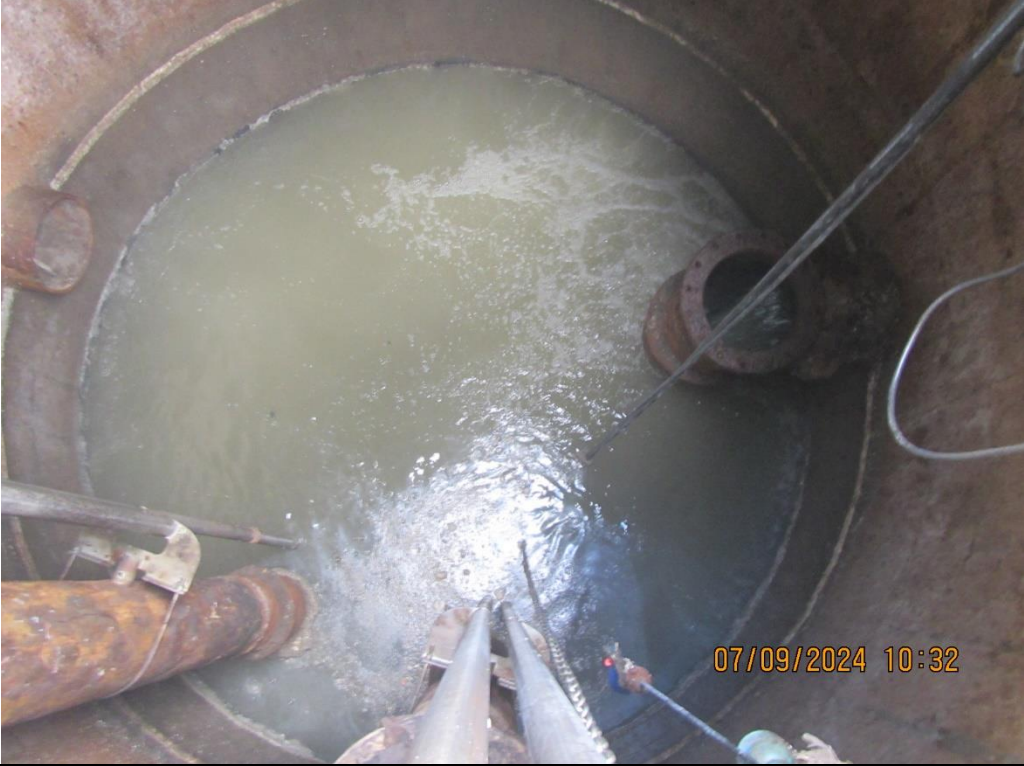
| Office of Water Quality Photographic Evidence Sheet | | | |
|---|---|---|---|
| Photo #: | 3 | | |

| <b>PUMP STATION VISIT (COMPLETE A SEPARATE CHECKLIST FOR EACH PUMP STATION VISITED)</b> | |
|---|---|
| MINIMAL ACCUMULATION OF GREASE AND SOLIDS IN WET WELLS: | <input checked="" type="checkbox"/> S <input type="checkbox"/> M <input type="checkbox"/> U <input type="checkbox"/> NA <input type="checkbox"/> NE |

| Office of Water Quality Photographic Evidence Sheet | | | |
|---|---|---|---|
| Description: | Simmons lift station with minor/no accumulation of solids and grease. | | |

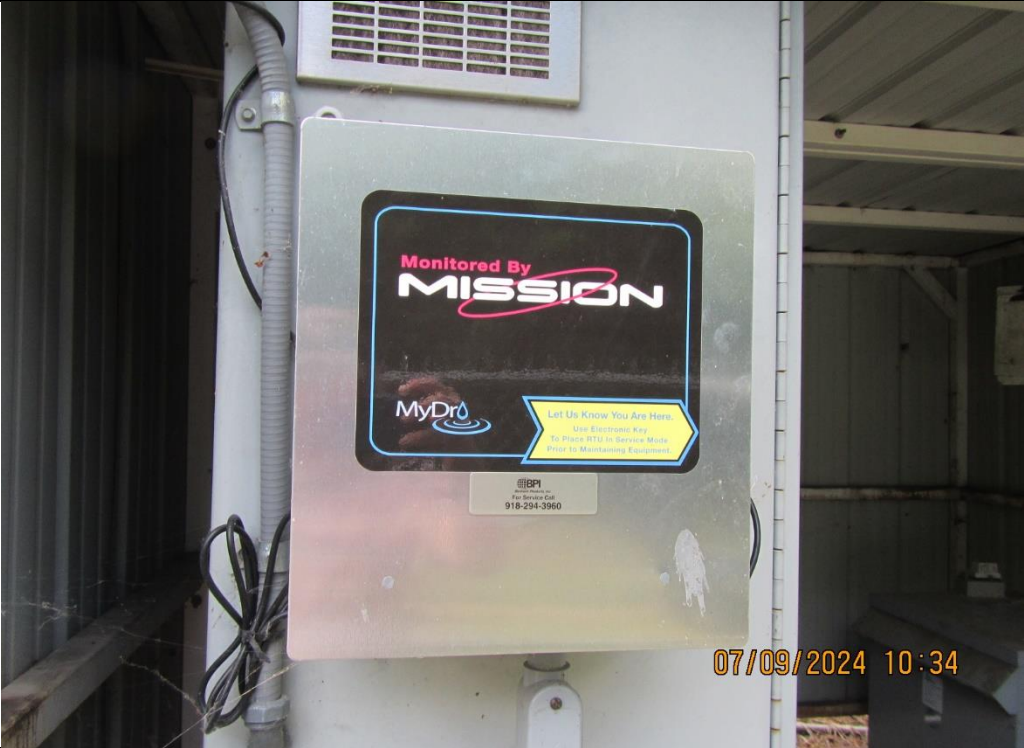
| Office of Water Quality Photographic Evidence Sheet | | | |
|---|---|---|---|
| Photo #: | 4 | | |

| Office of Water Quality Photographic Evidence Sheet | | | |
|---|---|---|---|
| Description: | Example of the Monitored by Mission system/program for collection system. | | |
