**DIVISION OF  
ENVIRONMENTAL  
QUALITY**

RE: Rogers Pollution Control Inspection – PDS #133298 (Benton County)  
AFIN: 04-00155 Permit No.: AR0043397

| <b>ENVIRONMENTAL<br/>QUALITY</b> | <b>OFFICE OF WATER QUALITY<br/>INSPECTION REPORT</b> | | | | |

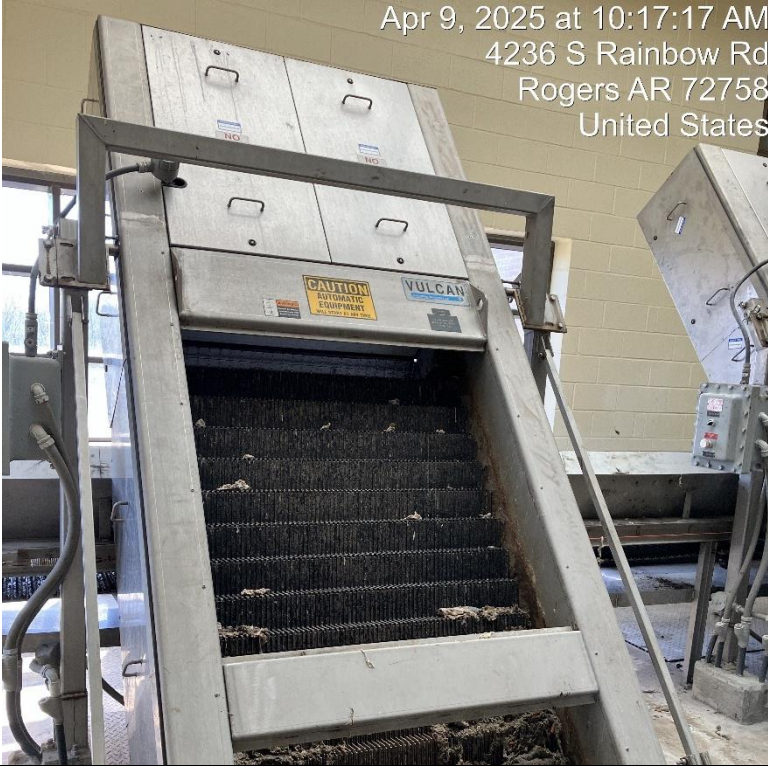
| Office of Water Quality Photographic Evidence Sheet | | | |
|---|---|---|---|
| <b>Automatic bar screen at headworks/influent.</b><br><div style="text-align: right;"> Apr 9, 2025 at 10:17:17 AM<br/> 4236 S Rainbow Rd<br/> Rogers AR 72758<br/> United States </div> | | | |

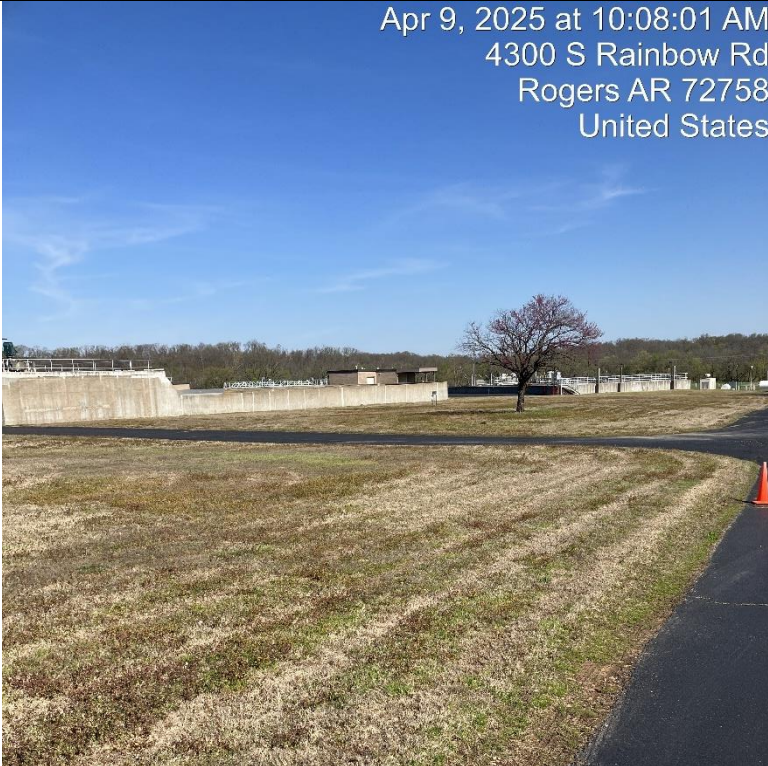
| Office of Water Quality Photographic Evidence Sheet | | | |
|---|---|---|---|
| <b>Location of the future train for secondary treatment.</b><br><div style="text-align: right;"> Apr 9, 2025 at 10:08:01 AM<br/> 4300 S Rainbow Rd<br/> Rogers AR 72758<br/> United States </div> | | | |

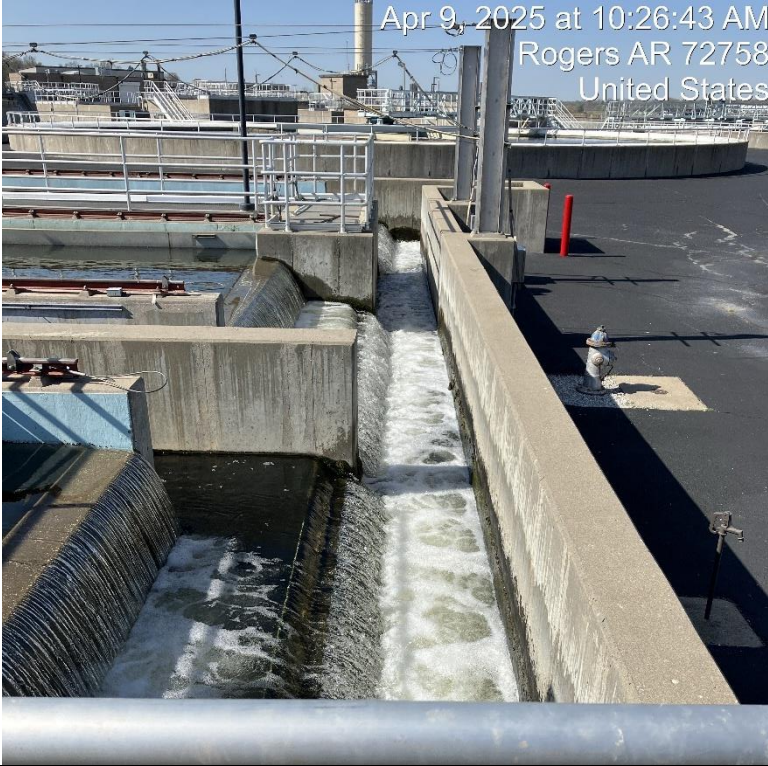
| Office of Water Quality Photographic Evidence Sheet | | | |
|---|---|---|---|
| Description: | <b>Sand filter discharge point to further treatment.</b> | | |

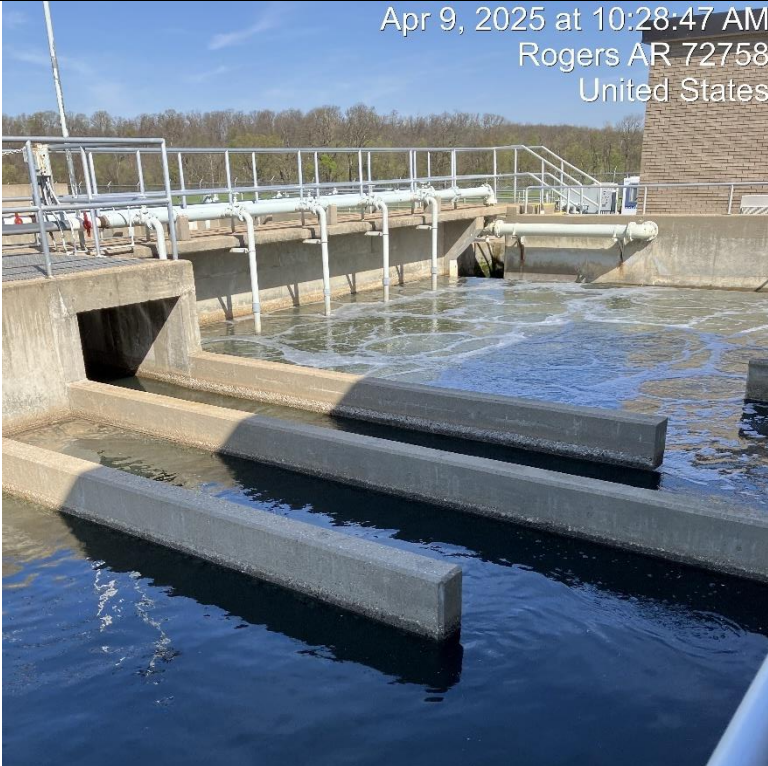
| Office of Water Quality Photographic Evidence Sheet | | | |
|---|---|---|---|
| Description: | <b>Chlorine contact chamber to re-aeration prior to discharging from outfalls.</b> | | |

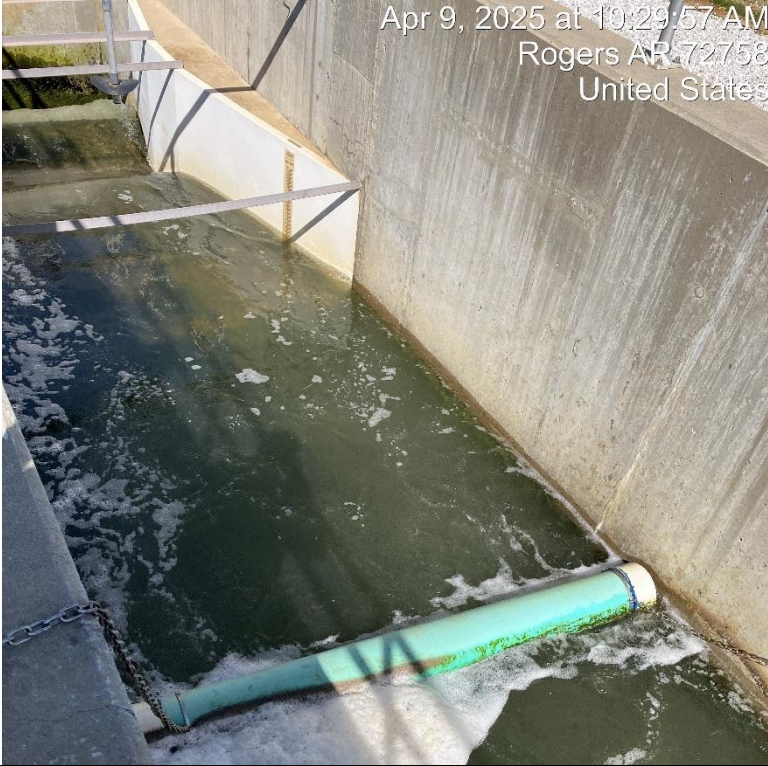
| Type & Size of Primary Flow Measurement Device: 5' Parshall flume | | | | | |

| Office of Water Quality Photographic Evidence Sheet | | | |
|---|---|---|---|
| Description: | <b>Parshall flume for Outfall 001.</b> | | |

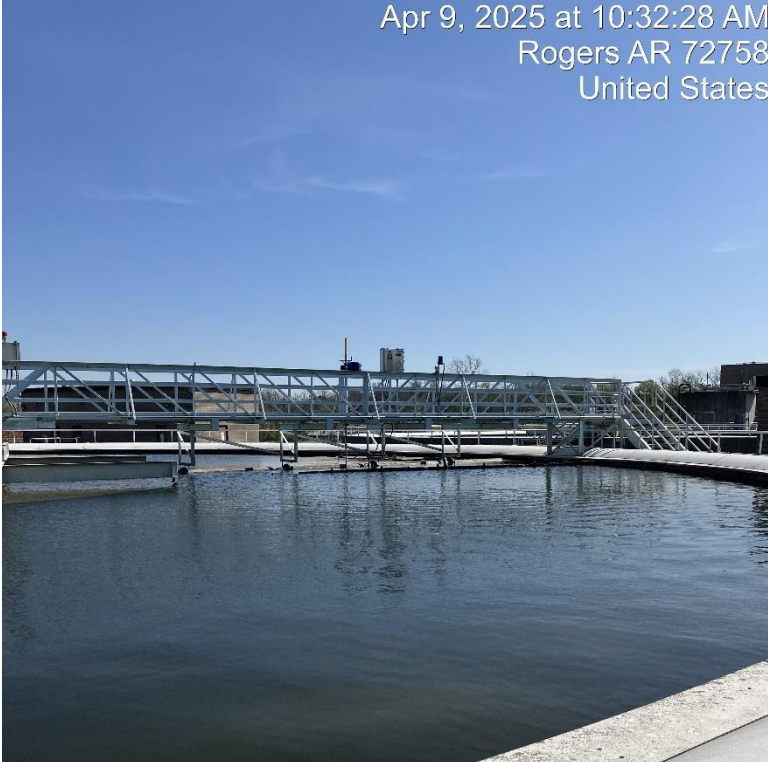
| Office of Water Quality Photographic Evidence Sheet | | | |
|---|---|---|---|
| Description: | <b>Clarifier with minimal biological foam on the surface.</b> | | |

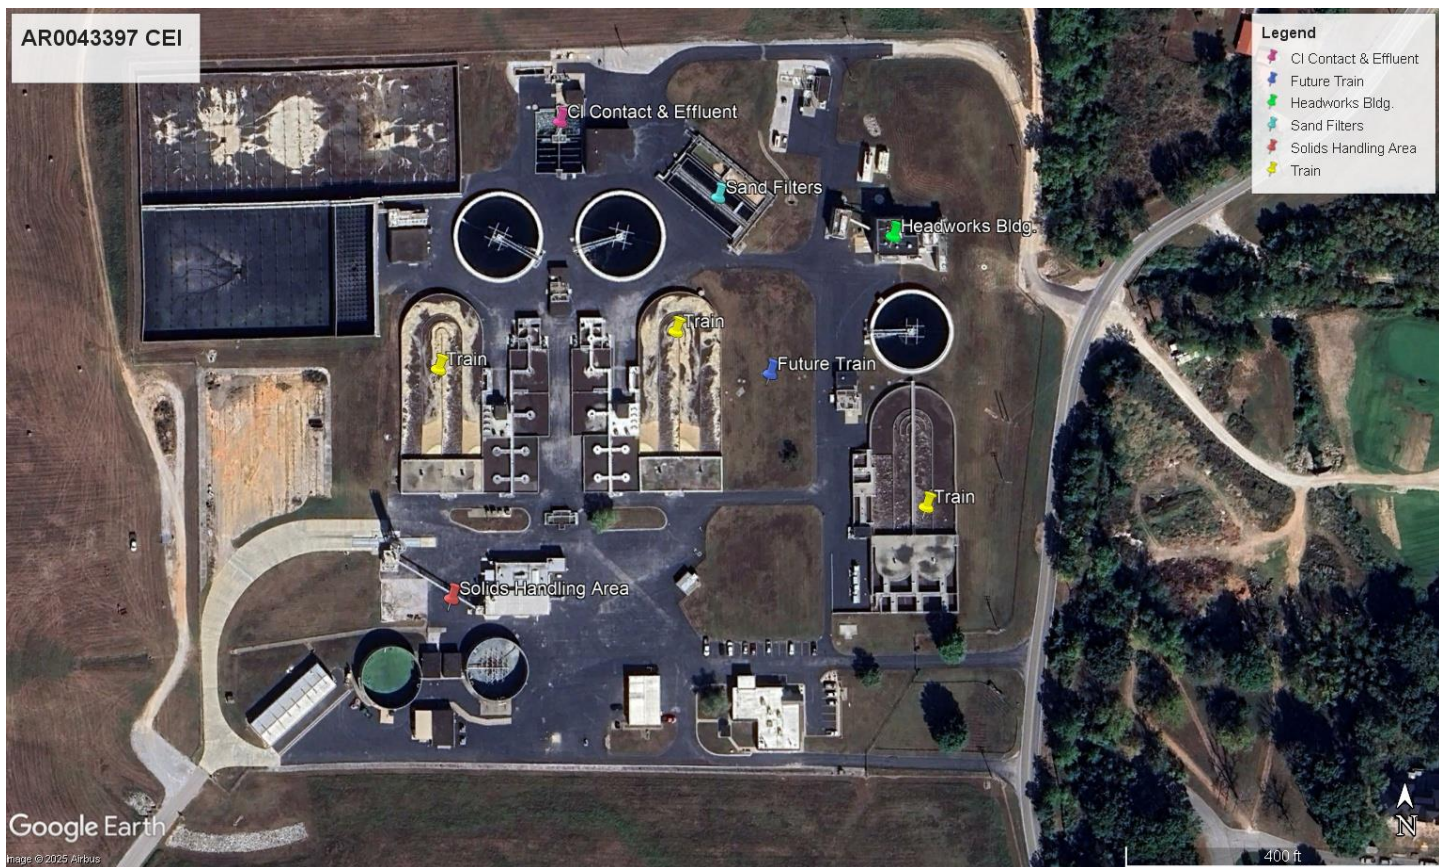
**Attachment 1.** Google Earth satellite imagery with pins labeling the facility's treatment units.
