RE: Paragould Municipal Utilities Inspection PDS# 133494 & 133495 (Greene Co.)  
AFIN: 28-00470 Permit No.: AR0033766

On May 22, 2025, I performed a Compliance Evaluation Inspection and an SSO/Collection System Inspection of the above referenced facility in accordance with the provisions of the Federal Clean Water Act, the Arkansas Water and Air Pollution Control Act, and the regulations promulgated thereunder. Copies of the inspection reports are enclosed for your records.

| <div style="display: inline-block; vertical-align: middle;"> <b>ENVIRONMENTAL<br/>QUALITY</b> </div> | <b>OFFICE OF WATER QUALITY<br/>INSPECTION REPORT</b> | | |

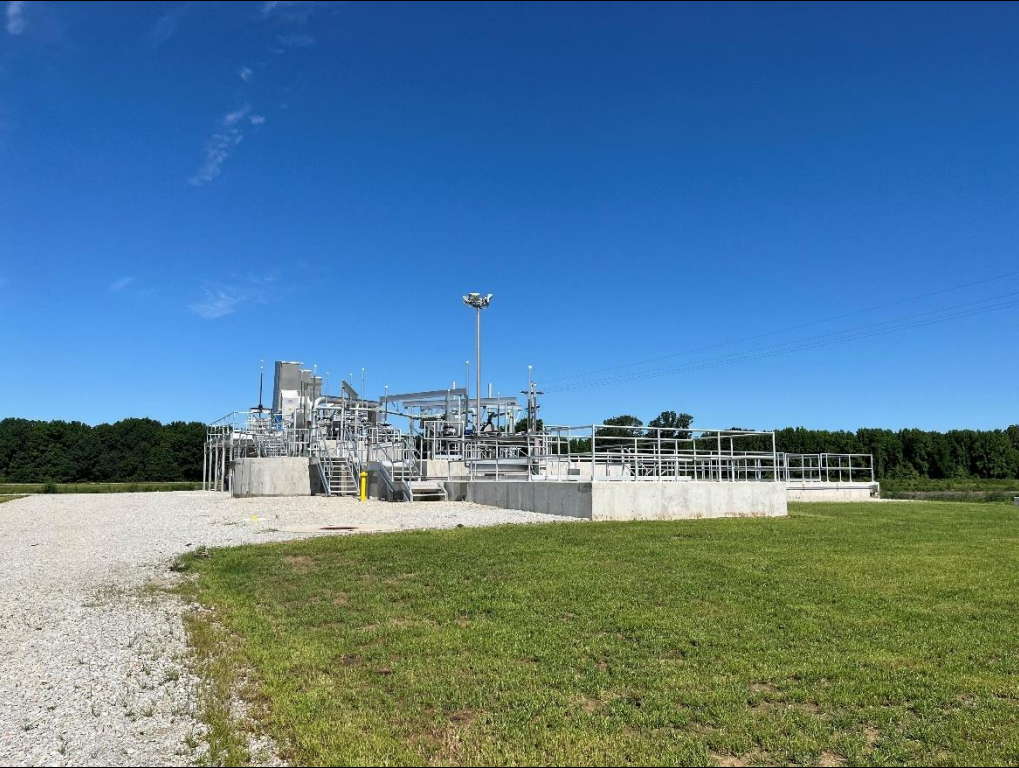
| <p><b>A newly constructed headworks has been added to the treatment system (Photos 1-5). This headworks has helped the facility not only collect more grit than the previous system (Photo 4) but also is a huge asset to the overall treatment of wastewater. This facility is planning on adding another aeration basin for potential industrial and population growth for the City of Paragould.</b></p> <p><b>Walter Kincade and Sarah Harrod, DEQ Inspectors, also participated in this inspection.</b></p> <p><b>An SSO/Collection System Inspection was also performed in conjunction with this inspection. Please view PDS 133495 for more details.</b></p> |

| Office of Water Quality Photographic Evidence Sheet | | | | |
|---|---|---|---|---|
| Description: | <b>View of the newly constructed headworks.</b> | | | |

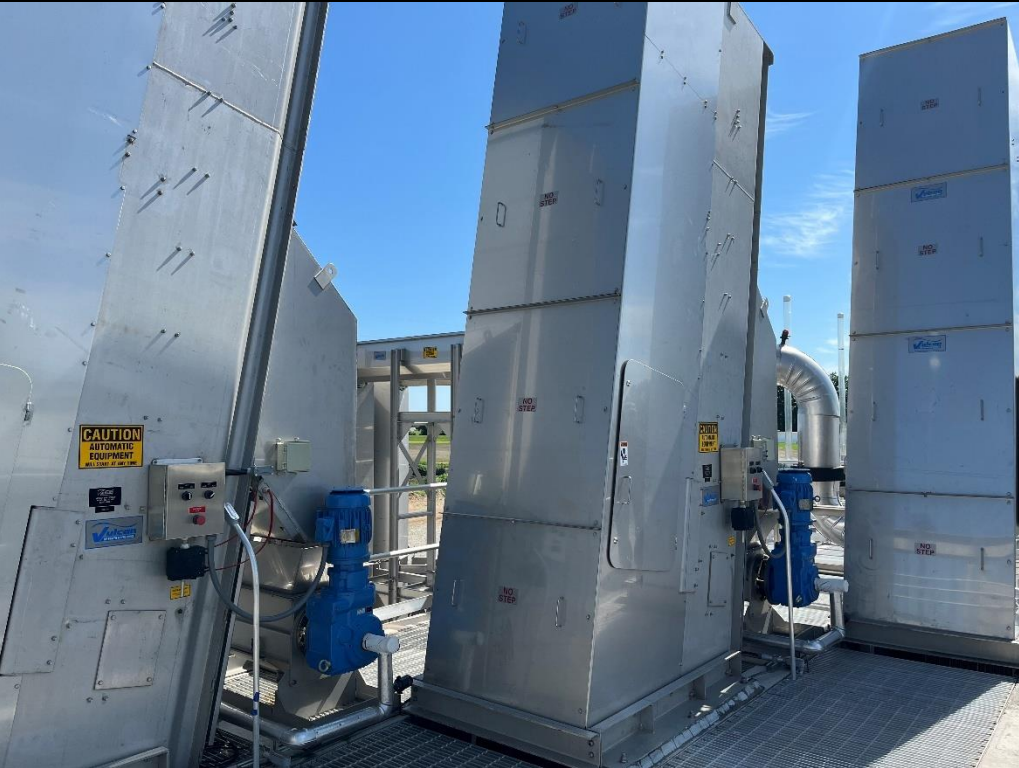
| Office of Water Quality Photographic Evidence Sheet | | | | |
|---|---|---|---|---|
| Description: | <b>View of the automated bar screen to the headworks.</b> | | | |

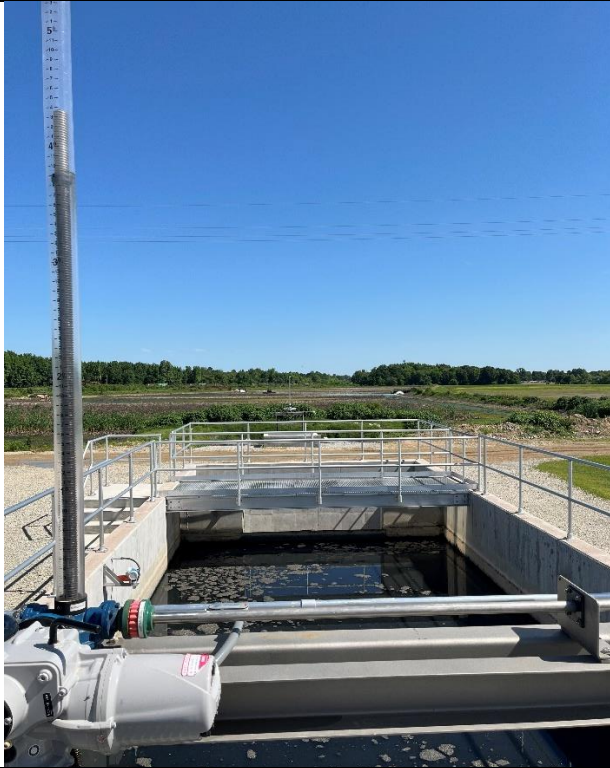
| Office of Water Quality Photographic Evidence Sheet | | | |
|---|---|---|---|
| Photo #: | <b>3</b> | | |

| Office of Water Quality Photographic Evidence Sheet | | | |
|---|---|---|---|
| Description: | <b>View of the holding cell for rainfall events.</b> | | |

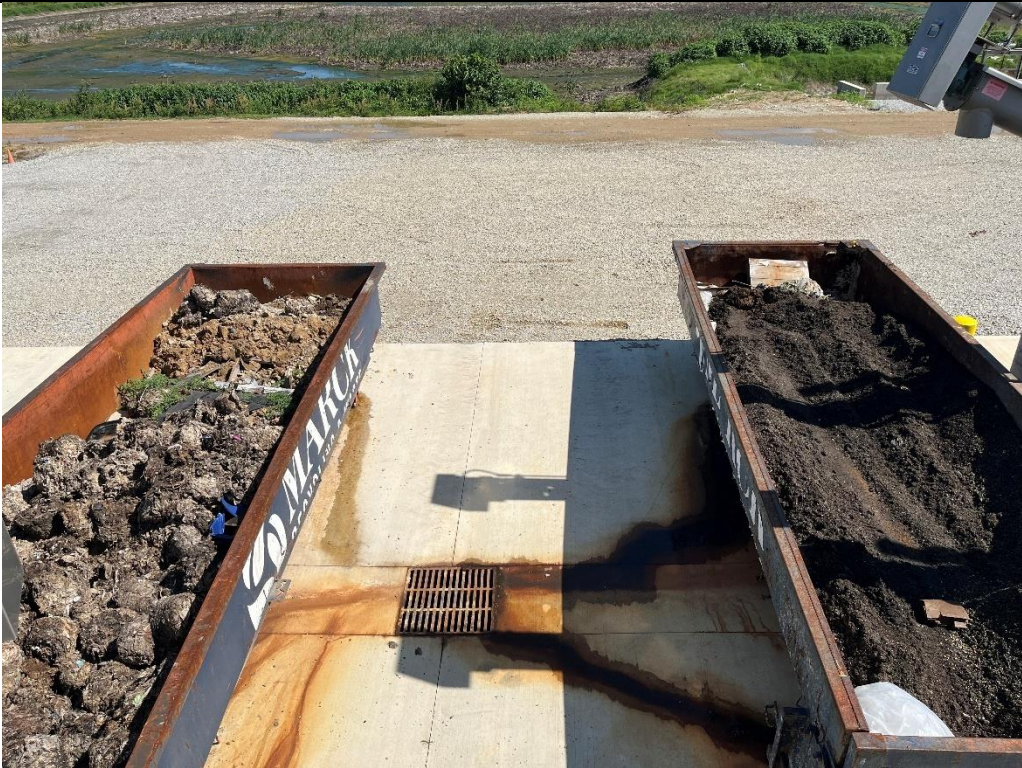
| Office of Water Quality Photographic Evidence Sheet | | | |
|---|---|---|---|
| Photo #: | <b>4</b> | | |

| Office of Water Quality Photographic Evidence Sheet | | | |
|---|---|---|---|
| Description: | <b>View of the roll-off dumpsters. Note the amount of grit collected.</b> | | |

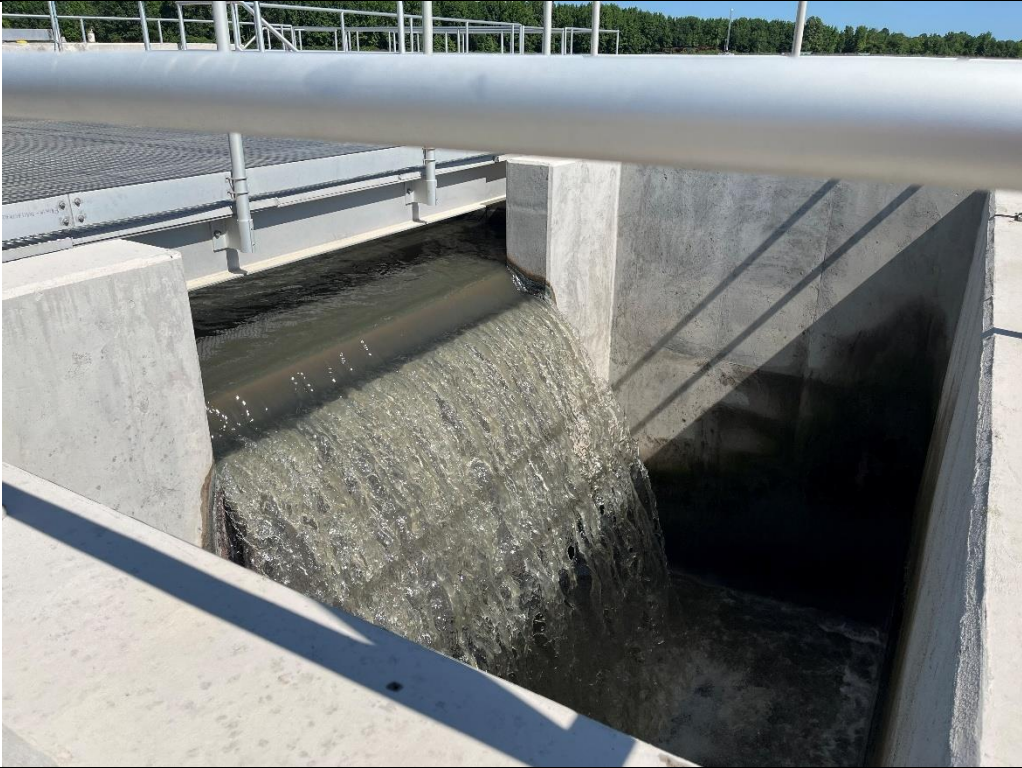
| Office of Water Quality Photographic Evidence Sheet | | | | |
|---|---|---|---|---|
| Witness: | <b>Walter Kincade and Sarah Harrod</b> | | Photo #: | <b>5</b> |

| Office of Water Quality Photographic Evidence Sheet | | | | |
|---|---|---|---|---|
| Description: | <b>View of the influent entering the wastewater treatment plant.</b> | | | |

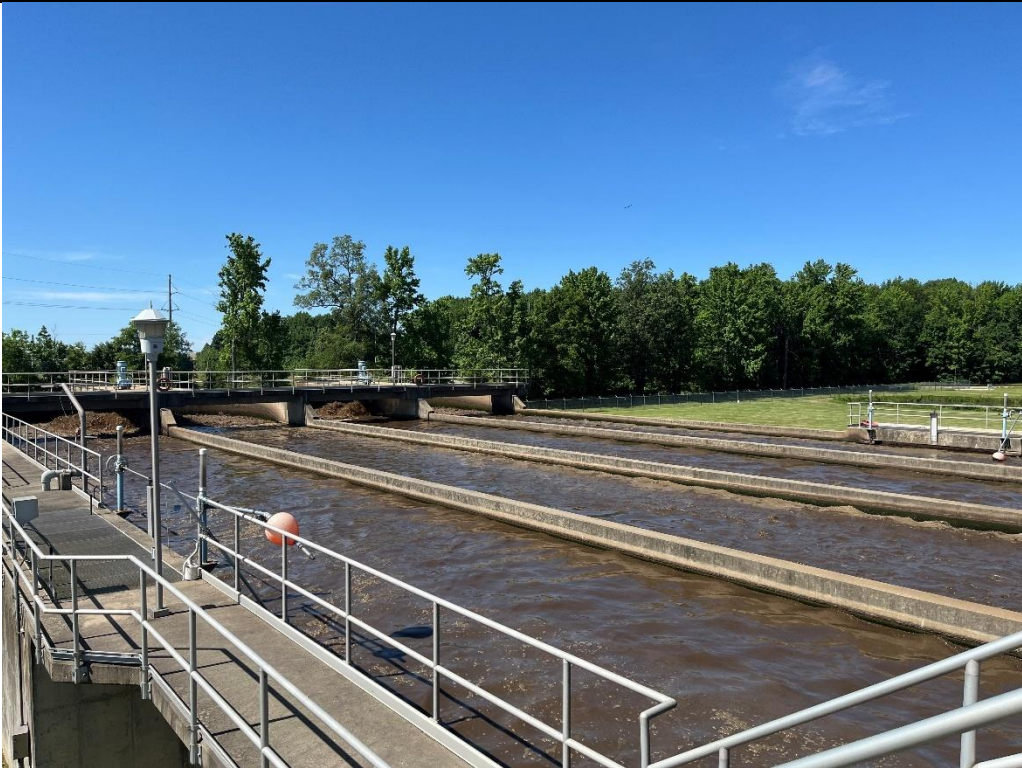
| Office of Water Quality Photographic Evidence Sheet | | | | |
|---|---|---|---|---|
| Witness: | <b>Walter Kincade and Sarah Harrod</b> | | Photo #: | <b>6</b> |

| Office of Water Quality Photographic Evidence Sheet | | | | |
|---|---|---|---|---|
| Description: | <b>View of the aeration basin.</b> | | | |

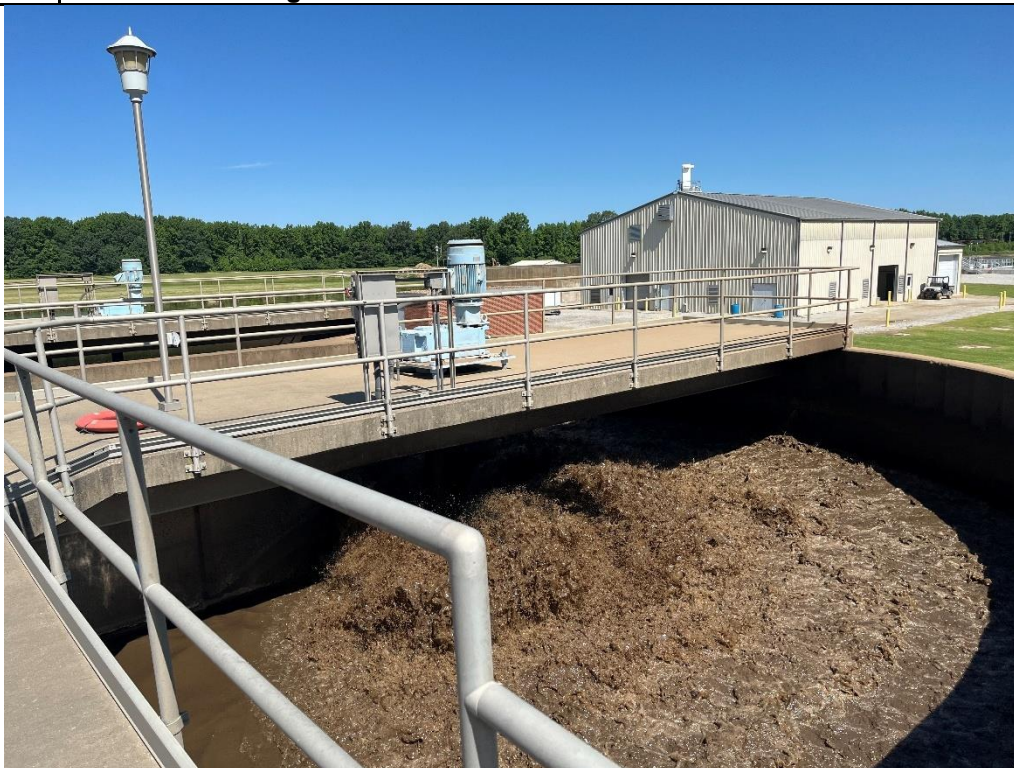
| Office of Water Quality Photographic Evidence Sheet | | | |
|---|---|---|---|
| | | Photo #: | <b>7</b> |

| Office of Water Quality Photographic Evidence Sheet | | | |
|---|---|---|---|
| Description: | <b>View of the mixing wheel of the aeration basin.</b> | | |

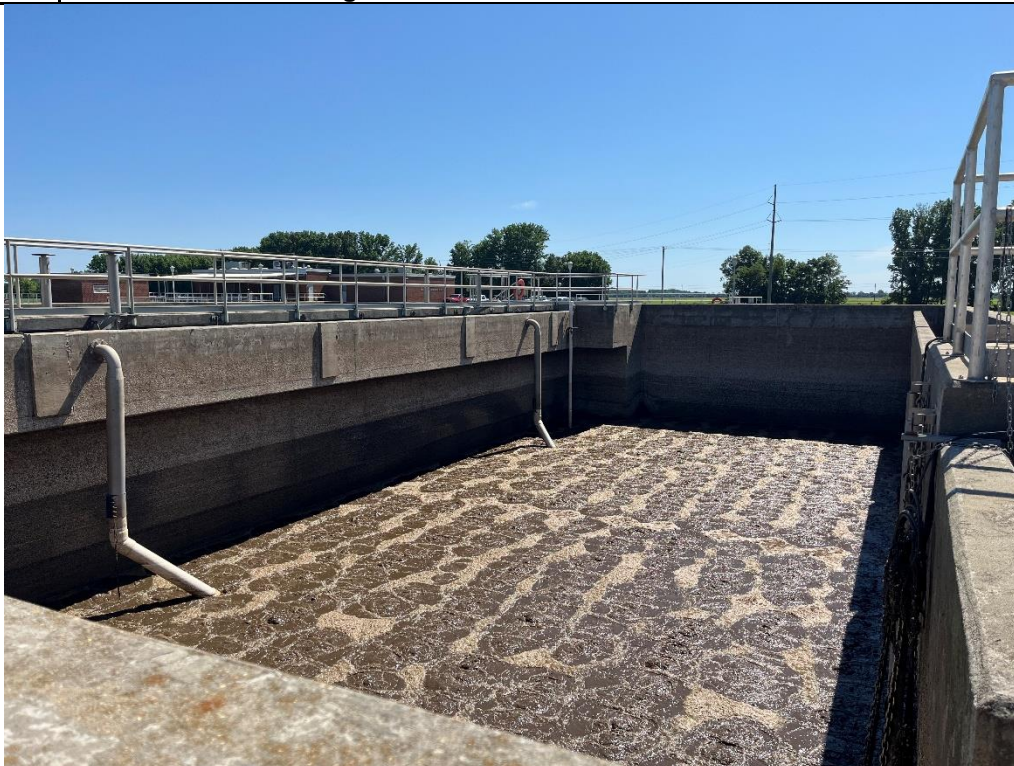
| | | Photo #: | <b>8</b> |

| Description: | <b>View of the aerobic digesters.</b> | | |

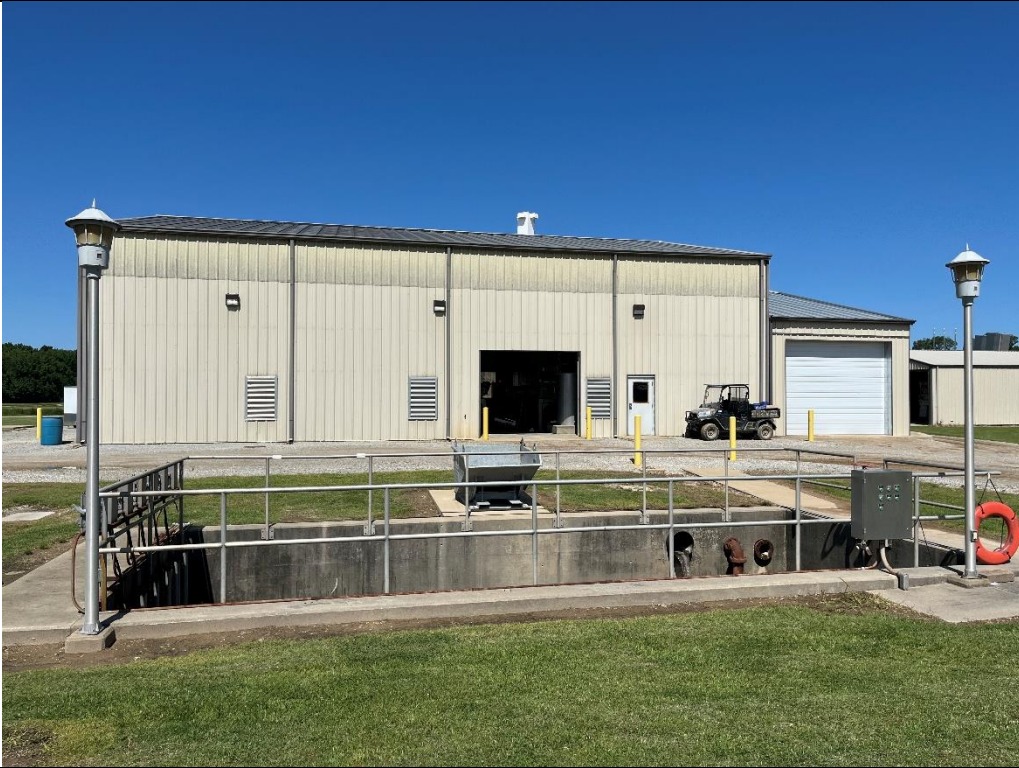
| | | Photo #: | <b>9</b> |

| Description: | <b>Overview of the biosolids building.</b> | | |

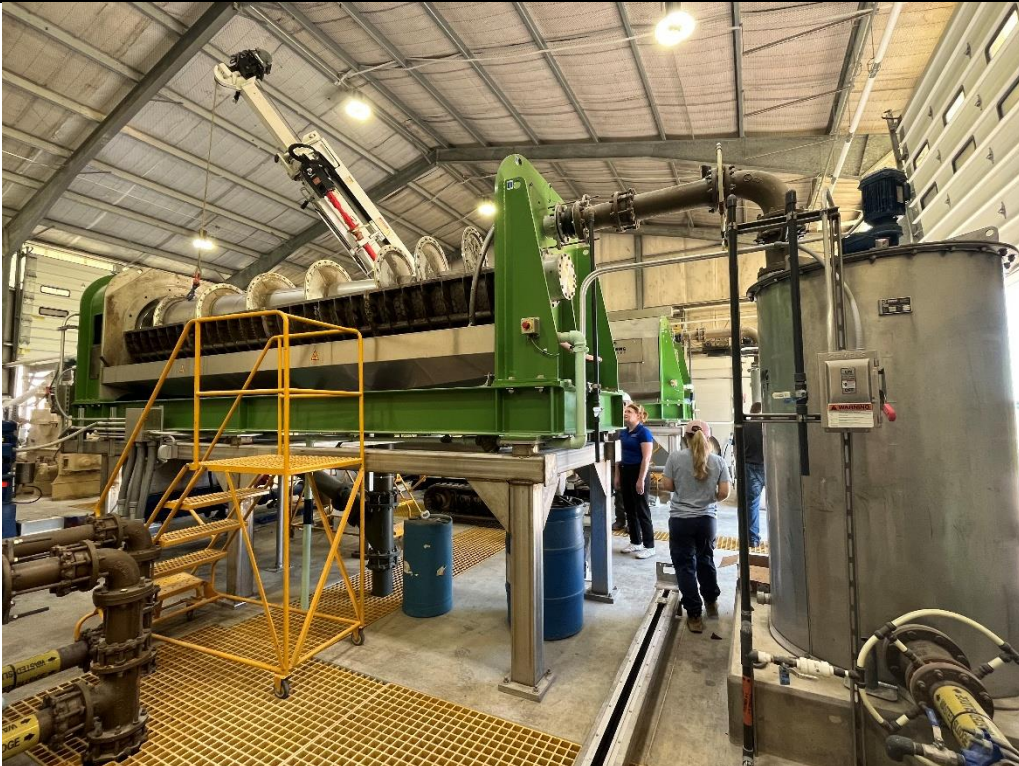
| | | Photo #: | <b>10</b> |

| Description: | <b>View of the inside of the biosolids building. Note the repairs to the screw press.</b> | | |

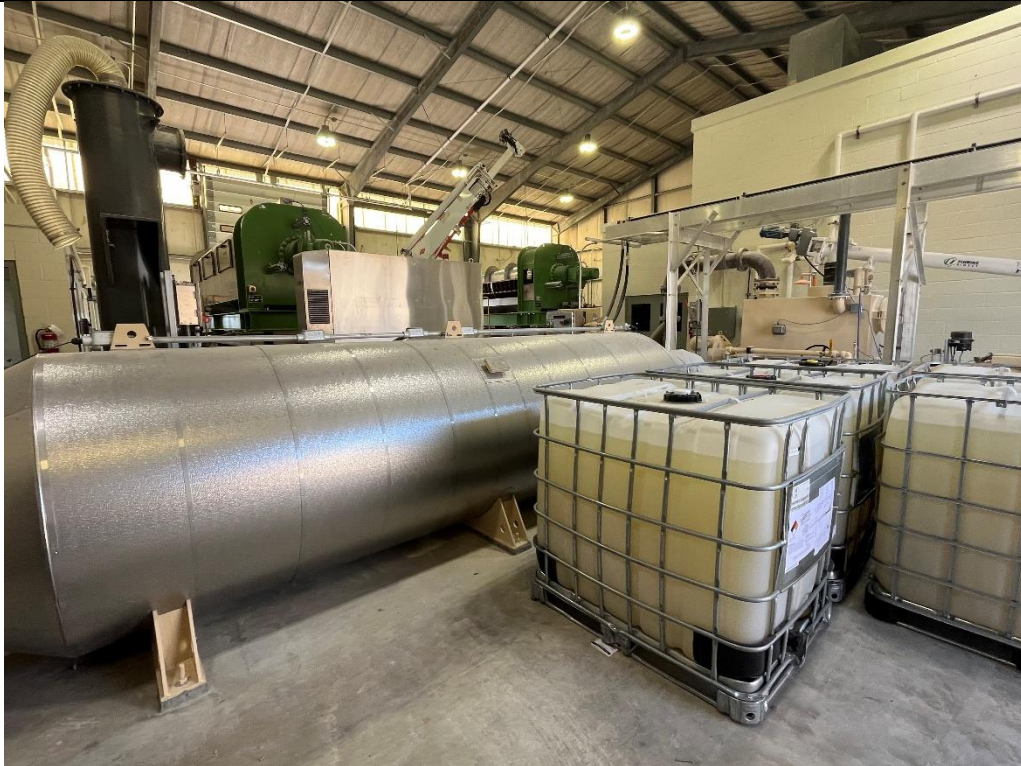
| Office of Water Quality Photographic Evidence Sheet | | | |
|---|---|---|---|
| Description: | <b>View of the biosolids processing.</b> | | |

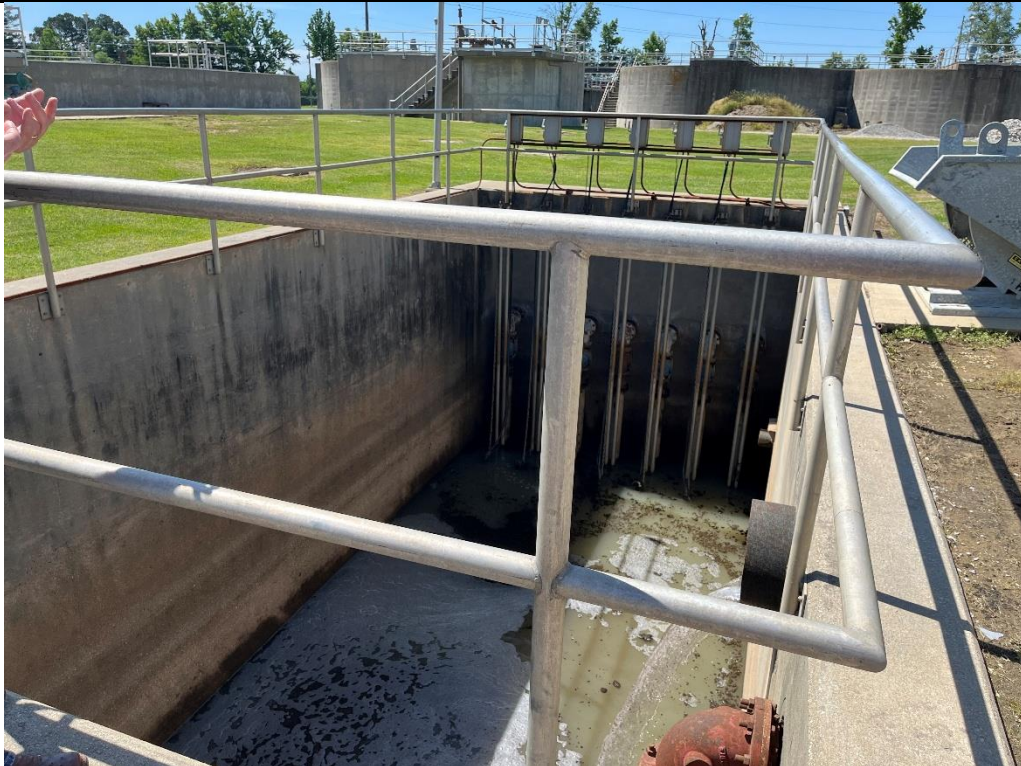
| Description: | <b>View of the return water from the biosolids processing.</b> | | |

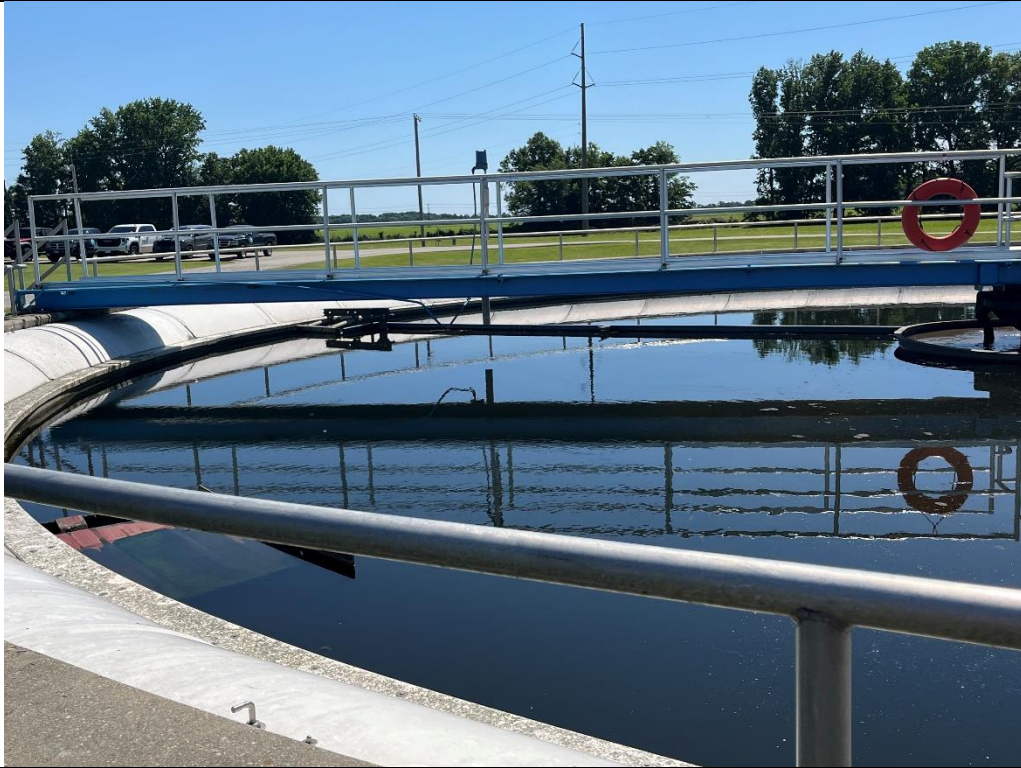
| Description: | <b>View of the clarifier.</b> | Photo #: | <b>13</b> |

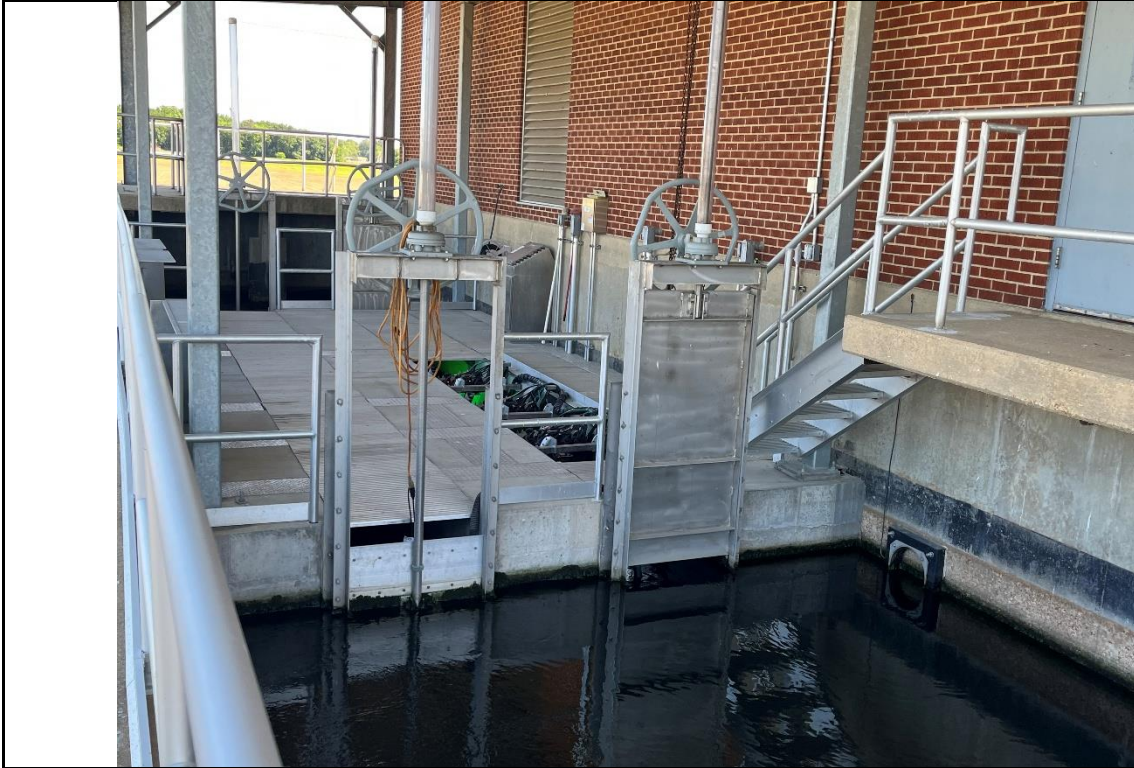
| Description: | <b>View of the UV system.</b> | | |

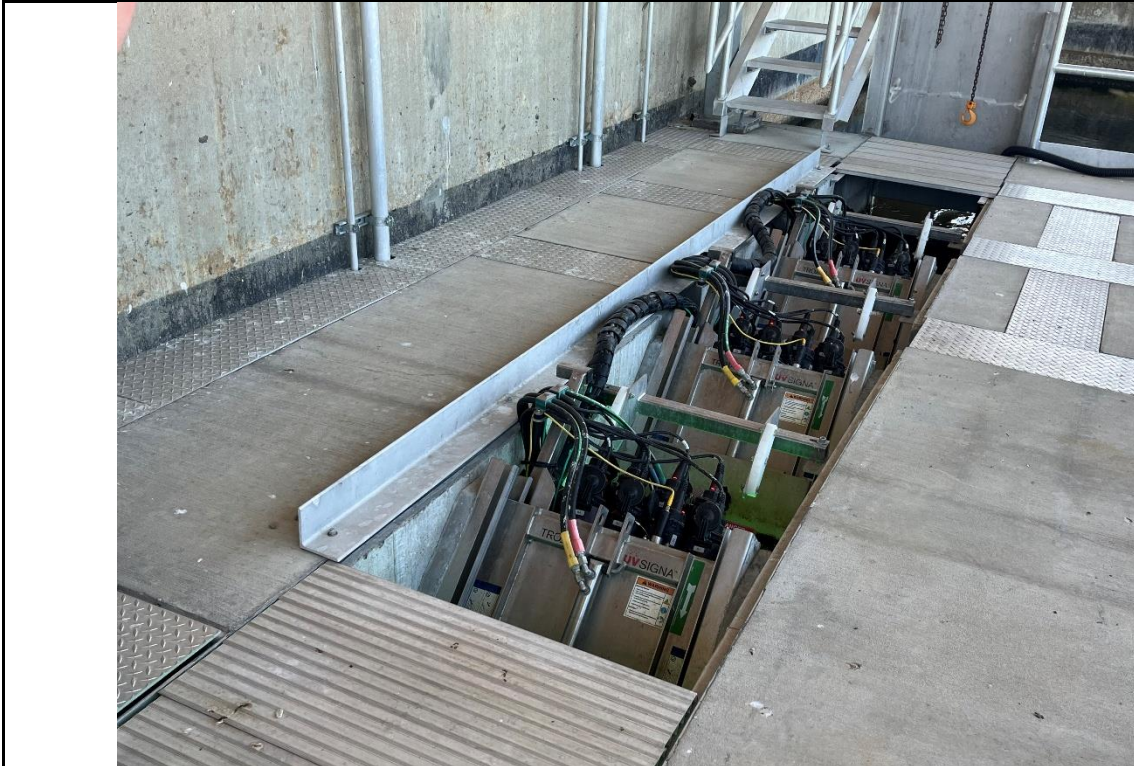
| Description: | <b>Close-up view of the UV disinfection system.</b> | | |

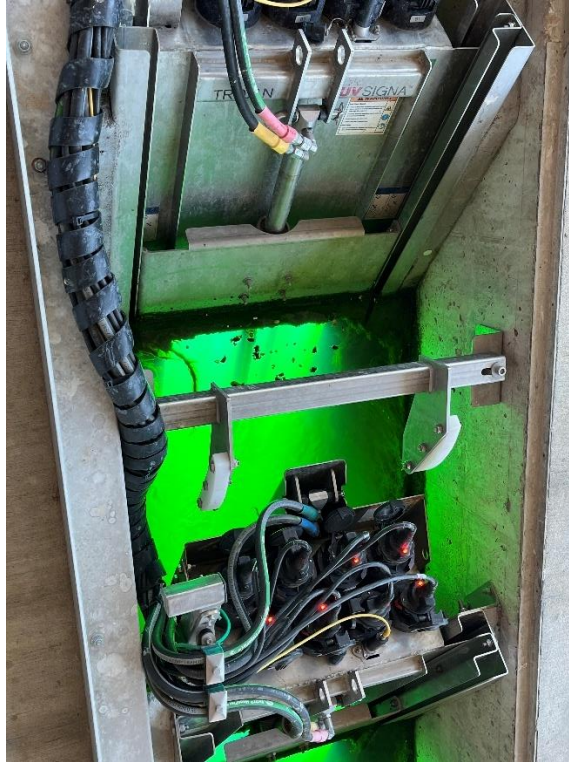
| | | Photo #: | <b>17</b> |

| Description: | <b>View of the UV disinfection in the water.</b> | | |

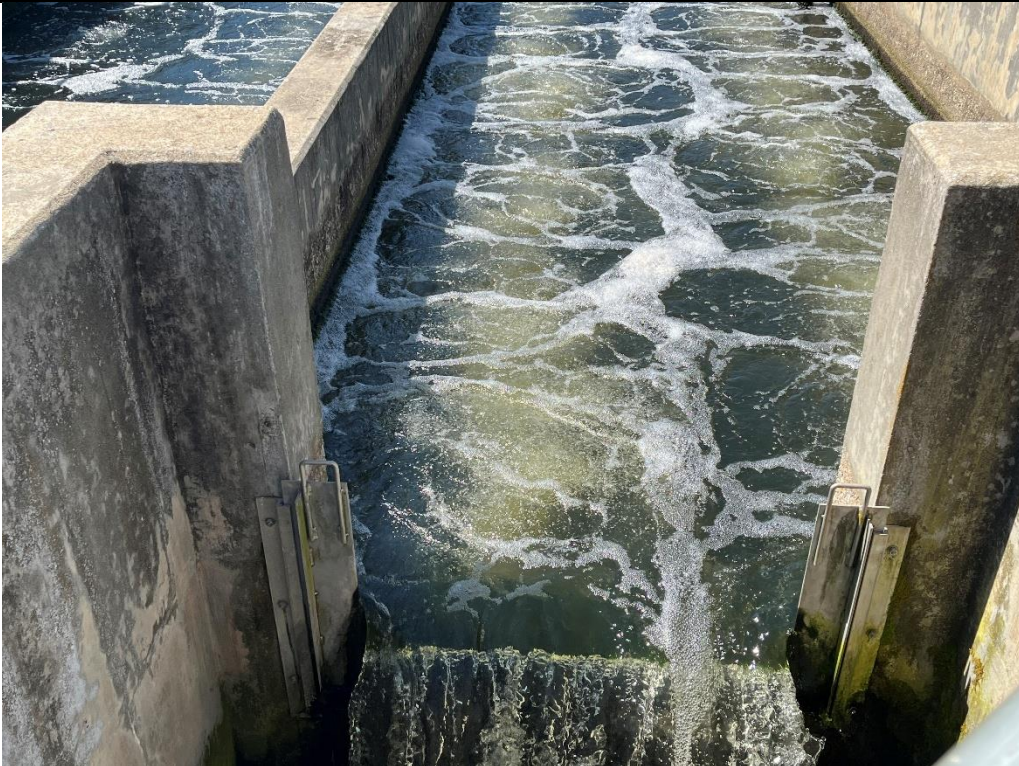
| | | Photo #: | <b>18</b> |

| SECTION D: SAMPLING | |
|---|---|
| 1. PRIMARY FLOW MEASUREMENT DEVICE PROPERLY INSTALLED AND MAINTAINED: <u>Yes</u> TYPE OF DEVICE: <u>4 ft. Rectangular weir with end contractions</u> | <input checked="" type="checkbox"/> Y <input type="checkbox"/> N <input type="checkbox"/> NA <input type="checkbox"/> NE |

| Description: | <b>View of the rectangular weir.</b> | | |

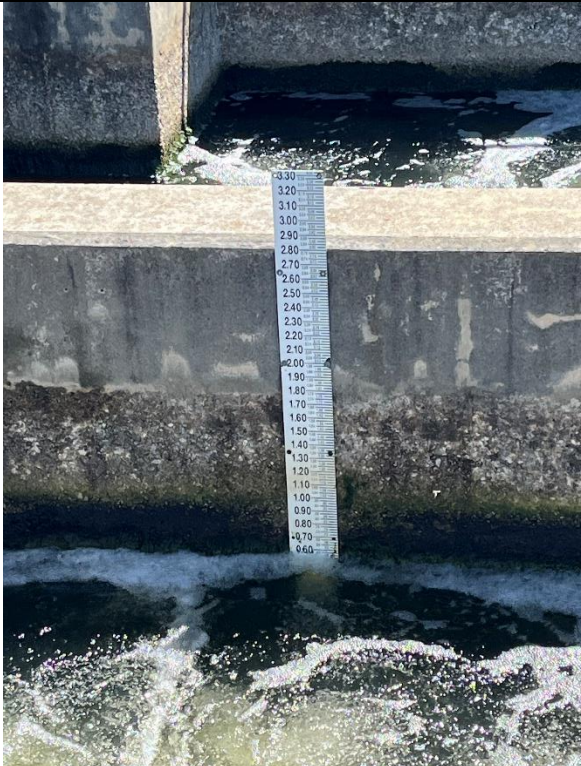
| Office of Water Quality Photographic Evidence Sheet | | | |
|---|---|---|---|
| Photo #: | <b>19</b> | | |

| Office of Water Quality Photographic Evidence Sheet | | | |
|---|---|---|---|
| Description: | <b>View of the staff gauge at the outfall structure.</b> | | |

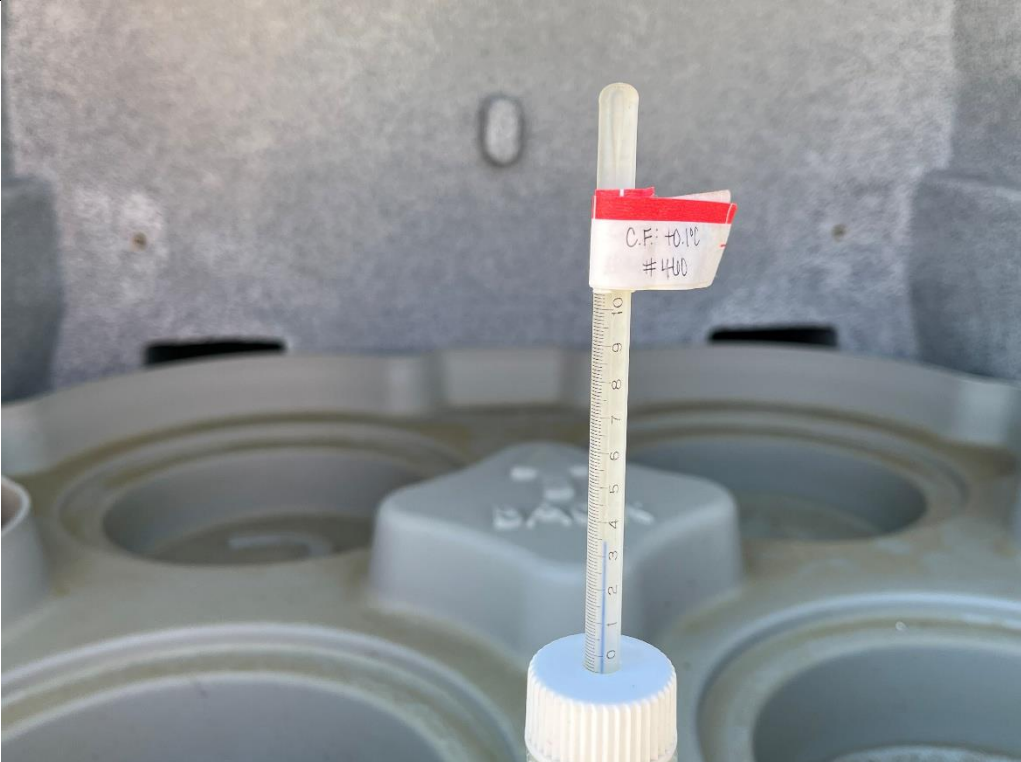
| Photo #: | <b>20</b> | | |

| Description: | <b>View of the thermometer used in the sampler. Note the temperature lower than 4°C.</b> | | |
